POST COLLISION VEHICLE FIRE ANALYSIS

Markus Egelhaaf

DEKRA Automobil GmbH, Accident Research Stuttgart
Germany

DEKRA Automobil GmbH, Heilbronn Office
Germany
Paper Number 11-0315

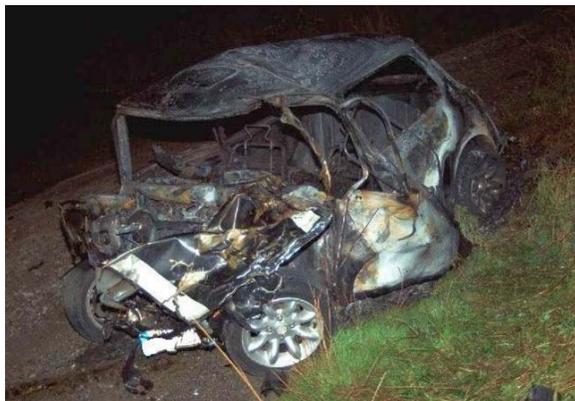
Figure 2. Severely damaged Mini Cooper after a frontal crash against a truck's side [16]

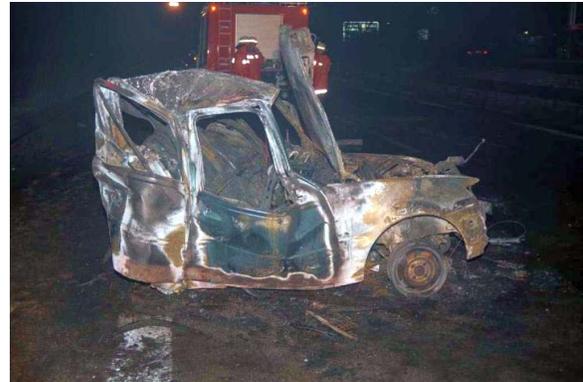
Figure 3. Passenger car after a car-on-car impact resulting in fire due to a bursting fuel tank [16]

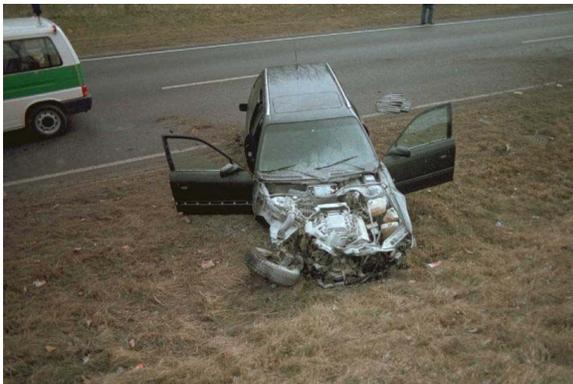
An Audi was travelling on a country road. When overtaking a truck it collided with an oncoming car, resulting in a fire in the engine compartment due to an electrical short circuit. The fire was extinguished soon after ignition with a fire extinguisher, Figure 4.

Figure 4. Engine fire after short circuit

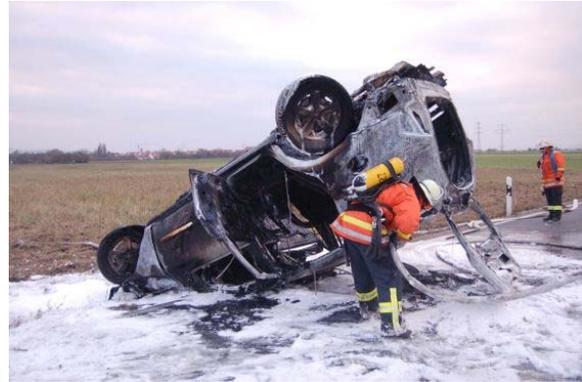
A new Mercedes GL went off the road while speeding and rolled over in the neighbouring field when its wheels became stuck. Even though there were only minor deformations, an edge of the hood pinched the wiring harness, producing a short circuit. When the fire department arrived on the scene about 10 to 12 minutes after the accident, the vehicle was completely ablaze, Figure 5.

Figure 5. Rollover with only little deformations of the vehicle followed by a fire

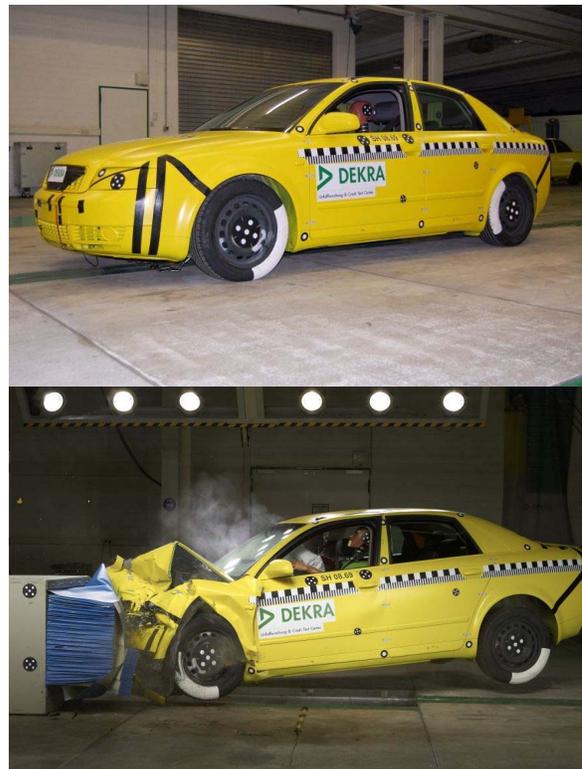
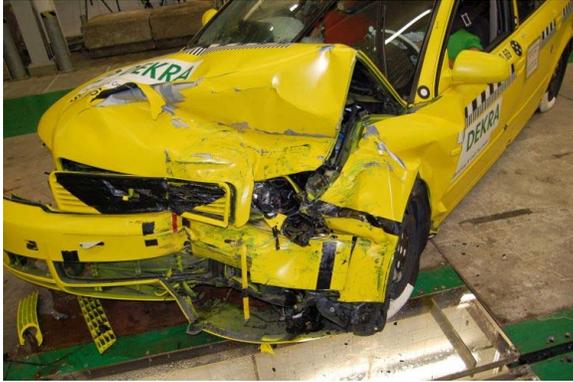
The first Audi was crashed against a deformable barrier at a speed of 58.1km/h (36.1mph) and with 40% overlap. The crash weight was measured at 1,610kg (3,542lbs). The 40% overlap was chosen so the results could be compared with those obtained in Euro NCAP and ECE-R 94 tests, Figure 6.

Figure 6. Crash test with a collision speed of 58.1km/h and the resulting deformations

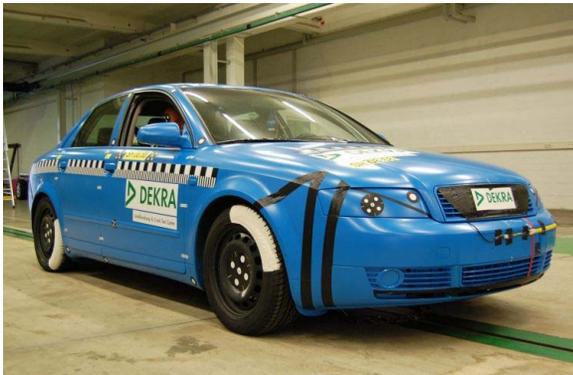
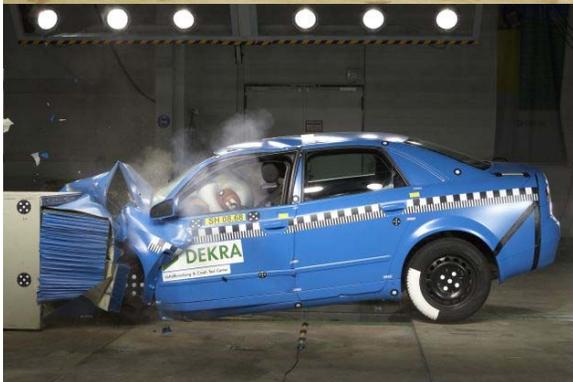
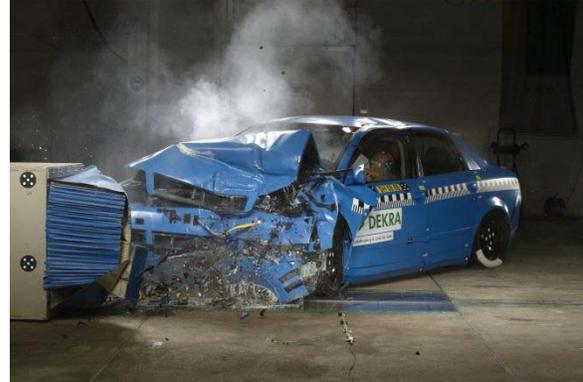
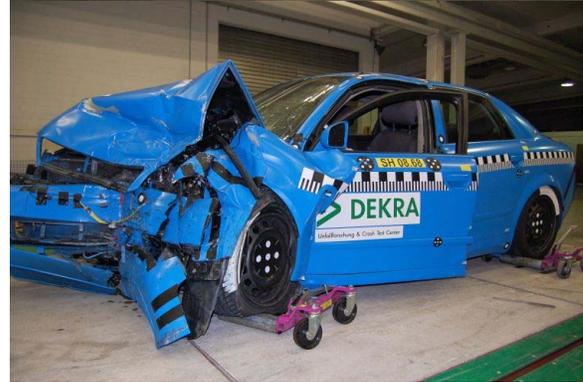
The second Audi was crashed against a deformable barrier at a speed of 68.9km/h (42.8mph) and with 40% overlap. The crash weight was measured at 1,620kg (3,564lbs), Figure 7.

Figure 7. Crash test with a collision speed of 68.9km/h and the resulting deformations

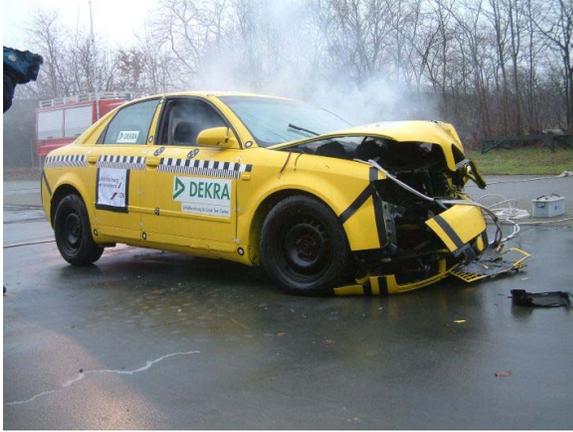
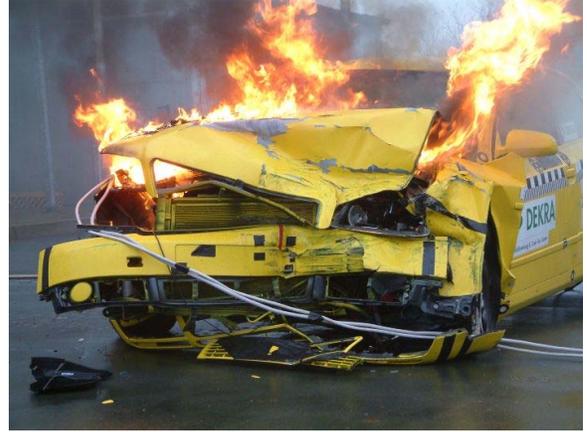
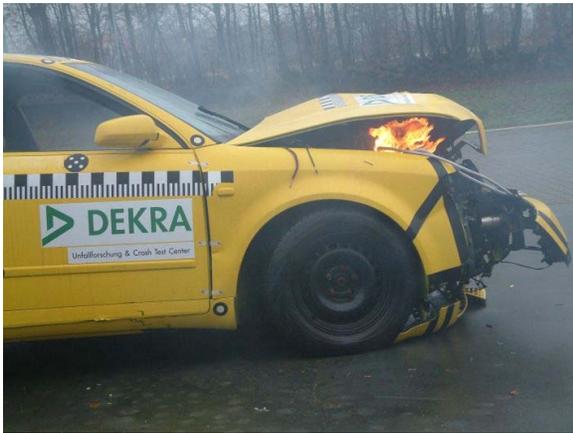
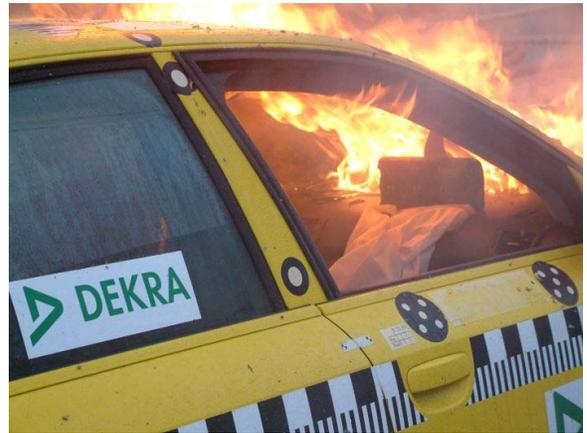
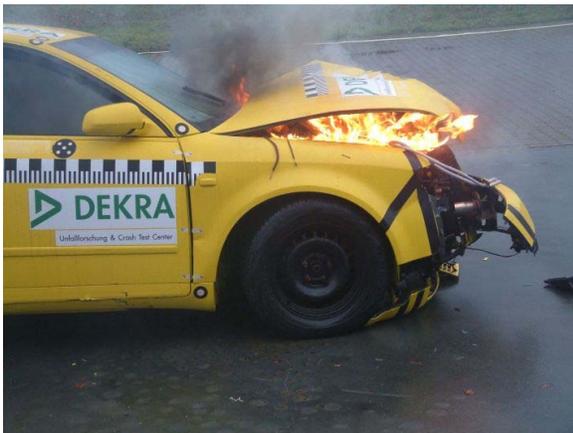
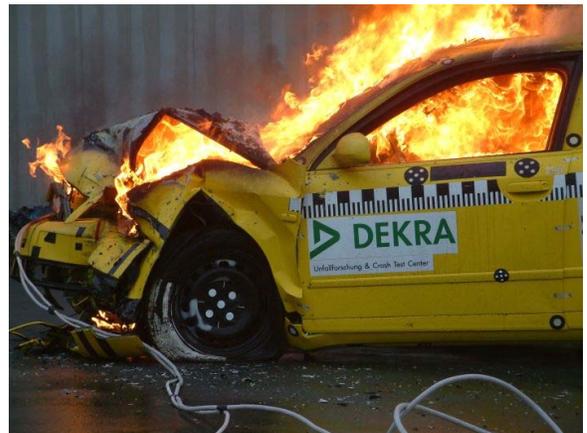
Figure 9. Sequence of fire test 1

Subjective findings: immediately after energizing the wire, white smoke was emitted. The ventilation system was still working and transporting the smoke into the passenger compartment. About 30 seconds after t_0 , white smoke was visible at the driver's seat. The smoke density in the passenger compartment depended on the wind direction (both front windows were open). The compartment was filled with smoke at a very early point in time. Fire-fighting was complicated by burning light metals in the passenger compartment.

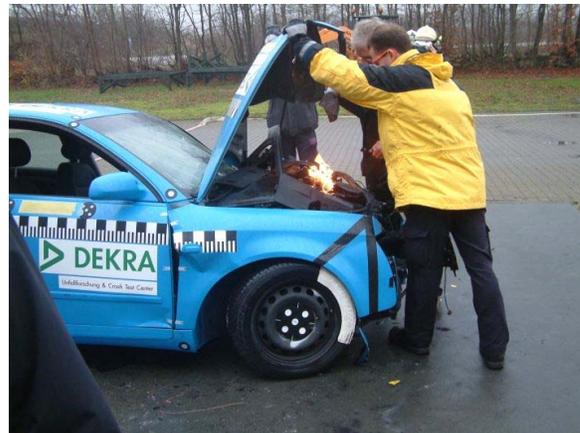
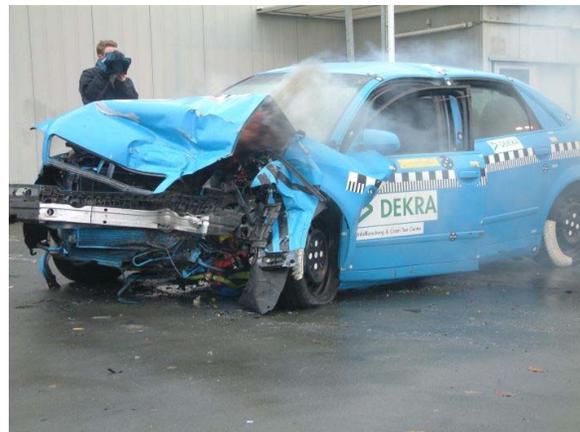
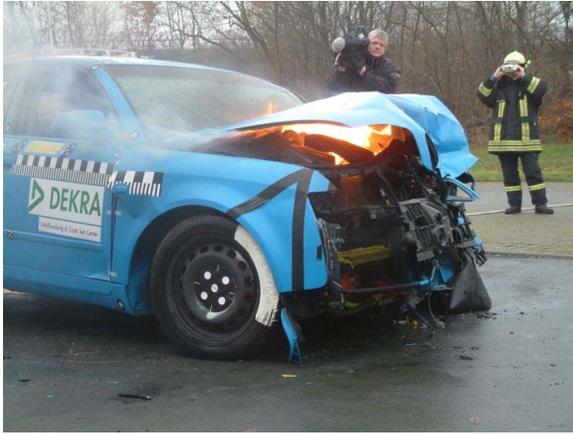
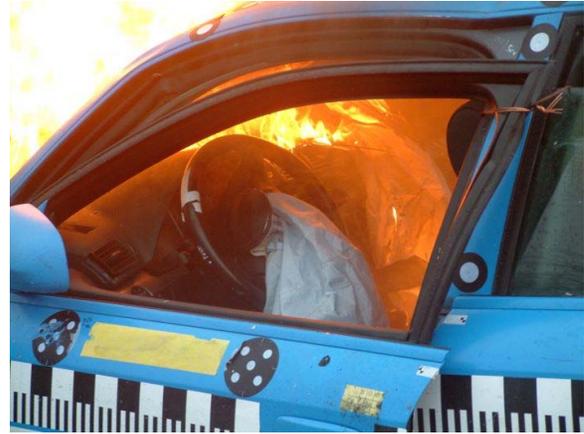
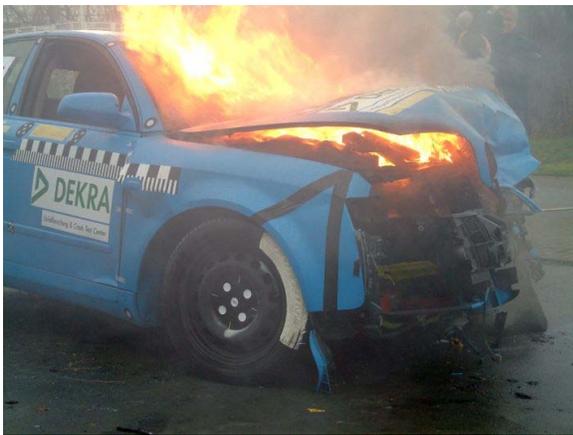
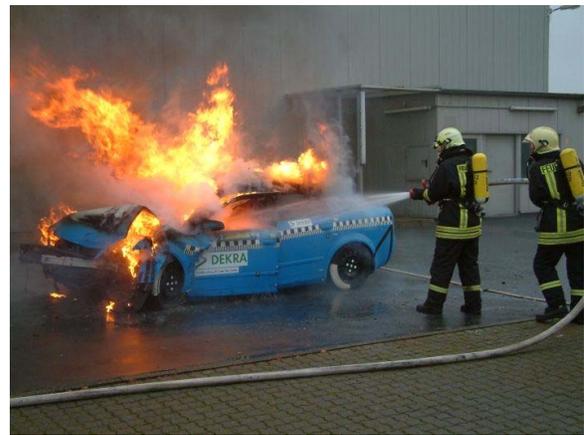
Figure 10. Sequence of fire test 2

Subjective findings: immediately after ignition, white smoke was emitted. 30 seconds later, nearly no smoke was visible any more. A vehicle fire was not perceptible before second 166. Starting at that point, it took only a little more than 5 minutes to a fully developed fire in the engine and passenger compartment.

Due to the compression of the components in the engine compartment, fire damage was limited to the top of the engine. Fire did not spread to the lower parts of the engine.

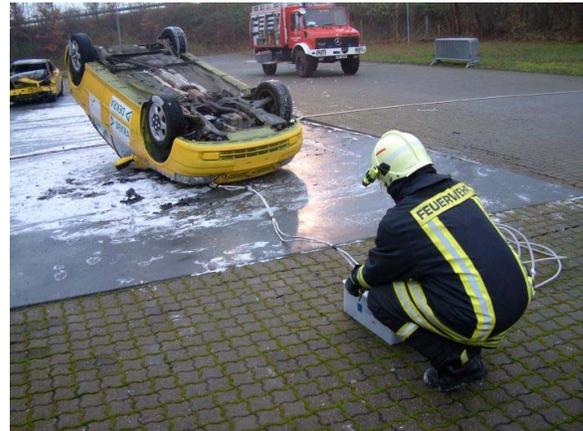
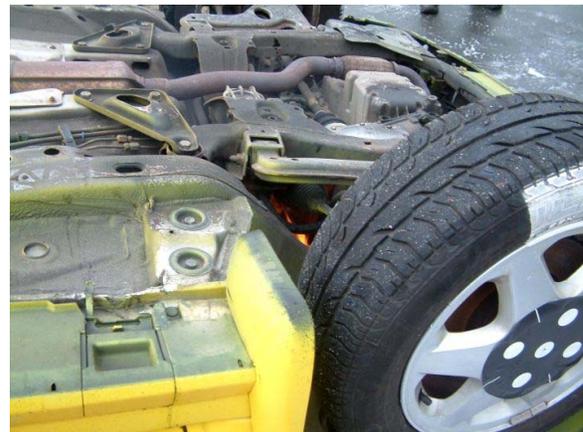
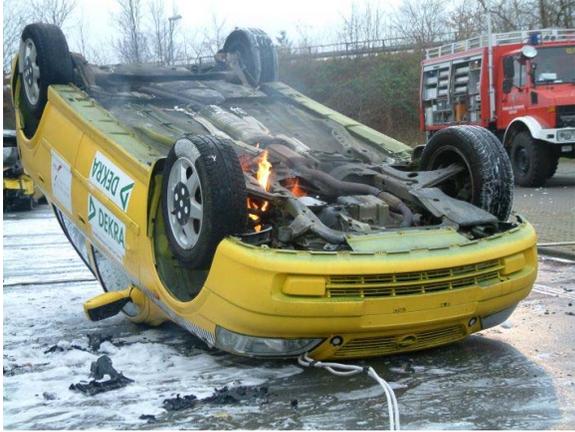
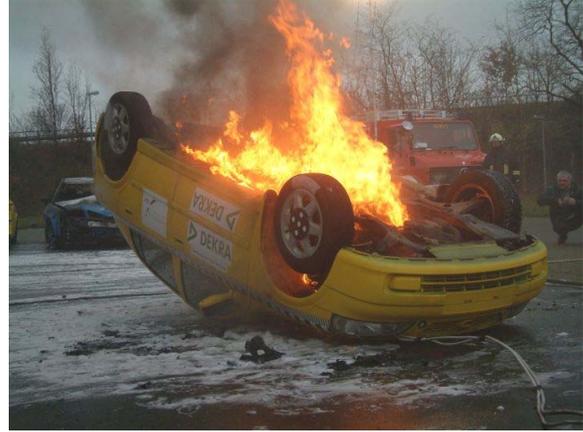
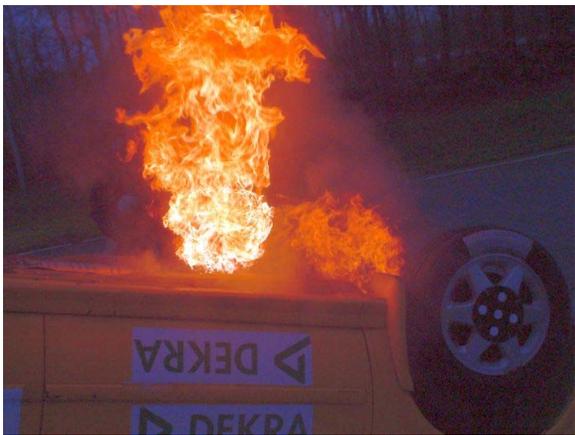
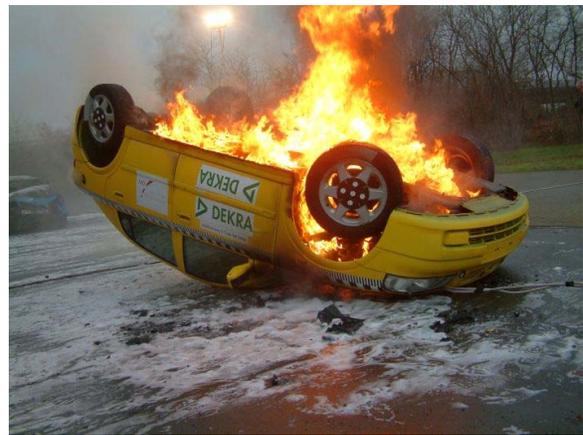
Figure 12. Sequence of fire test 3

Subjective findings: nearly no smoke was visible during the first 216 seconds. With the fire burning along the fuel line, the fire spread along the vehicle's underbody towards the rear axle and fuel tank. Only a few seconds elapsed from when smoke first entered the passenger compartment until it was completely filled with thick smoke. Fire-fighting was complicated by burning light metals in the engine compartment.
