A CONTINUOUS VIDEO RECORDING SYSTEM ON A LAP-BELT EQUIPPED SCHOOL BUS: REAL-WORLD OCCUPANT KINEMATICS AND INJURIES DURING A SEVERE SIDE IMPACT CRASH

National Transportation Safety Board
USA

Paper Number 15-0253

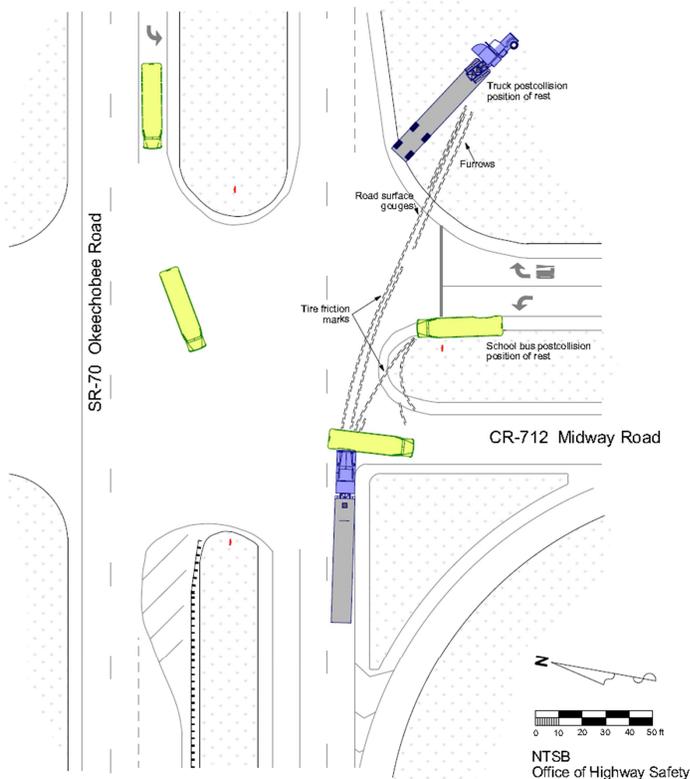
Figure 1. The crash scene diagram.

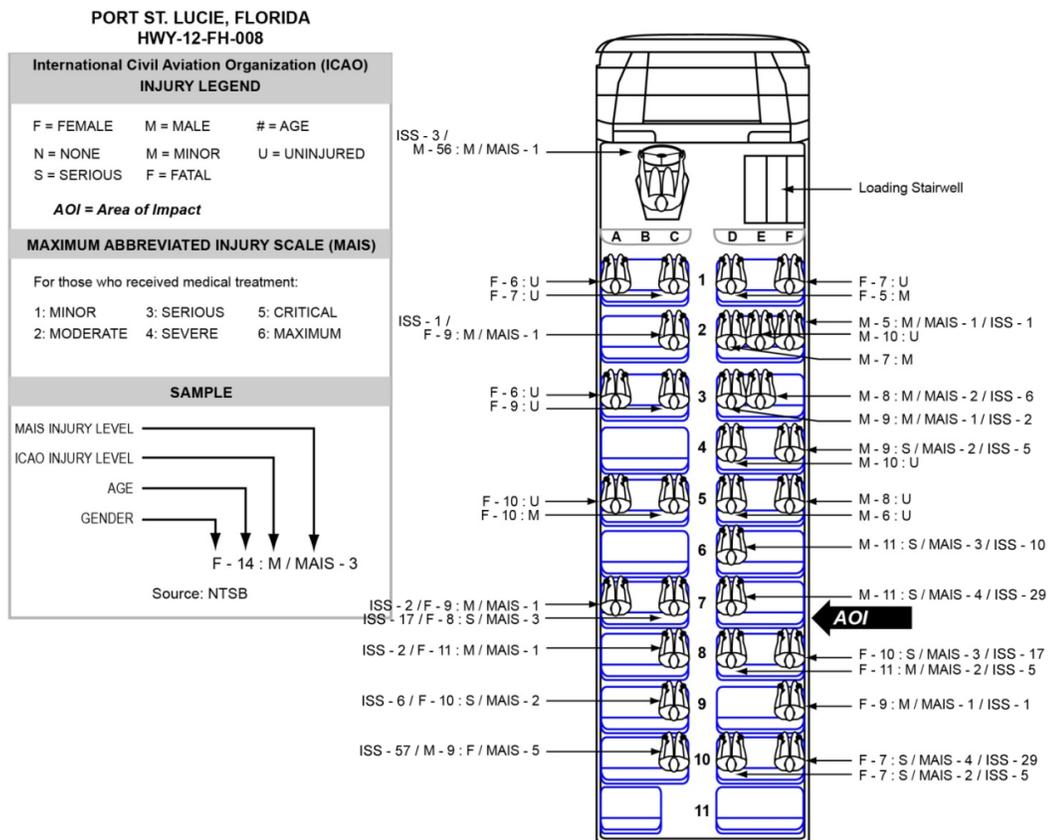
The seating chart established based on the continuous onboard video system is shown in **Figure 3**. All occupants are marked with the ICAO code. For those occupants with medical records, the maximum AIS level and the ISS score are also documented. In addition, occupant gender and age are listed. Seating positions were labeled based on the seat row (1-11) and the seat position (A-F from left to right as viewed from the back). The area of impact (AOI) is shown on the chart. Additional details on the injury documentation are included in the NTSB’s Highway Safety Report – Commercial Vehicle Onboard Video Systems. [11]

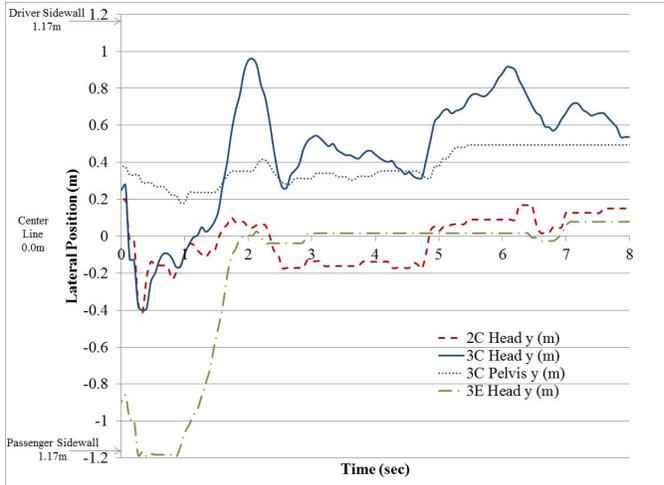
Using the "Front" camera, the head positions of occupants 2C, 3C, and 3E and the pelvis position of occupant 3C were tracked in the bus based coordinate system. The lateral position versus time history can be seen in *Figure 4*, where the lateral centerline of the bus is zero and motion toward the driver side is in the positive direction. The lateral distance from the bus centerline to the sidewall was 1.17m and is labeled on the graph.

Figure 4. The lateral (y axis) head position of occupant 2C, 3C, and 3E and the lateral pelvis position of occupant 3C.

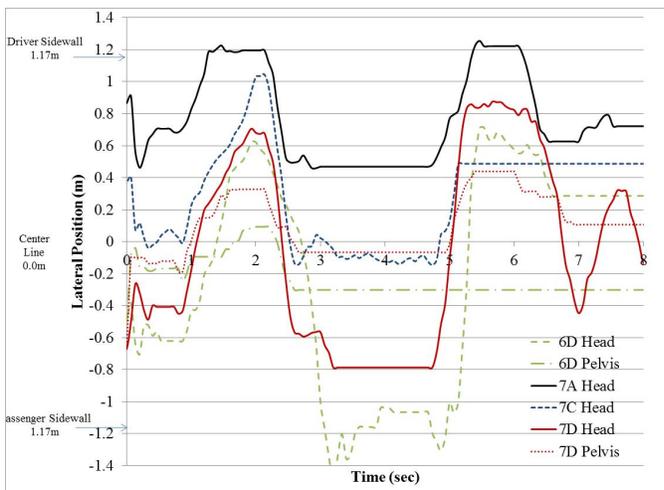
Using the “Mid” camera, the head positions of occupants 6D, 7A, 7C, and 7D and the pelvis position of occupant 6D and 7D were tracked. The lateral position versus time history can be seen in *Figure 5*.

Figure 5. The lateral (y axis) head position of occupant 6D, 7A, 7C, and 7D and the lateral pelvis position of occupant 6D and 7D.

Using this correction for the “Mid” camera, the maximum intrusion into row 7 was approximately 0.48m during the first 0.13 seconds with a recovery of 0.12m during the next 0.13 seconds. Similarly, the maximum velocity of the right sidewall in row 7 was 2.41 m/s and the maximum velocity of the aisle-side point on seat 7D was 3.50 m/s at 0.13 seconds. Note that these velocities are lower bounds on possible velocities because the calculation is limited by the video frame rate. Maximum displacement could have occurred between frames and not captured until the subsequent frame, 67 milliseconds later, which would reduce the calculated velocity.
