STATUS OF NHTSA'S EJECTION MITIGATION RESEARCH

National Highway Traffic Safety Administration
United States of America

Paper Number 19-0036

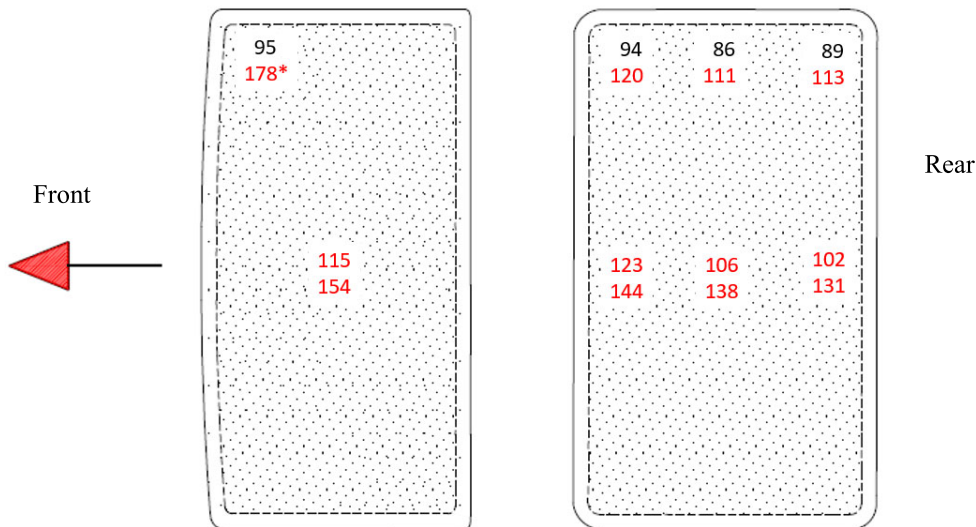
Figure 12. Production Glass (baseline) Results.

For production glass, on the front movable panel, hits at the center had PVB stretch and transverse frame bending. At the corner of the front panel there was rail failure using the higher impact speed and therefore a large ram excursion. On the rear fixed panel, there was no edge failure for any location. At 16 kilometers per hour, ram excursions were below or just over 100 millimeters, except for at the forward transverse edge which is thinner and weaker and therefore had a higher excursion.

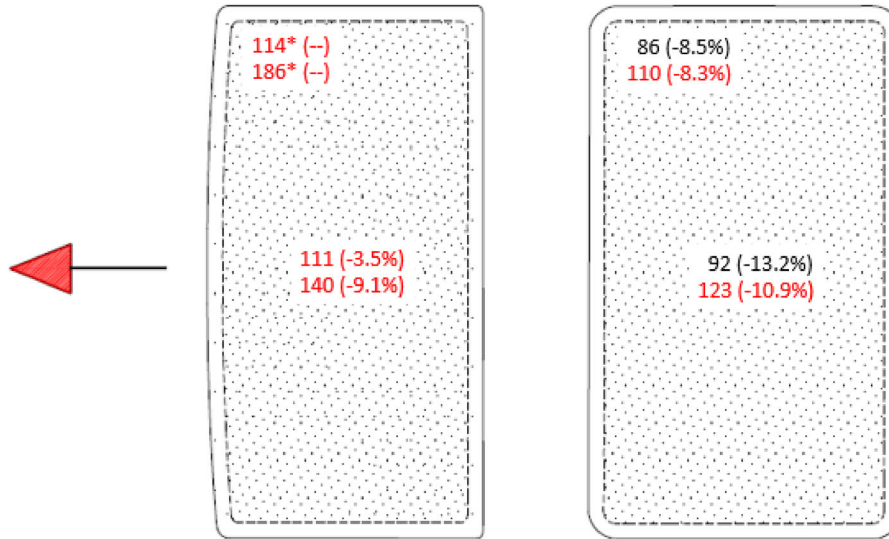
Figure 13. Thicker PVB Results.

For the thicker PVB panels, on the front movable panel, hits at the center showed less stretch but more transverse frame bending than the baseline panels. At the corners, catastrophic edge failure (complete detachment of the panel frame from the rail) was seen. On the rear panel, the thicker PVB reduced excursions by approximately 10 percent.

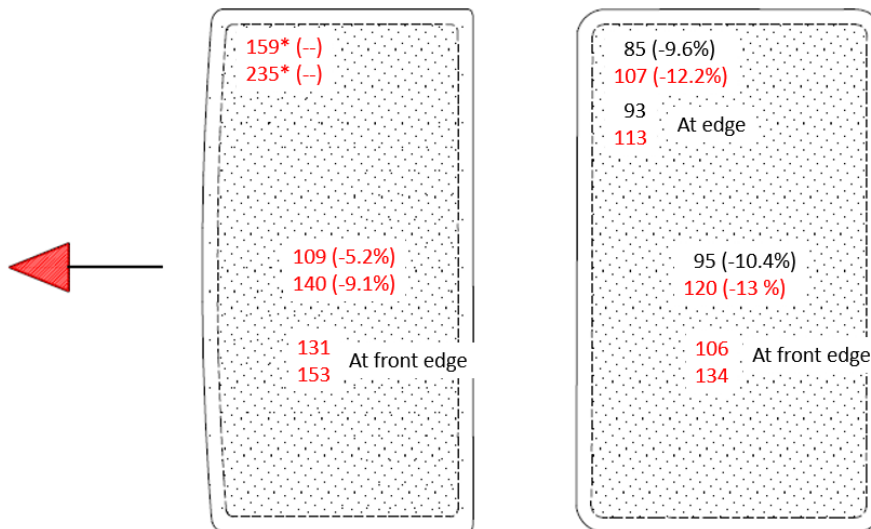
Figure 14. Protec® II Results.

For the Protec® II panels, hits on the front movable panel, at the center, had less film stretch but much more transverse frame bending than the baseline panels. At the corner, there was catastrophic edge failure at both speeds. On the fixed rear panel, there was approximately a 12 percent reduction in excursions. Like the thicker PVB, the reduced film stretching of the Protec® II led to increased loads on the edges.

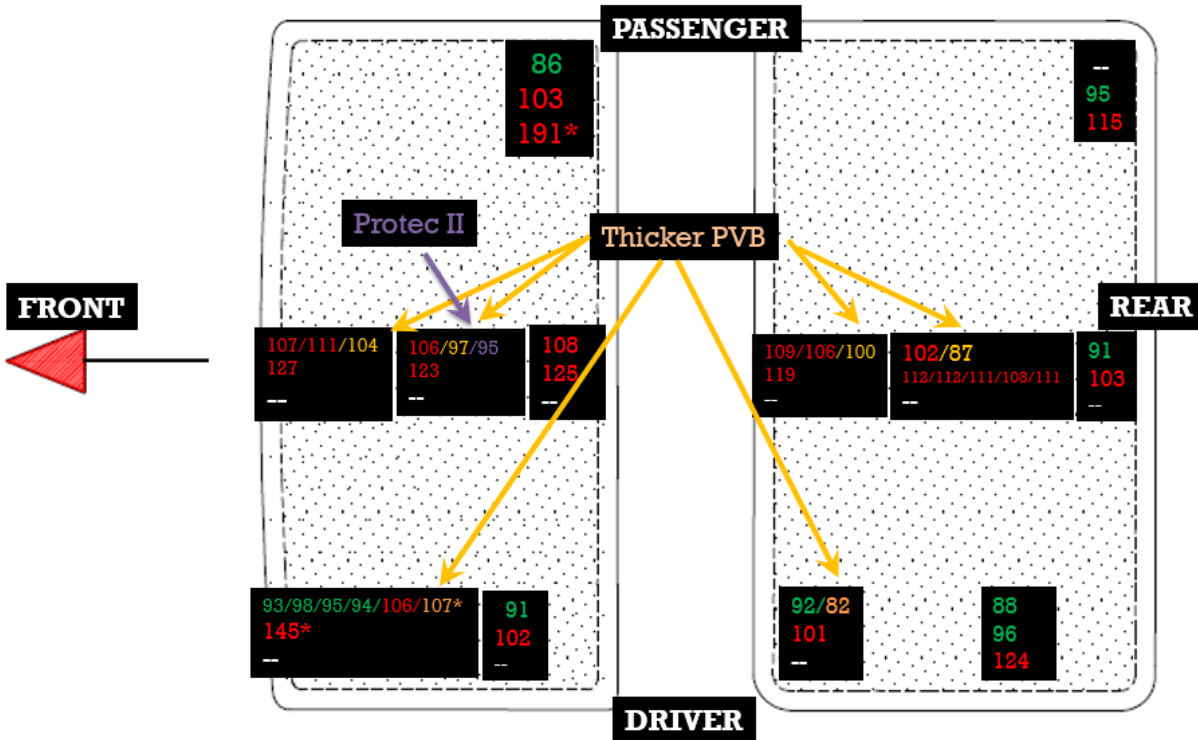
Figure 16. Ford F-150 Results.

As seen in previous testing, the movable panels presented more challenges in containing the headform than fixed panels. Failure at the inserts into the rails occurred on the moving panel. The fixed panel had higher excursions at the unsupported edges (front and rear edges of rear panel).

The plastic layer of the countermeasures (thicker PVB and Protec® II) did not tear in any test. Both countermeasures reduced plastic layer stretch and ram excursions compared to baseline. However, since more forces were transferred to the edges, larger openings were sometimes produced at the edges (i.e. edge excursions, highlighted in yellow in Tables A.1 and A.2).

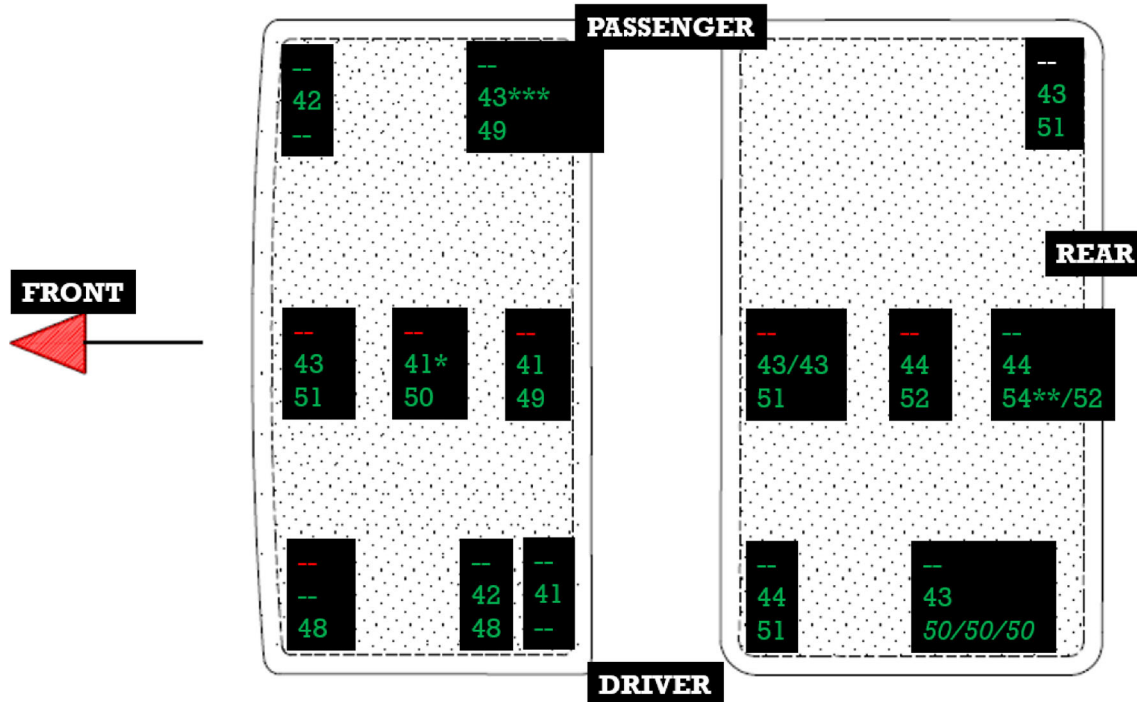
Figure 17. Toyota Prius V Results.

All Prius impacts had less than 100 millimeters excursions, generally around 50 millimeters. No separation at the glue interface was seen. Additionally, no failure of the polycarbonate or glue interface was seen even for multiple impacts at 20 kilometers per hour at the same location. Overall there were low ram displacements, however, due to less flexion of the sunroof panel there were high head deceleration values and therefore high forces on the headform. For example, when comparing an impact in the center of the Ford F-150 fixed panel at 16 kilometers per hour to an impact in the center of the Toyota Prius panel at 16 kilometers per hour, the forces on the headform were 2282 and 8663 Newtons, respectively. This is shown in Figure 18 below, with the F-150 in red and the Prius in blue.

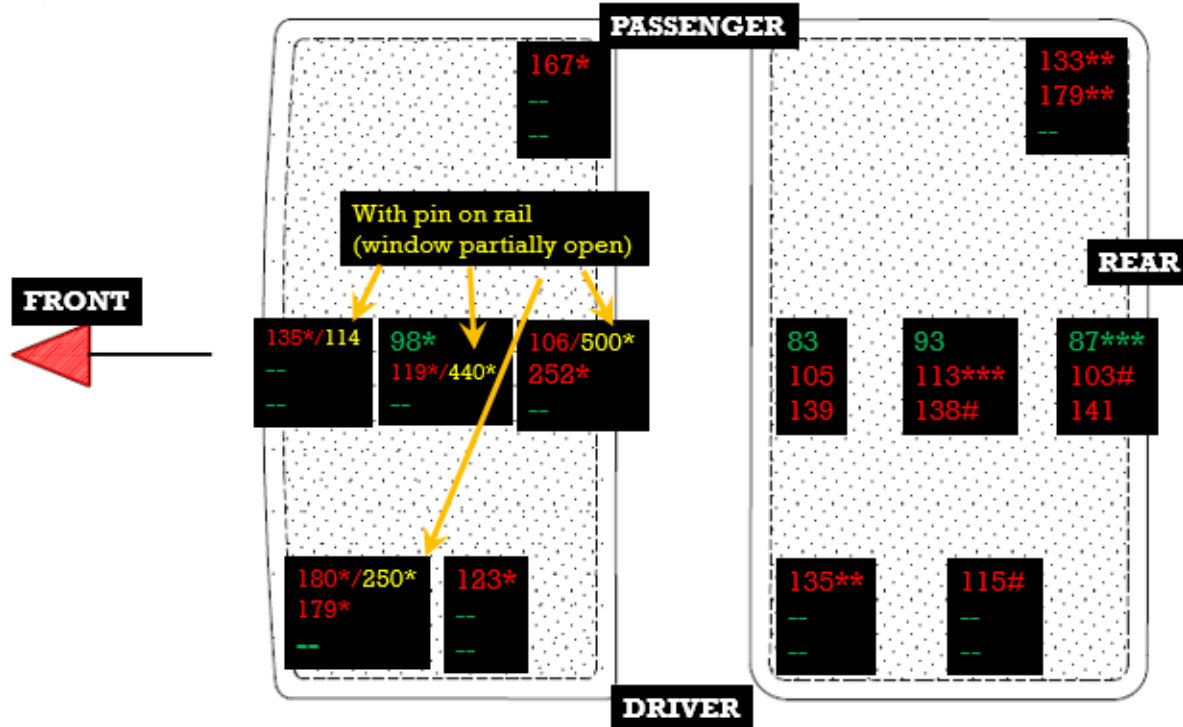
Figure 19. Aisin Sunroof Results.

The Aisin sunroof had many failure modes. Some examples of these failure modes are shown in Table 2 below.

The headform did not push through the PVB layer for any of the tests. In some tests, where the frame inserts didn't fail, the PVB layers had tears in it. On the front movable, panel brittle fracture of the plastic cam, which is used to raise the front edge when sliding the panel to open, occurred in some tests. In tests where the panel was moved to a partially open configuration there were also rail insert failures. The rail inserts had weakness at all locations impacted on the front panel. The rear fixed panel had weakness at the attachment brackets. Failures occurred at the bracket to glass glue adhesion as well as at the bracket attachment bolt. Bending of the encapsulation frame was also observed for many tests.

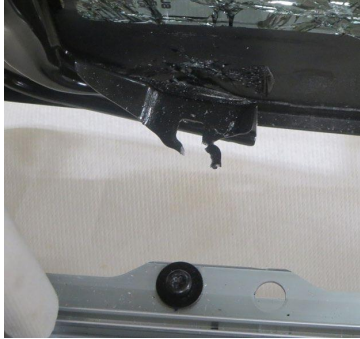
| Rear panel - attachment bracket | Rear panel bracket – glue attachment | Rear panel – PVB tear at attachment |

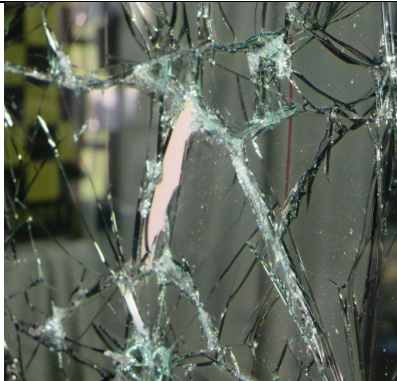
| Glass PVB tear | Front panel corner pin -rail insert | Front panel corner pin and rear attachment |
