PROTECTING OCCUPANTS IN ROLLOVER CRASHES: CASE EXAMPLES AND LATEST TECHNOLOGIES

by Byron Bloch, Auto Safety Expert
Potomac, Maryland, USA

22ND ESV Conference 2011 - Paper 11-0344
Washington, D.C.

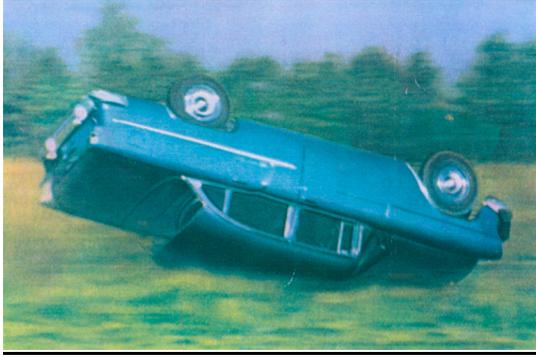
1950's: General Motors (GM) conducted dynamic rollover tests back in the 1950's, in *50 miles per hour rollovers* that GM referred to as the *“supreme test”* as noted in the adjacent GM illustration.

The 1955 Chevrolet's roof structure, with its closed-section or box-section windshield header, and its mid-body roof bow and center pillars, was shown by GM to be strong enough to prevent roof buckling and collapse. Sufficient roof strength and its performance in actual dynamic rollover testing was demonstrated.

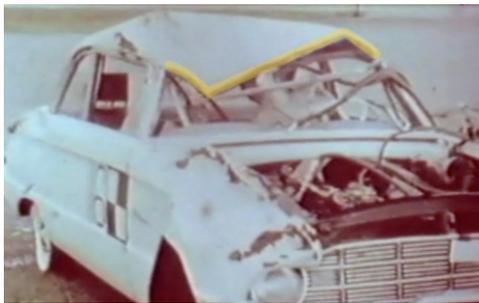
1960: In 1960, Ford conducted Crash Test 116, a dynamic rollover test of a 1960 Ford Falcon passenger car. This ramp-type rollover test at 34 miles per hour was conducted in order to evaluate the Falcon's roof structure. The design of the Falcon's windshield header was a "hat section" – an open section design that's very similar to many of the windshield header designs in cars and SUVs throughout the 1970's to the present. *After two and one-half rolls, the Ford Falcon's roof had buckled and crushed downward... very much like what happened to the roofs in many rollover accidents over the past decades.*

"The roof structure proved inadequate. The front of the roof collapsed. The hat section reinforcement at the very front of the roof was insufficient to withstand the load."

That kind of roof-buckling failure in a 34 miles-per-hour rollover certainly means the roof structure is inadequate and insufficient in its design and performance.

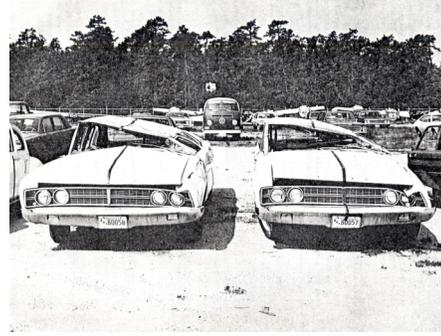
1971: The NHTSA report "*Test for Vehicle Rollover Procedure*" was based on a series of dynamic lateral rollover tests of a variety of vehicles. The abstract noted that "The tests proved the adequacy of this procedure to produce repeatable rollovers and to demonstrate the applicability over a large range of vehicle sizes and configurations."

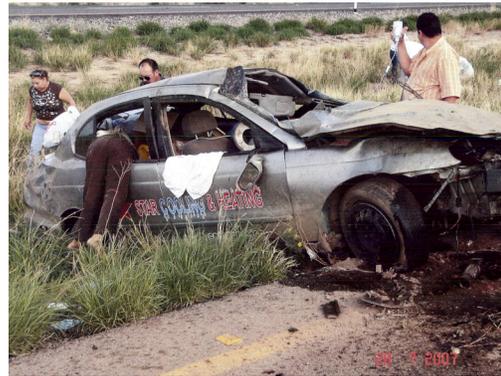
In a rollover accident when the side window glass shattered out, a seat-belted woman in the rear seat was partially ejected and suffer fatal trauma. She was found with the seatbelt still fastened, with her legs protruding outward through the window opening.

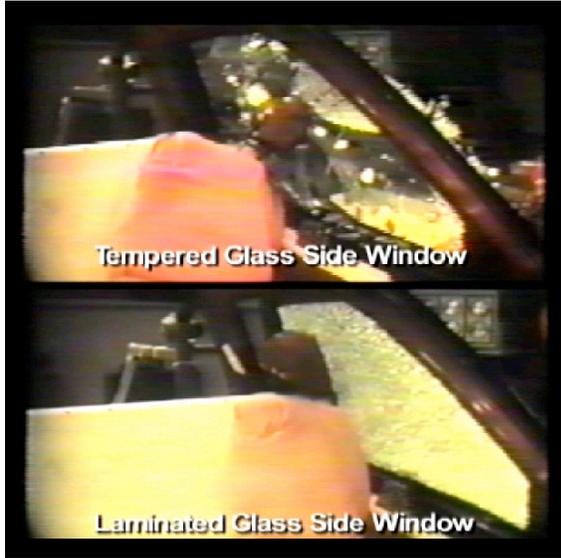
As demonstrated in NHTSA's comparison tests, the *tempered* glass shatters out completely and allows the occupant to be ejected through the opening, while the

safer *laminated* glass may break but still stays intact and serves as a “life net” to keep occupants safely within the vehicle. Note that *the front windshield* of all vehicles is made of *laminated* glass, a three-layer sandwich of glass-plastic-glass that is analogous to what could and should have also been utilized for the side windows.

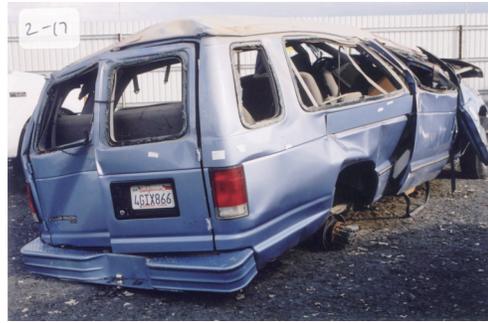
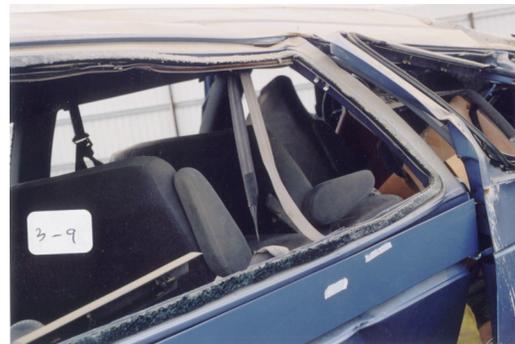
As just one accident case example, the right-rear tire of a Ford 15-passenger van lost its tread, and the van went out of control and rolled over. There were ten occupants in the van, and three were fully ejected when the large side window tempered glass completely shattered out.

Note the particles of tempered glass still embedded to the adhesive and rubber molding strip of the large side windows.

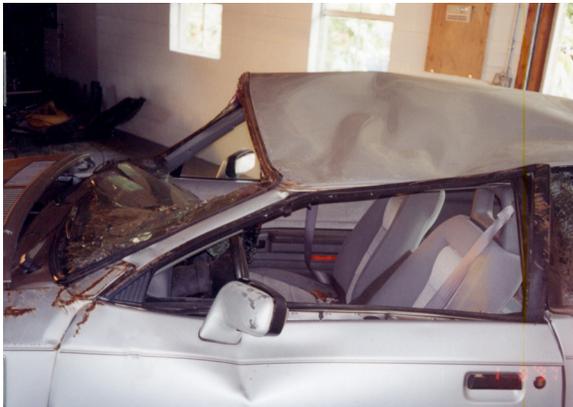
This rollover accident occurred when the driver of a 1989 Ford Escort 2-door hatchback tried to avoid another vehicle that had cut into his lane, and rolled over at about 35 mph on a grassy center median. The seat-belted driver was rendered a quadriplegic.

The Escort's roof design was very minimal. The windshield pillar was internally reinforced with a baffle plate, but only in its lower 6 inches, and that's where it bent over in the rollover. The windshield header was a flat channel, a weak open-section, and was further weakened by many large hole cutouts, and the roof buckled in those predisposed weak

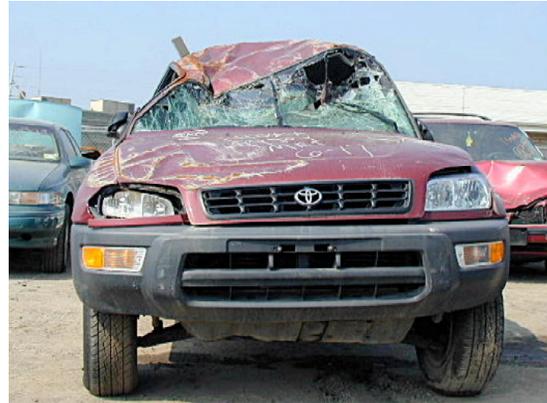
This rollover accident occurred when a 1999 Toyota RAV4 SUV was impacted by an adjacent vehicle, and rolled over on the road. The seat-belted right-front passenger was subjected to the roof crush and was rendered a quadriplegic, while the driver was only moderately injured.

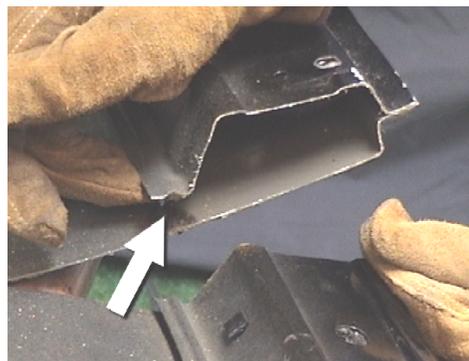
The RAV4 windshield header was an open-section shallow channel design, with many large hole cutouts and dimpled contours, and the corner gussets overlap only a short distance onto the header. In the rollover, the roof buckled and crushed down in these predictable weak areas.

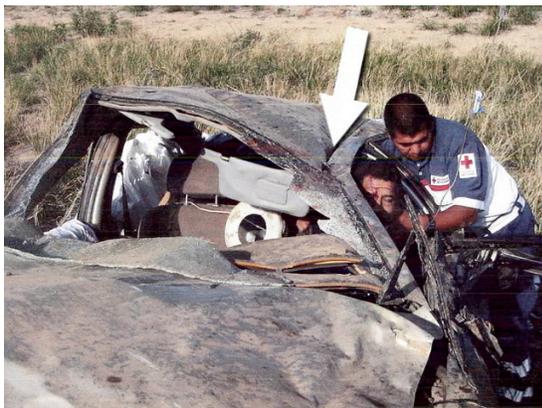
In the course of the vehicle rollover, the Daewoo Leganza sedan’s roof buckled and crushed down into the “survival space” of the driver. Photos at the scene show the seat-belted driver still positioned upright in the seat. He had suffered fractures of his cervical vertebrae, and was rendered a quadriplegic.

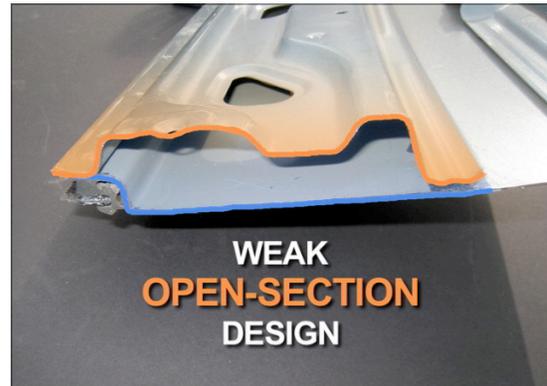
The windshield header was an “*open section*” shallow channel-type design, which is much weaker and less safe than a “*closed-section*” tubular design, which is about 3 times stiffer and stronger. The header design

had many “*Swiss cheese*” hole cut-outs and minimal overlaps, and was only .030-inch thin, all factors contributing to its weakness in rollovers.

Note the predictable weak zone where the roof buckled in the accident.... as shown in the photo below. It’s in this area about 6 to 8 inches inboard from the windshield pillar... where there’s only a minimal overlap of only about one inch, and just three spotwelds, where two pieces of thin sheetmetal overlap each other, adjacent to a large hole cutout. That’s the critical “*weak zone*” where the windshield header buckled, allowing the roof to distort laterally and downward.

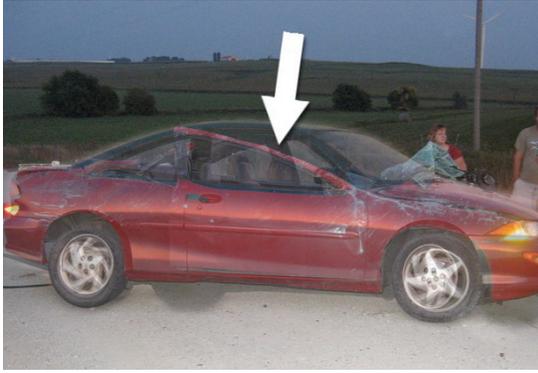
The rollover accident car was a 1996 Chevy Cavalier 2-door coupe, and the roof buckled and crushed down on the right-front passenger, a young man wearing his seatbelt. He suffered cervical spinal injuries that rendered him a quadriplegic, and paramedics cut off the roof in order to extricate him. The driver, seated where there was virtually no roof crush into her area, was essentially uninjured.

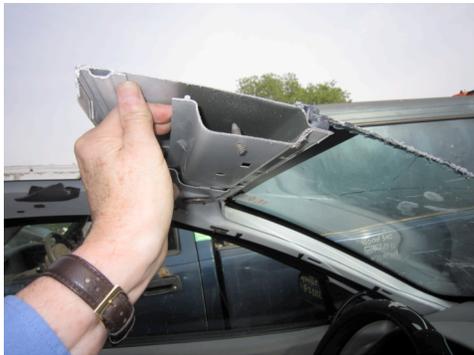
A key design defect in the Chevy Cavalier roof is the windshield header, a thin flat-channel design, an “open section” minimal design that is very weak that is easy to buckle and lacking in stiffness and strength.

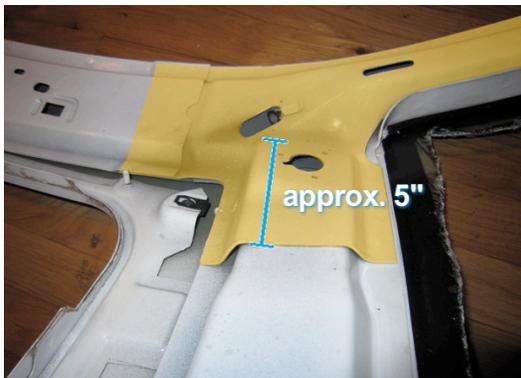
The roof structure is further weakened by the short corner gusset that only overlaps about 5 inches, rather than continuing completely across the header from A-pillar to A-pillar, which would add more strength.

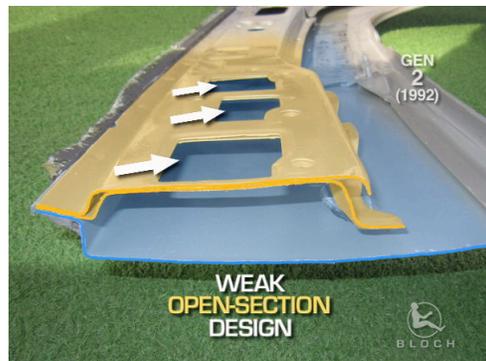
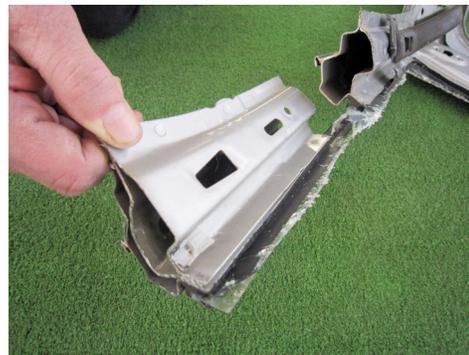
The Toyota 4Runner of the 1989-1995 era is known as Generation 2. The windshield header was an open-section flat-channel design with an additional strip of thin sheetmetal down the center. The header had many large hole cutouts, and the material was only about 30-thousandths. The corner gussets were very short, and ended adjacent to large hole cutouts, creating structural weak zones that are predisposed to buckling when loads are applied onto the roof in a rollover accident.

The windshield pillar had an internal reinforcement, but it only extended upward about 7 inches from the bottom. The roof siderail had a short reinforcement that ended about 8 inches back from the A-pillar. Thus there were weak zones where these structural discontinuities were located in the A-pillar and roof siderail, making them susceptible to deformation and buckling.

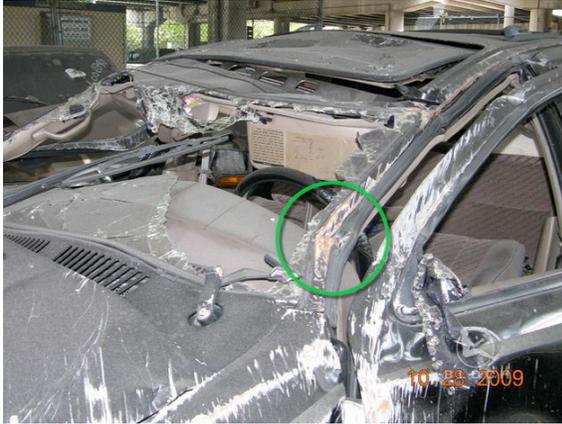
Inspection of the 4Runner showed that roof had buckled in those weak zones, including the A-pillar acting as a hinge at the location 7 inches from the bottom where the inner baffle reinforcement ended.

The open section flat-channel design of the windshield header, with its many large hole cutouts and minimal gusset overlaps, also proved inadequate in the rollover. Lacking in stiffness and strength, the windshield header deformed and buckled, predictably in the areas of large hole cutouts and structural discontinuities.

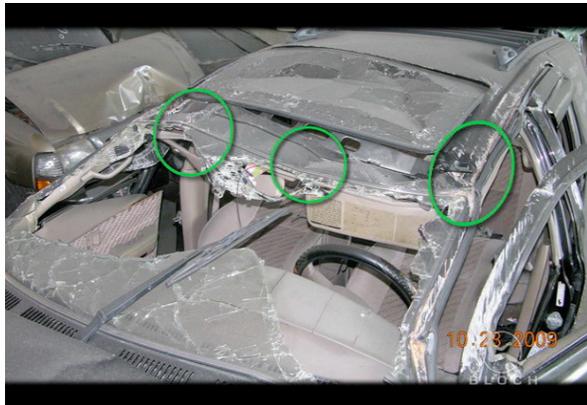
The combined buckling of the A-pillar and header and siderail allowed more extensive downward and lateral deformation and crush of the roof into the driver's "survival space" thereby causing cervical spinal loads that rendered the seatbelted driver into a quadriplegic.

The 4Runner 3rd generation (1996-2002) adopted the well-known closed-section or box-section design for the windshield header. Though of the same thin 30 thousandths of an inch, the box-section design is about three times stiffer and stronger than the open-channel design that was used previously. Again, the short corner gussets and large hole cutouts were additional weaknesses that needlessly compromised the box-section design of the windshield header.

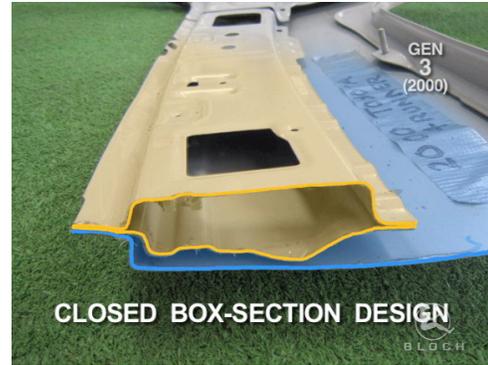
The 4Runner Generation 3 windshield pillar design was similar to the previous Generation 2 version, with the internal reinforcement too short, extending upward from the base only a few inches, rather than continuing the full length of the pillar.

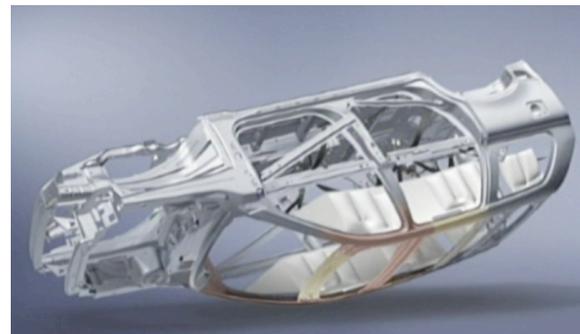
Figure 8. Volvo illustrates how strong roof structural integrity, side curtain airbags, and seatbelt pre-tensioners enhance safe performance in dynamic rollover testing.
