## Post-crash Fuel Leakage and Fire Safety Experiments for Hydrogen Vehicles

U.S. National Highway Traffic Safety Administration (NHTSA)

Battelle

Paper Number 11-0439

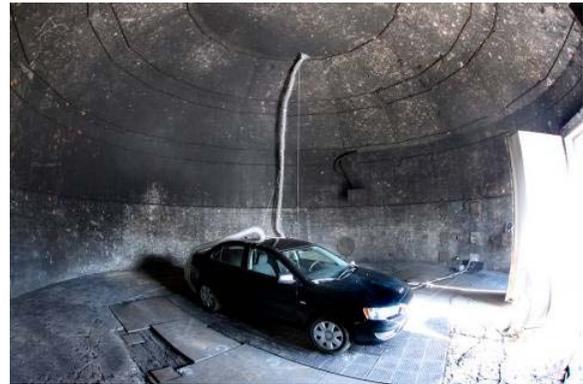
Tests were conducted at Battelle’s High Energy Research Laboratory Area (HERLA) inside a 42-ft diameter blast containment chamber. The test vehicle was a 2008 Mitsubishi Lancer. Figure 1 shows the test vehicle in the blast chamber.

**Figure 1. Mitsubishi Lancer in HERLA blast chamber for indoor testing of hydrogen leaks in and around a vehicle**

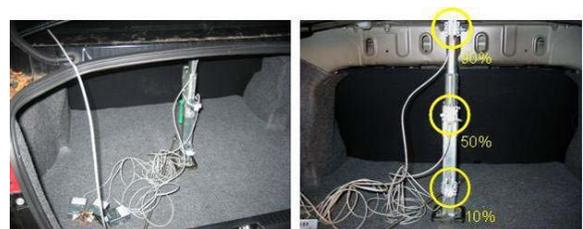
The sensors were positioned at 10%, 50% and 90% of the vertical dimension of each compartment, along the vehicle center line, except in the case of the engine compartment, where a modified placement was necessary due to spatial constraints. Figures 2 and 3 show the positioning of the trunk and passenger front seat sensor suites.

**Figure 2. Positioning of trunk sensors at 10%, 50%, and 90% heights**

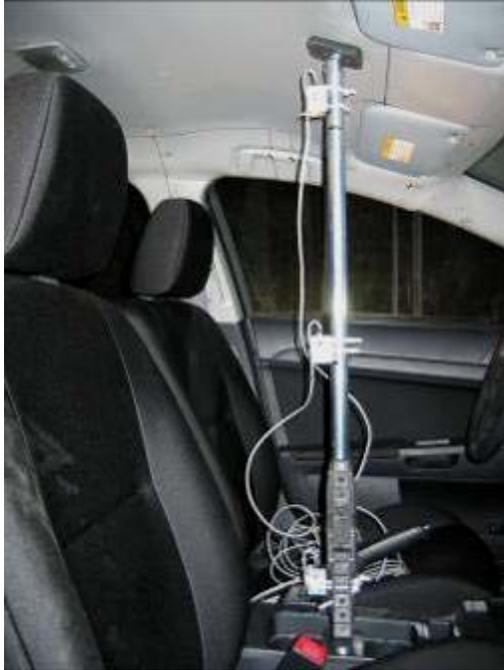
**Figure 3. Positioning of front passenger compartment sensor suite at 10%, 50%, and 90% heights**

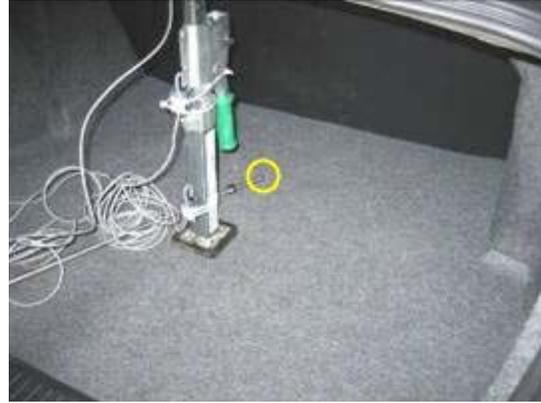
**Figure 4. Hydrogen leak originating in the trunk**

Figures 4, 5, and 6 photographically illustrate interior and exterior leak locations.

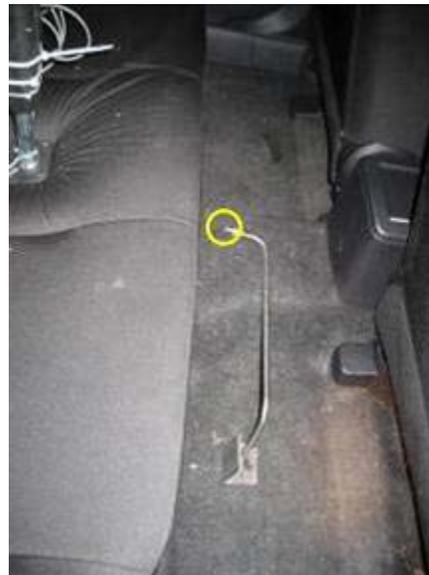
**Figure 5. Hydrogen leak originating in floor of passenger compartment**

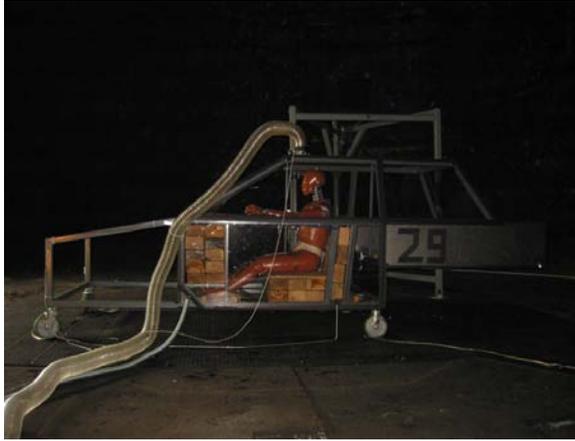
**Leak** The ASC panels were held in place with magnets. All exterior panel seams were taped with duct tape, and hydrogen sensors were positioned at the 50% trunk and front seat passenger compartment levels. The ignition source was located on the dashboard. The right underarm, back knee, left outer wrist, and left cheek heat flux sensors were not used in this test. The setup for test 29 is shown in Figure 12.

**Figure 12. Test 29 ACS setup**

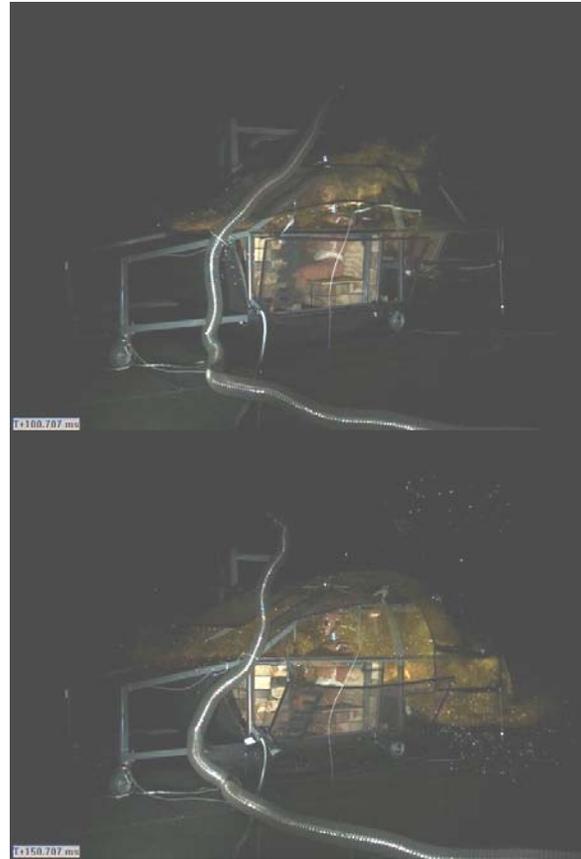
Sensors in the right eye, right cheek, right shoulder, right inner elbow, groin, left underarm, right hand palm, right hand between fingers, and left hand between fingers, detected heat fluxes that could cause second-degree burns. No overpressure was measured by the pressure transducers. High speed stills in Figure 14 show some luminosity during combustion. The slight overpressure from combustion caused panels to separate from the ACS framework.

**Figure 14. High speed stills showing combustion in Test 33.**

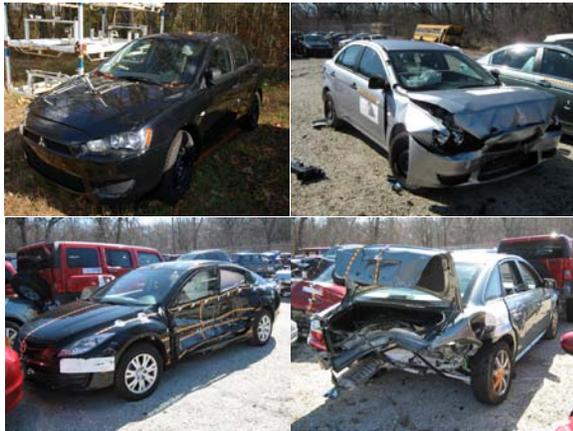
were conducted on four vehicles: intact and front-impacted 2008 Mitsubishi Lancers; side-impacted 2009 Mazda6 Sedan; and rear-impacted 2008 Ford Taurus. These test vehicles were transferred from NHTSA's Compliance and New Car Assessment crash test programs. The test vehicles are shown in Figure 18.

**Figure 18. Test vehicles for accumulation and ignition experiments**
