**REAR OCCUPANT PROTECTION JNCAP TEST
– TEST RESULTS AND FINDINGS –**

National Agency for Automobile Safety and Victims' Aid (NASVA)
JAPAN
Paper Number 11-0445

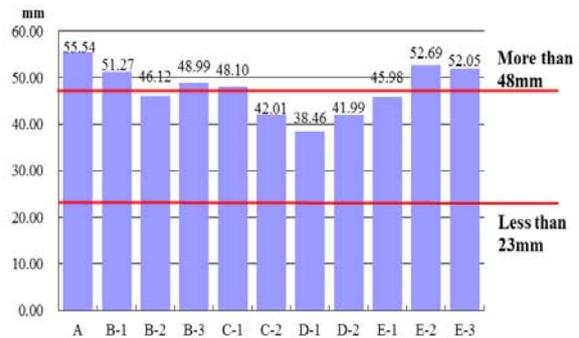
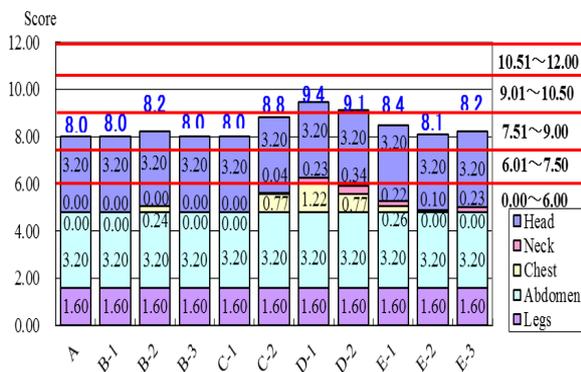
Figure 1. Result of front-collision rear seat occupant protection performance tests in 2009

JNCAP published the results of the rear seat occupant protection performance evaluation tests it conducted in 2009 for eleven models of vehicles^[4]. Figure 1 shows the result of those tests. Nine models were at Level 3 and two models at Level 4. Looking at the results by region of injury, we can see that the score of the chest injury most influences the level evaluation.

(Chest displacement)

(Overall score)

In FY 2010, the Program is conducting tests on fourteen models. While the number of models at Level 4 increased, one model dropped to Level 2. On some models, the head suffered a secondary collision and the pelvis slid up.

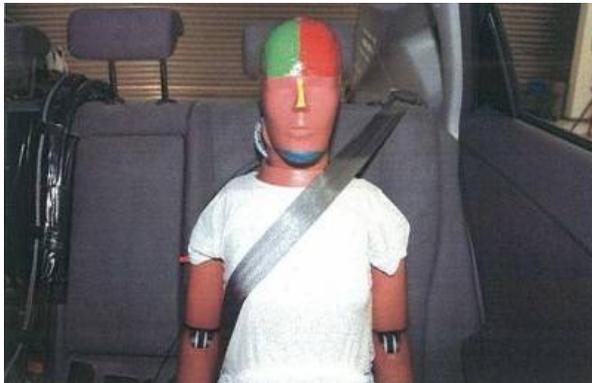
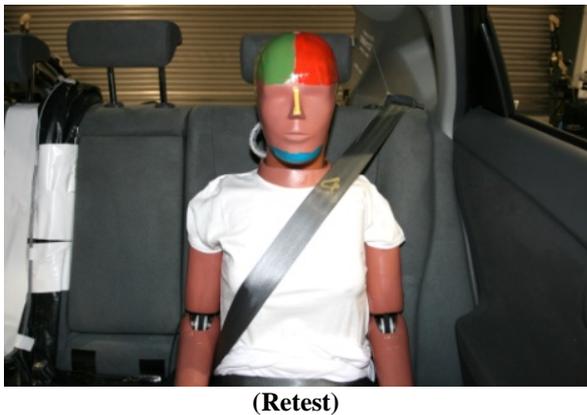
Figure 2. Difference of belt paths

bottom of the jaw and the center of the belt). The difference of the belt path was visually noticeable, too, as the belt passed through the upper right chest and where it touched the neck (Fig. 2).

One of the offset frontal collision tests conducted in 2009 was done with a belt path for the rear seat occupant dummy set significantly differently from the normal path. According to the test procedure of JNCAP, the belt path was supposed to be set at the designed standard position designated by the vehicle manufacturer. Although there was not any prescription as to the error range, there was a vertical difference of 35 mm between the designed standard position and the actual position at the center of the dummy (between the

In normal use, it was inconceivable that the belt could take such “a path over the upper right chest.” Further, if the belt took such a path, the injury value (chest deflection) would presumably be smaller than when it took other paths, given the structural factors of the ribs of the dummy (fixture of the potentiometer, ribs, etc.). Therefore, after consulting with the vehicle manufacturer, we decided to conduct a retest for this vehicle.

Table 3 shows the results of the initial test and the retest of the test vehicle. As predicted, the initial test showed smaller injury values than the retest, thus confirming that the belt path influences the injury value of the chest deflection.

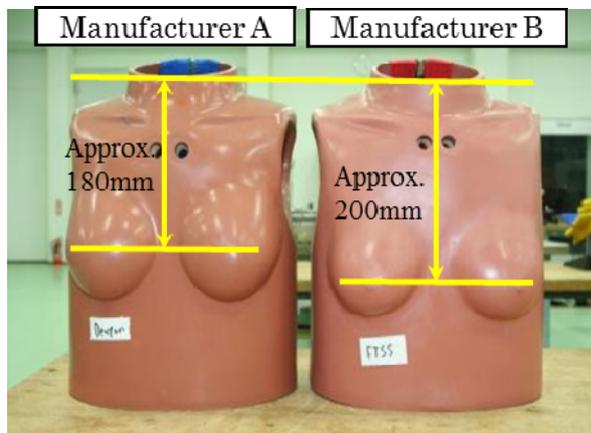
Figure 3. Difference among dummy manufactures

JNCAP conducts its tests using AF05 from two dummy manufacturers. During the examination entailed above, it was found that the form of the chest and the internal structure of the jacket were different between those manufacturers of the dummies used: In addition to the sizes being slightly different, the combinations of the jacket and the dummy’s body (ribs, etc.) resulted in different rigidity among dummies. (Fig. 3)

- A: material of lower/top part of breast are harder
- B: inside of breast is hollow

The difference of injury values between dummy manufacturers had already been the subject of discussion at ISO. A universal specification has not agreed yet, but the two manufacturers was collaborated to make the “universal jacket,” with which the dummies of each manufacturer verifies the calibration tests. Since the use of this jacket allows it to conduct its tests under the same conditions as to belt path and belt slipping out of the shoulder (see below), JNCAP has

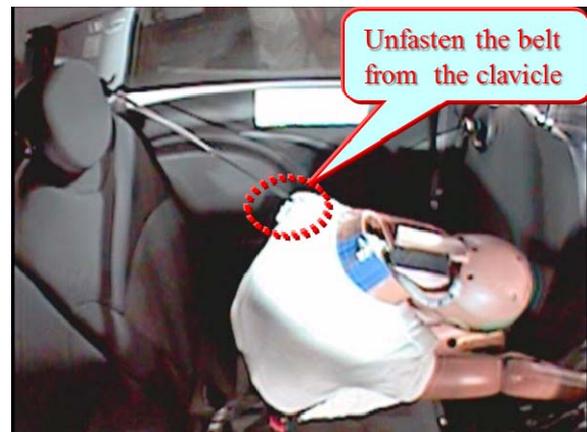
Figure 5. Case where the shoulder belt was judged to be slipped out moved from the clavicle toward the shoulder joint

Since it is difficult for the time being to define the criteria of slipping out of the seat belt from the shoulder and how to assess it quantitatively, we decided for this year to limit ourselves to assess it based on the video record of the tests. Further, we installed another high-speed camera in upper front of the dummy, for it was delicate to determine whether or not the seat belt slipped out of the shoulder.

In the tests conducted in FY2010, taking into account of the opinions of the experts, we do assessment by checking the test video to see whether or not the seat belt keeps slipping over the clavicle while the head is shaken and also by checking whether or not the shoulder belt moves from the clavicle towards the shoulder joint during the lapse of time between the beginning of the collision and the moment the forward displacement of the head reaches maximum. When it is difficult to determine, we try to judge from a comprehensive point of view taking other factors into account.

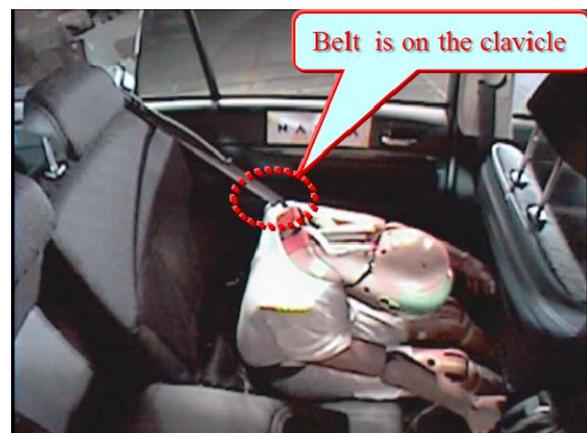
Figure 6. Case where the shoulder belt was judged to be maintained over the clavicle
