STATUS OF THE SECONDARY SAFETY OF COACHES – UPDATED STATISTICS, CURRENT STANDARDS AND ADDITIONAL TECHNICAL MEASURES

Alexander Berg, Peter Rücker, Walter Niewöhner

DEKRA Automobil GmbH, Accident Research Stuttgart, Germany

Paper Number 13-0341

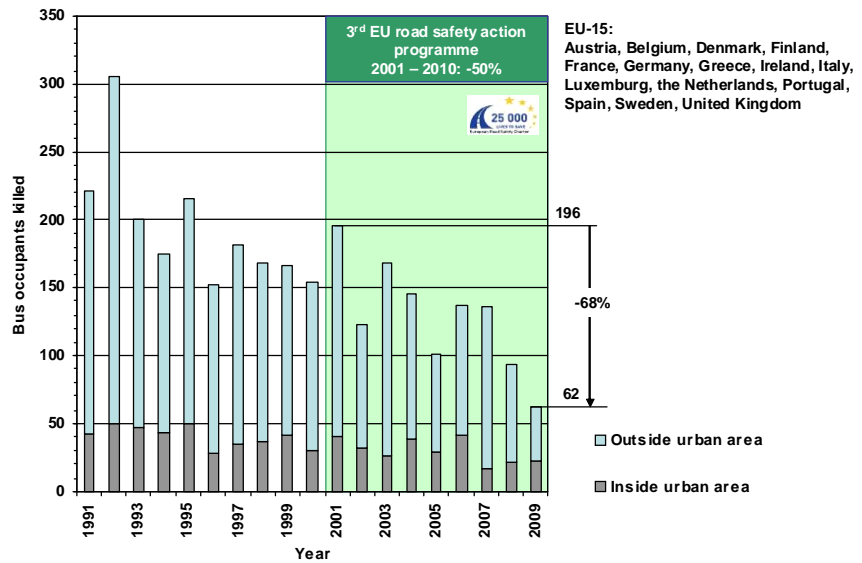
Figure 1. Evolution of the absolute figures of occupants of buses/coaches killed per year in road accidents inside and outside urban area in 15 member states of the European Union (EU-15) from 1991 until 2009 (data source: CARE [1] with last update on 29/Nov/2012)

In the case of 15 EU member states it was possible for CARE to identify the number of bus/coach occupants killed annually from 1991 until 2011 and broken down according to the location of the accidents, Figure 1. The maximum was recorded in 1992 with a number of 305 killed bus/coach occupants. In 2009, the number fell to 62. Most bus/coach occupants died in accidents which occurred outside urban areas. The proportion in 2009 amounted to 65% (i.e. 40 out of a total of 62 fatalities).

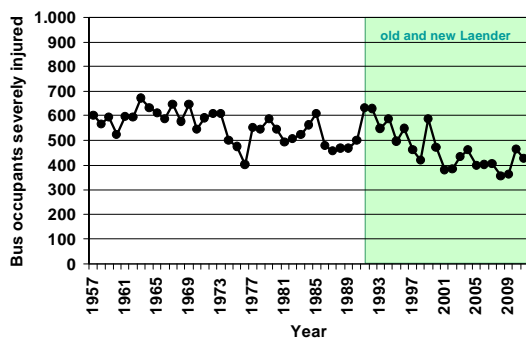
Figure 5. Bus/coach occupants severely injured in accidents on roads in the Federal Republic of Germany per year from 1957 until 2011 (data source: Federal Statistical Office [3, 4, 5])

The long-term pattern of severely-injured bus occupants in Figure 5 is less apparent than the number of persons killed as influenced by annual variations. In the 'old Laender' of the Federal Republic of Germany (1957 -1990) brief periods of falling numbers were followed by some clear increases.

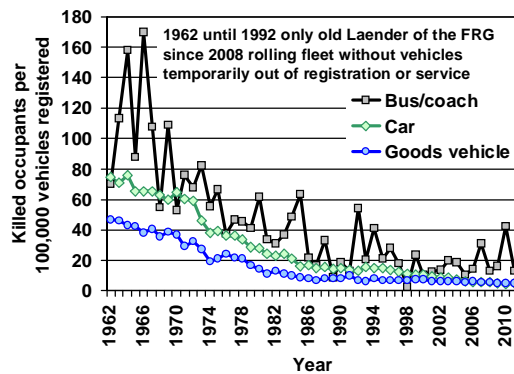
Figure 9. Risk indices for the occupants of buses/coaches, cars and goods vehicles calculated as killed occupants per 100,000 vehicles registered in the rolling stock (Federal Republic of Germany, 1962 until 2011)

Figure 9 compares the development of the risks related to the rolling stock of buses/coaches, cars and goods vehicles from 1962 to 2011. Since the collection of data for rolling stock numbers only applies to re-unified Germany from 1993 onwards, for the time up to and including 1992 only the numbers recorded in the ‘old Laender’ of the Federal Republic of Germany (FRG) have been taken into account.

Here, too, the influence of single severe bus/coach accidents causing a strongly varying pattern for bus/coach occupants killed per 100,000 vehicles can be seen. Conforming to the general pattern of evolution towards a higher level of safety for vehicles and occupants there was a significant reduction in the 1980s for all the three vehicle categories studied. After that curves flattened out.

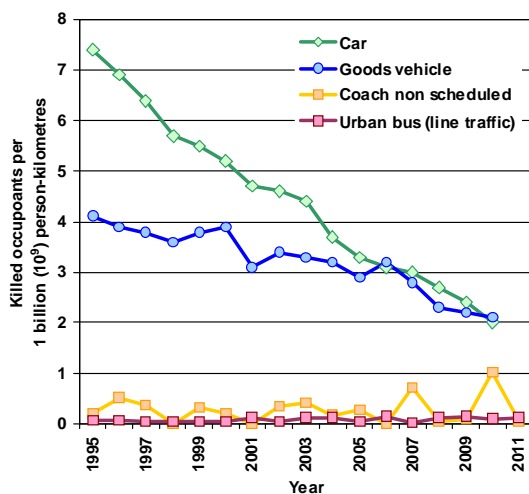
Figure 11. Risk indices for the occupants of urban buses, coaches, cars and goods vehicles calculated as killed occupants per 1 billion person-kilometres (Germany 1995 until 2010/2011)

Here it can be seen that for the occupants of urban buses very low risk factors are given, without any exception. In 2010 that risk factor was 0.1 occupants killed per billion person kilometres. Generally, the risk for occupants of long-distance coaches is low. In this instance, however, because of the relatively high number of persons killed in individual years (2007: 18 fatalities, 2010: 22 fatalities), the risk attached to these vehicles is in some years significantly greater than for urban buses. For 2010 there is a figure of 1.0 occupants in long-distance coaches killed per billion person-kilometres. For 2011 this figure is 0.05.

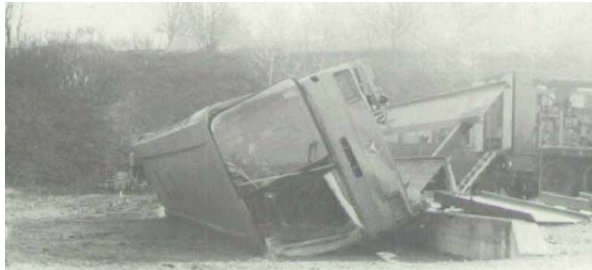
Figure 13. Rollover test on a Mercedes-Benz O 303 in accordance with ECE-R 66 conducted in 1987

ECE-R 66 first came into force on December 1st 1986. It was ratified in Germany on July 16th 1988. This was preceded by a number of examinations of real-world accidents in the course of which the bus/coach structure had deformed after it had tipped or rolled over. The behaviour of bus/coach structures in such accidents had been examined earlier in the 1970s and 1980s in countries such as Hungary under corresponding conditions and the results analysed comprehensively [20]. Similar activity had been carried out in Germany and in the UK. Rollover tests under various conditions had been performed at Daimler, for example. Figure 13 shows a test using a Mercedes-Benz coach O 303. The test conditions were as prescribed by ECE-R 66.

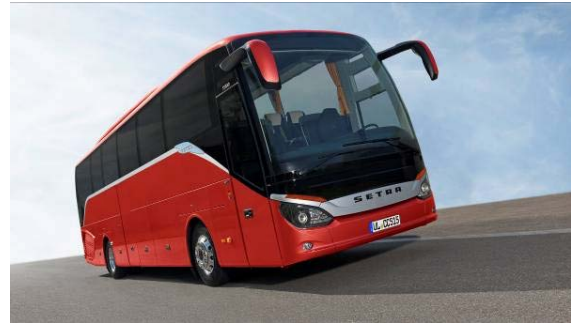
Figure 14: Coach Setra ComfortClass 500

The Setra Comfort Class 500 shown in Figure 14 is the first coach series from the manufacturer Daimler to comply with the new regulation. One major development target was the reduction of fuel consumption and the CO₂-emission rate. Since the vehicle weight has a considerable influence on those matters, considerable attention was paid to lightweight design. Figure 15 shows the superstructure of the new coach series. The most important elements are the U-shaped roll bars, which form the safety cage of the vehicle. In case of a rollover they will carry most of the load and will absorb a high proportion of the kinetic energy by means of plastic deformation. In order to maximise the potential of energy absorption, high-strength steel is used as indicated in Figure 15.

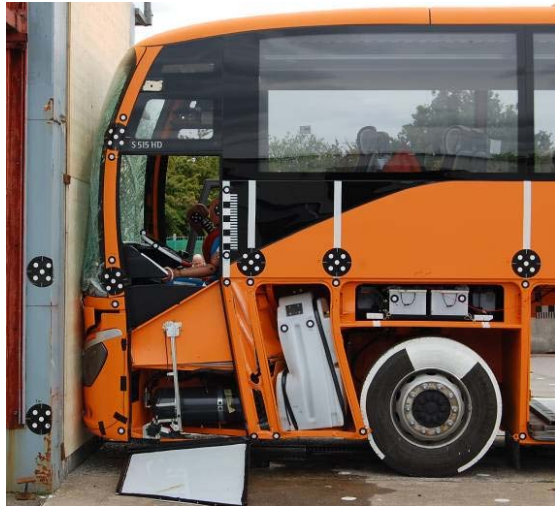
Figure 18: Coach Setra 515 HD after a full-frontal impact with a stationary rigid barrier at 25 km/h

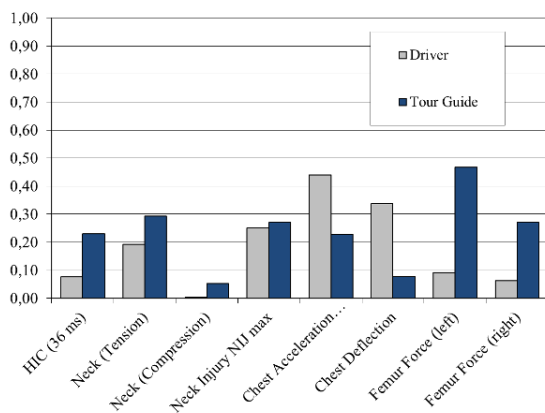
Figure 19: Occupant loadings relative to threshold values from the Standard FMVSS 208

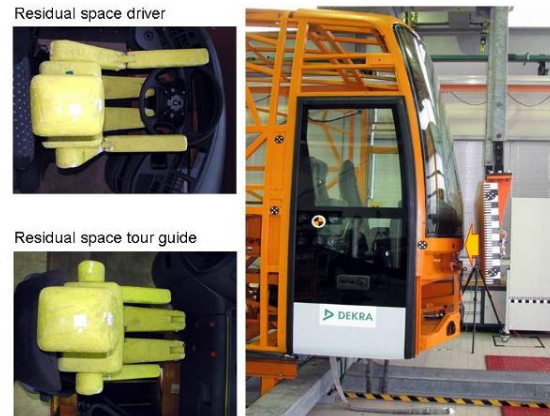
Figure 20: Mercedes-Benz Travego after frontal pendulum-impact test

and an external view of a Mercedes-Benz Travego after the test. It can be seen that the impact led only to minor deformations. The survival space of the driver and tour guide was completely preserved.

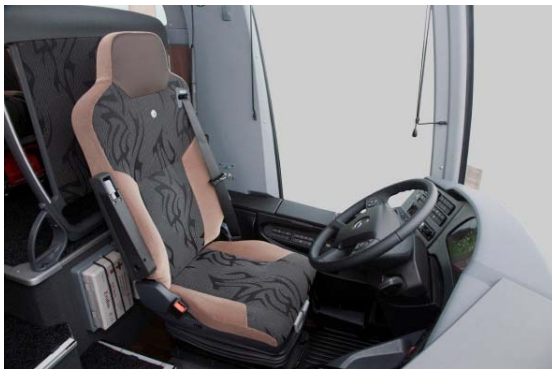
Figure 22: Coach driver seat fitted with 3-point-belt

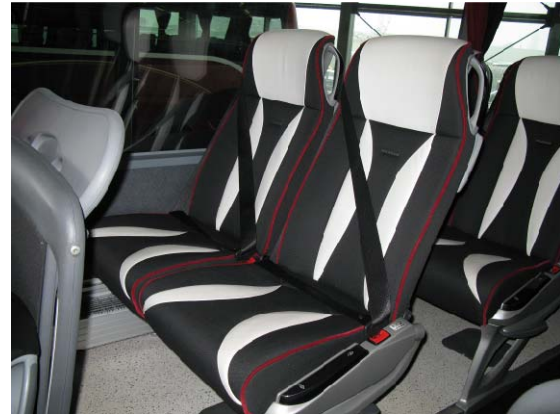
Figure 23: Coach passenger seats fitted with 3-point belts

In the case of frontal impacts the seat structure with the associated seat and belt anchorage must be able to hold the entire mass of the passenger occupying the seat. The loads on the anchorage points are then correspondingly greater.

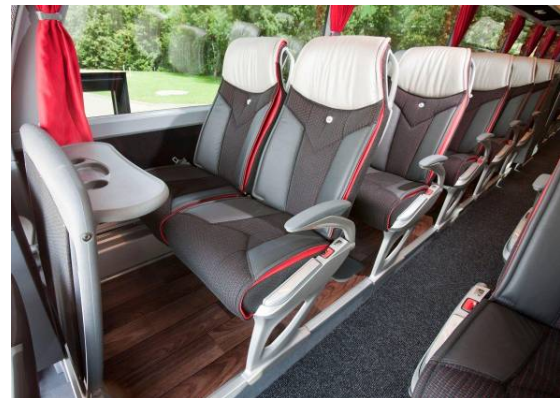
Figure 24: Coach passenger seats fitted with 2-point lap belts

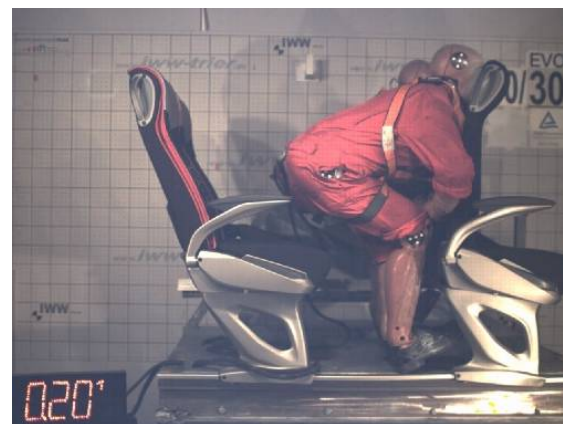
Figure 25. Dynamic test of a coach seat bench according to ECE-R 80 with 2 dummies unbelted impacting the back rest of the tested seats in front

For the first test an unbelted dummy sits in the auxiliary seat. In a simulated impact it is restrained only by the back of the seat under test (see test using 2 dummies in Figure 25). For the second test a belted dummy occupies the auxiliary seat (see test using 2 dummies in Figure 26). In this case both the belt and back of the seat under test restrain the dummy.

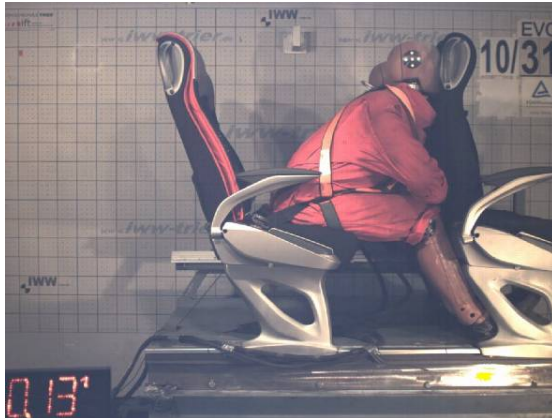
Figure 26: Dynamic test of a coach seat bench with 2 belted dummies according to ECE-R 80
