COLLISION AVOIDANCE SYSTEM FOR BUSES, MANAGING PEDESTRIAN DETECTION AND ALERTS NEAR BUS STOPS

Paper 17-0430

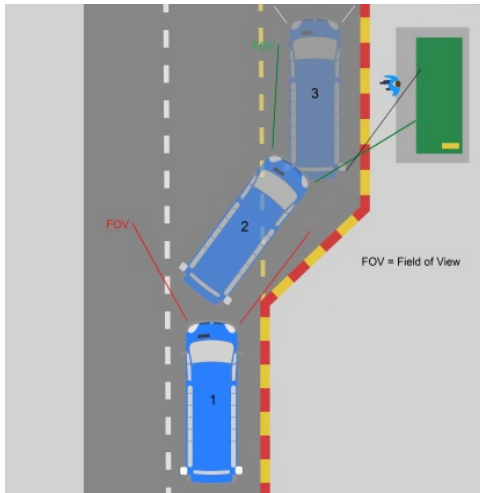
Figure 2. Bus Stop Approach Scenario

In this scenario, the vehicle is turning obliquely towards the bus stop and straightening quickly. This maneuver contains three distinct scenarios: Driving straight, partial turning and straightening parallel to the bus stop.

As seen in the figure above, the vehicle is approaching the bus stop (position 1), making an oblique right turn (position 2) and straightening away (position 3).

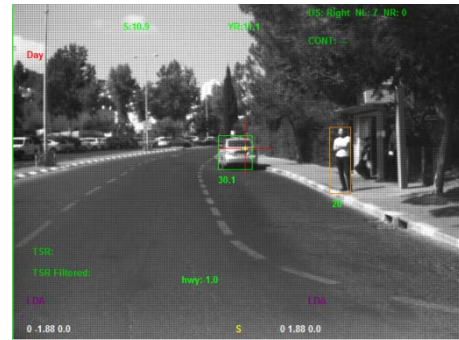
Figure 3. Waiting Pedestrian as seen while bus is in position 1

Figures 3, 4 and 5 show the scene as the bus approaches a pedestrian waiting at the bus stop. The Field Of View (FOV) is changing accordingly with each position. When about to reach the bus stop (Position 1 as seen in Figure 3), the system recognizes the pedestrian but does not alert as the pedestrian is not at a critical TTC. When approaching the bus stop (Position 2 as seen in Figure 4), the system detects the pedestrian and the TTC reaches the critical threshold due to the bus speed, direction and proximity to the detected pedestrian (Note the red cross is very close to the pedestrian indicating the system sees that pedestrian as being at risk to a direct collision). However, as the vehicle straightens (Position 3 as seen in Figure 5), the TTC drops as there is diminishing danger of collision (Note the red cross is now much further away from the pedestrian).

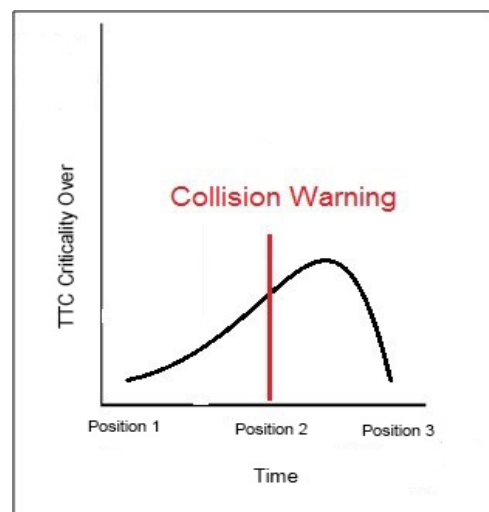
Figure 6. Bus Stop Approach Graph

The same scenario can be seen graphically in Figure 6 below. The graph shows the criticality of the TTC at each position of the vehicle over time.

As the vehicle's position and angle quickly change, the instantaneous TTC criticality becomes irrelevant as the pedestrian is in a danger zone only momentarily.

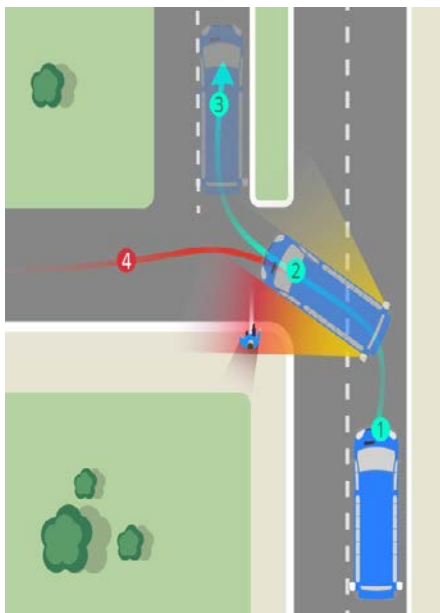
Figure 7. Left + Right Scenario

This maneuver is very similar to a bus stop scenario but in the opposite direction. As seen in Figure 7, the vehicle starts its journey at position 1, makes a slight left turn at position 2 and then amidst the left turn, the driver changes the course of the vehicle and makes a right turn (turning point) in order to arrive at position 3. Just before the turning point, the Shield+ system detects the pedestrian and determines that, given the current course of the vehicle and the pedestrian, the time to collision (TTC) is shortening critically and consequently alerts the driver with a collision warning. Figure 8 graphically shows the criticality TTC at the different positions within the scenario. (In the same fashion as the bus stop scenario with respect to TTC) The driver in this case as well, does not view the pedestrian as a potential risk since he intends to change course quickly and turn right. Therefore, he interprets the collision warning as a subjectively sensitive warning. The Shield+ System detects a true risk based on the current course while the driver doesn't consider it as a risk.

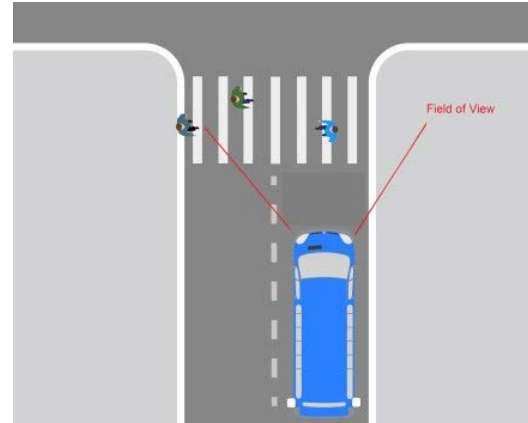
Figure 9. Crosswalk Scenario

Vehicle approaches the crosswalk as pedestrians are crossing. Vehicles may approach with too much speed when approaching the cross walk, thereby creating alerts, sometimes subjectively deemed overly sensitive by drivers.

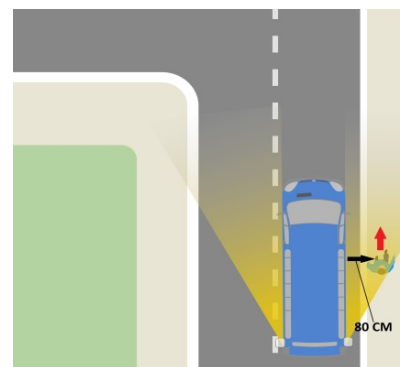
Figure 10. Parallel Pedestrian Scenario

Detection of VRUs when moving parallel to the bus – cyclists may pull up alongside the bus waiting at an intersection. Filtering must be done to provide detection for the driver without providing a warning unless the driver begins a turn. Pedestrians moving parallel to the bus along the sidewalk shall not create a collision warning unless the pedestrian changes direction suddenly.

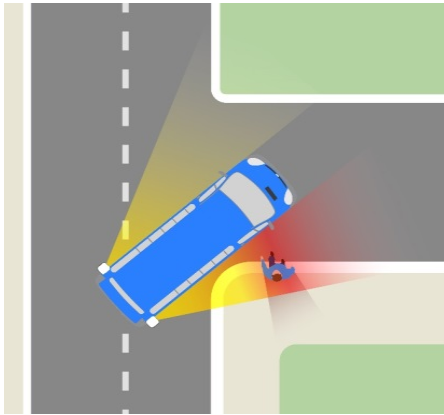
Figure 12. Turn w/ Pedestrian Alert

The Shield+ system must be configured to alert the driver only when the VRU is determined to be on a collision course below the TTC threshold. See Figure 12. Figure 13 illustrates the type of filtration that allows the Shield+ system to ignore pedestrians seen by the system either moving away or parallel to the vehicle but alert on pedestrians moving towards the vehicle.

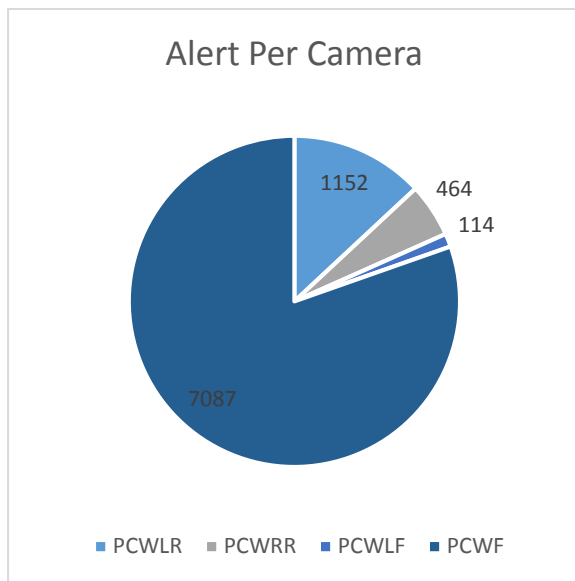
Figure 14. Alerts Per Camera

According to the table and as described in this pie chart, we can see that most of the alerts have been generated by the master camera (PCWF).

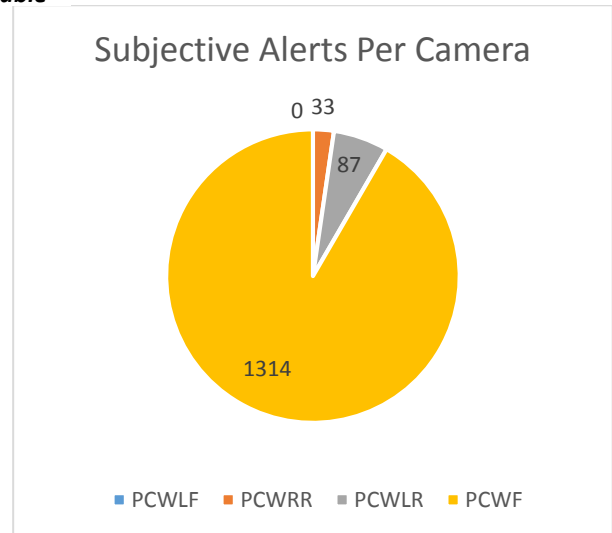
Figure 15. Subjective Alerts Per Camera

This Pie chart indicates that most of the subjective alerts have also been generated by the master camera. This corresponds to the preeminence of bus stop and crosswalk activity in the operation of a transit bus.

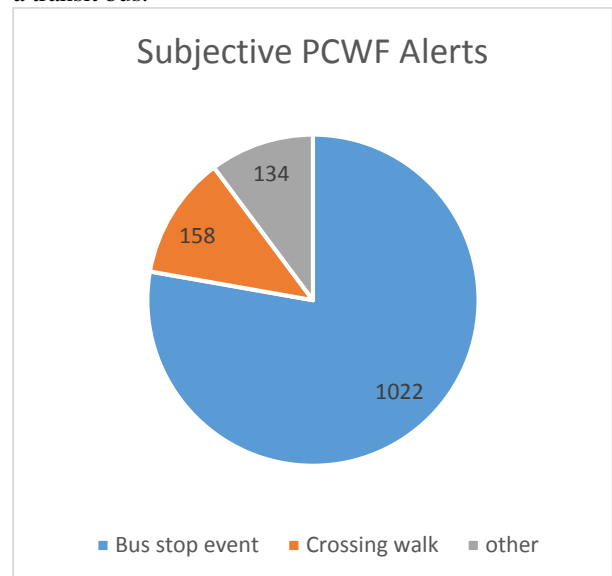
Figure 16. Subjective PCWF Alerts

By reviewing the video data from vehicles in the pilot, we determined that most of the subjective sensitivity alerts have been generated in the bus

stop scenario with the second largest amount coming from cross walk approaches.

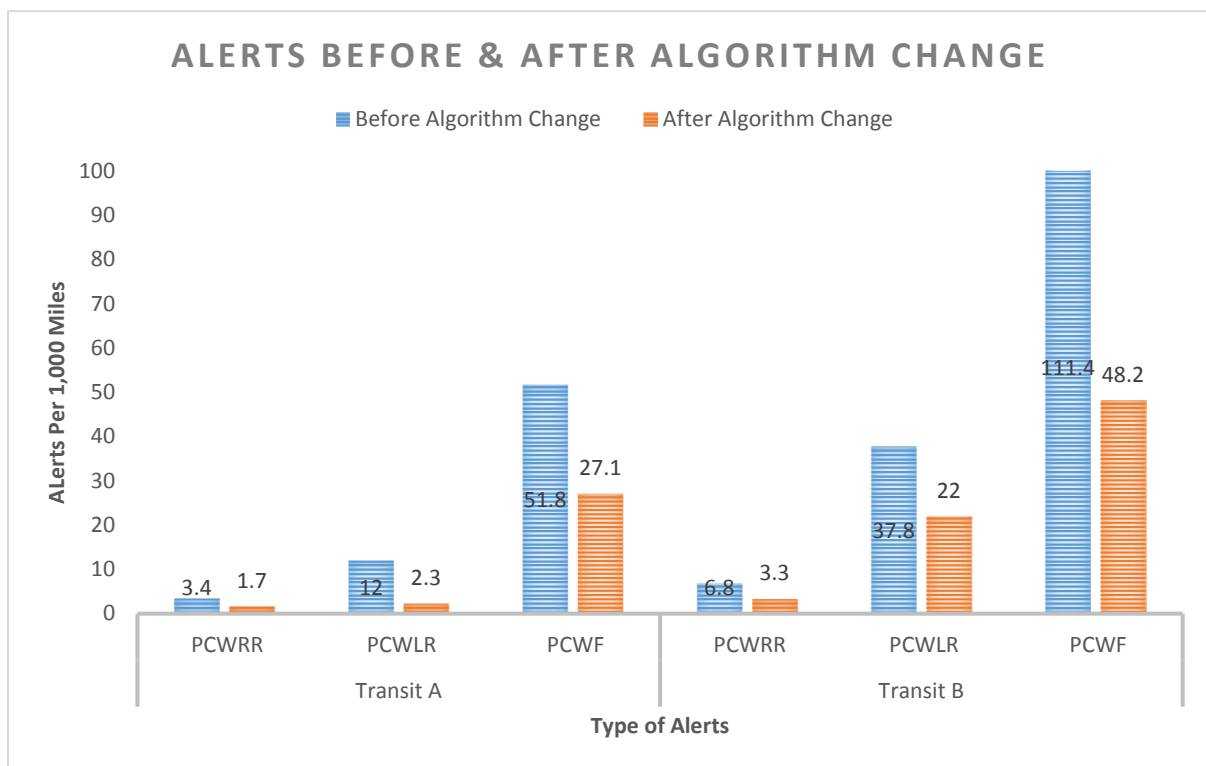
Figure 17. Graphical data from (2) transit properties before & after the bus stop algorithm change.

In Table 3 and Figure 17, data is shown from two transit properties in Washington State where the improved algorithm was applied. The resulting reduction in PCWF type alerts was indicative of reduced sensitivity based on the bus stop maneuver filtration.

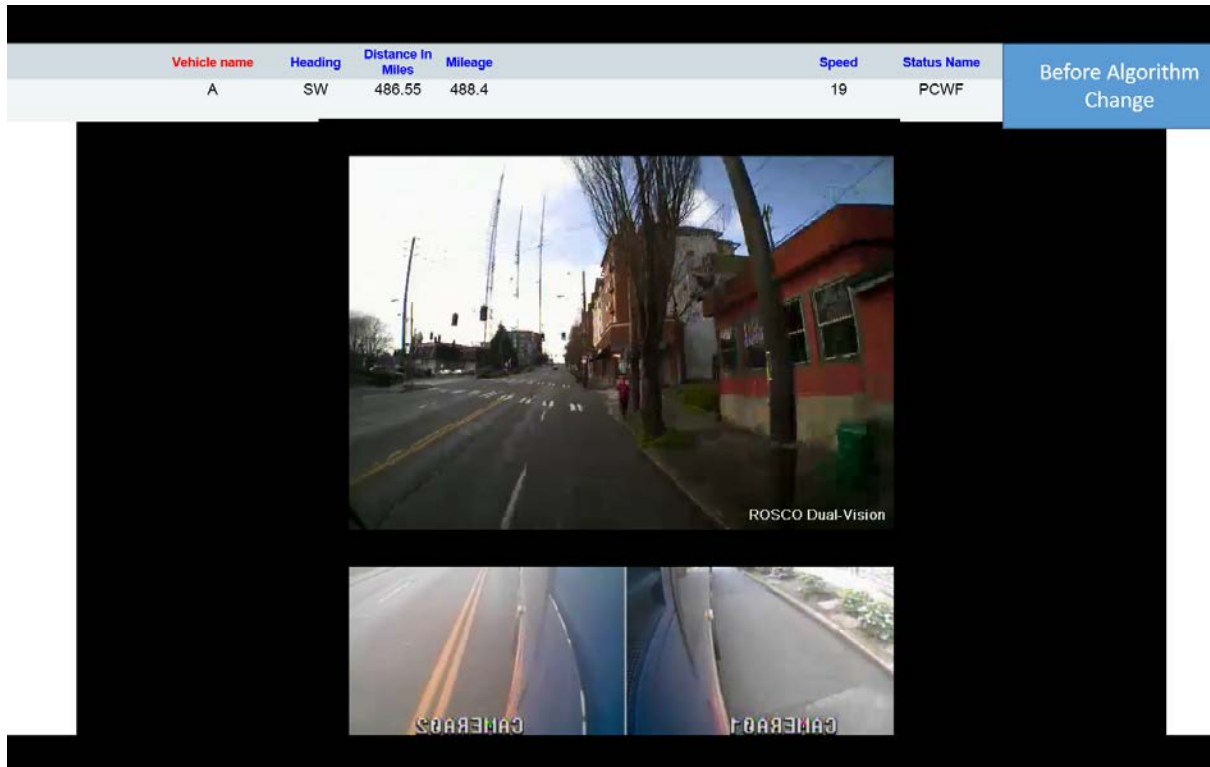
Figure 18. Vehicle A shows PCWF before algorithm change.

Figures 18 & 19 show screen shots of video playback before and after the algorithm changes at a specific Washington State transit authority. In the exact same locations with pedestrians standing at

the same bus stop, and with similar approach speeds and angles, the Shield+ system generated a PCWF alert before the change (Figure 18) and a PDZ (Detection alert) after the change (Figure 19).
