# **APPLYING LANE KEEPING SUPPORT TEST TRACK PERFORMANCE TO REAL-WORD CRASH DATA**

National Highway Traffic Safety Administration  
USA

Paper Number 19-0208

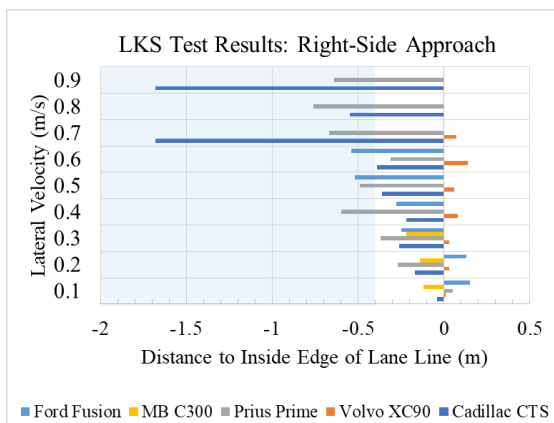
**Figure 2. LKS test results – right side departure**

Figures 2 and 3 illustrate the performance differences among the five test vehicles during tests performed with the various lateral velocities. Lateral deviations greater than those specified by the LKS performance criteria are shaded in blue.

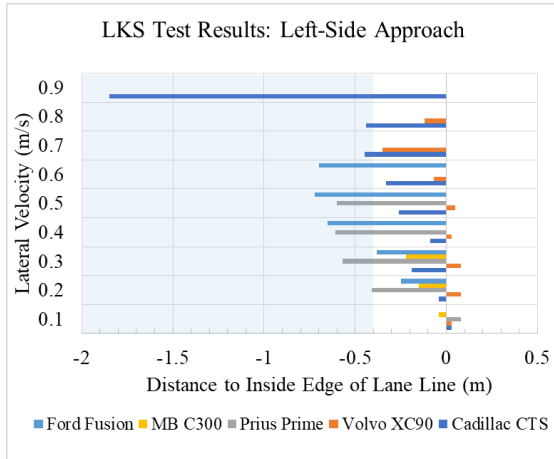
Figure 3. LKS test results – left side departure

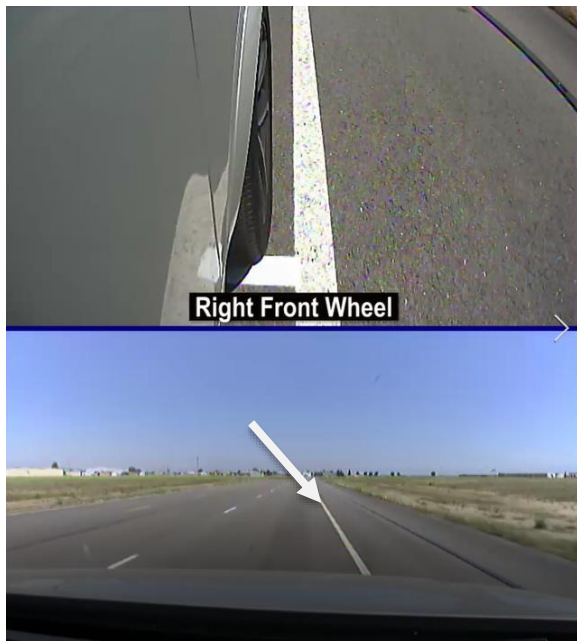
*Figure 4. Point of maximum lateral deviation observed during a right-side approach test performed with the Volvo XC90 and a 0.7 m/s lateral velocity*

Figures 4 and 5 are screen shots from test video recorded during right-side approaches performed with a lateral velocity of 0.7 m/s, for the Volvo XC90 and the Cadillac CTS, respectively. LKS intervened during both trials. The maximum lateral deviation recorded for the Volvo XC90 was 0.07 m from the inboard edge of the lane marking (able to satisfy the LKS performance criteria), whereas it was 1.68 m for the Cadillac CTS (unable to satisfy the LKS performance criteria). The white arrows shown in Figures 4 and 5 indicate the reference lane marking.

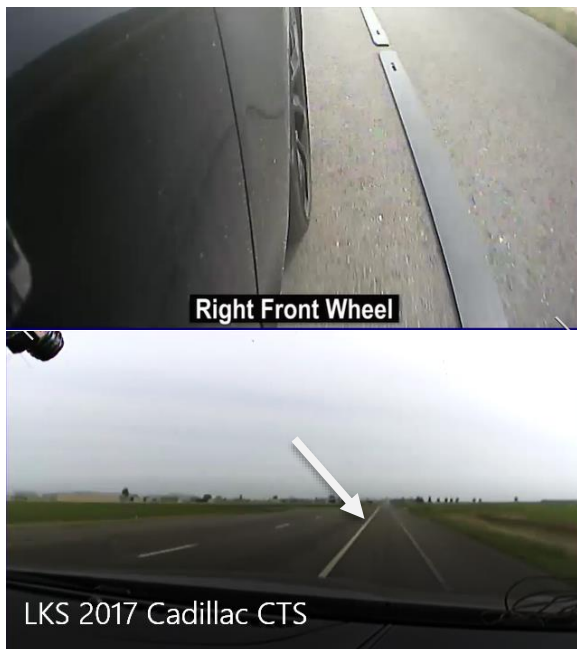
*Figure 5. Point of maximum lateral deviation observed during a right-side approach test performed with the Cadillac CTS LKS and a 0.7 m/s lateral velocity*

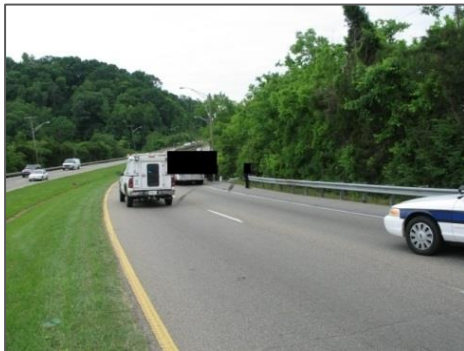
*Figure 6. NMVCCS Case No. 2006-045-063 shoulder width*

**Examples** In NMVCCS Case Nos. 2006-045-063 and 2007-78-071 the drivers drifted out of the lane on the left side. For these types of cases the road shoulder width measurement was estimated from the inside edge of the lane marker to the end of the road surface. This was conducted by examining the scene diagram and the scene photos, using the lane line width as the reference for the measurement. (Figures 6 and 7)

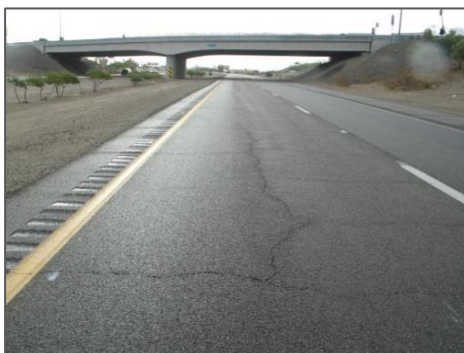
*Figure 7. NMVCCS Case No. 2007-078-071 shoulder width*

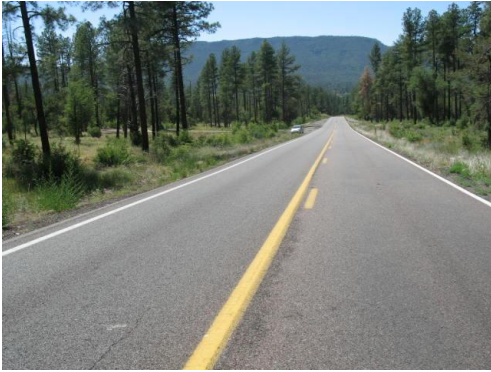
*Figure 8. NMVCCS Case No. 2005-76-035 adjacent lane on the left*

NMVCCS Case No. 2005-76-035 is an example where the subject vehicle departed the lane of travel into the “adjacent lane.” In this case the driver drifted over the center line and departed the road on the left resulting in a rollover (Figure 8).

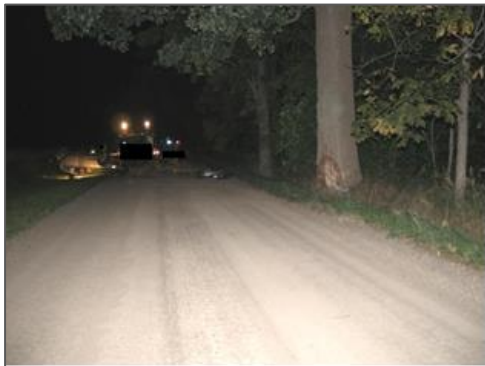
*Figure 9. NMVCCS Case No. 2005-11-61 road edge example*

NMVCCS Case No. 2005-11-61 is an example of crash where the vehicle was traveling a straight, level, two-way, rural gravel roadway with no painted lines (Figure 9). The subject vehicle drifted and exited the roadway to the right. This type of roadway was characterized by its “road edge.”

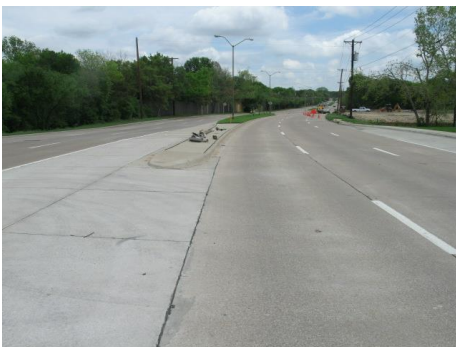
*Figure 10. NMVCCS Case No. 2007-49-043 curb example*

NMVCCS Case No. 2007-49-043 is an example of a roadway where there was no lane marking and just a curb at the end of the road surface on the side the vehicle departed the travel lane. In this case the subject vehicle was traveling east in left lane. After traveling through an intersection, the subject vehicle drove off the road to the left onto the curbed median striking a light pole (Figure 10). This crash also has some characteristics similar to the intersection crashes that were identified in the CISS data, and will be discussed later in this paper.

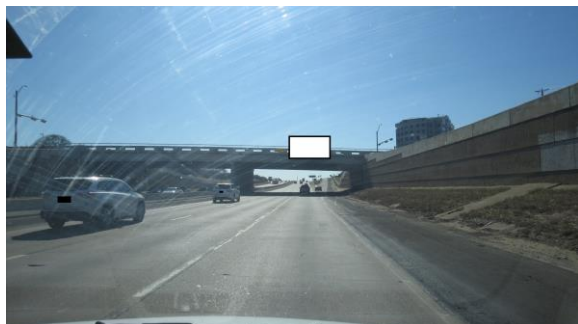
**Figure 12. CISS Case No. 1-13-2017-127-01 shoulder width example**

**Examples** CISS Case No. 1-13-2017-127-01, the subject vehicle initially departed its lane of travel on the right side prior to returning and departing the lane on the left side, resulting in a crash with a vehicle traveling in the adjacent lane. (Figure 12). In this case, the lane departure occurred on a highway whose shoulder width was measured from the inboard edge of lane line to the end of the road surface on the far right.

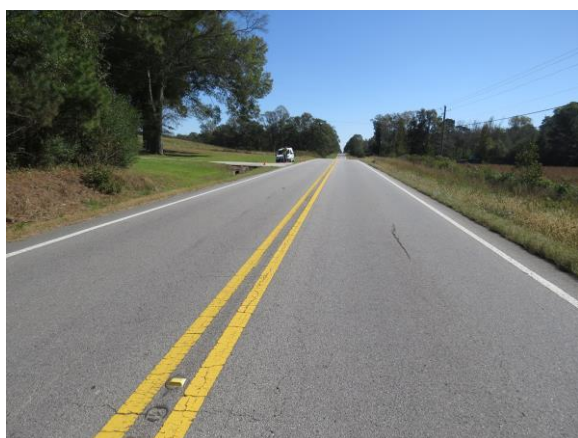
**Figure 13. CISS Case No. 1-19-2017-113-01 adjacent lane**

CISS Case No. 1-19-2017-113-01 is an example of a vehicle leaving the lane of travel into the adjacent lane. In this case the subject vehicle was traveling east on the highway, departing the lane on the left. The vehicle departed the roadway on the left where it struck a concrete driveway, and rolled over before coming to rest on its side (Figure 13).

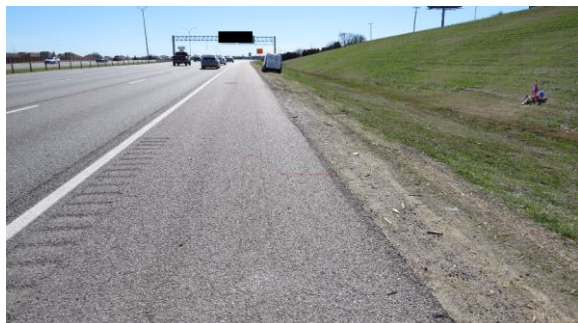
**Figure 14. CISS Case No. 1-32-2017-013-01 parked vehicle**

CISS Case No. 1-32-2017-013-01 was categorized as a vehicle parked on shoulder. In this case the subject vehicle was traveling on a major highway. The vehicle departed the roadway to the right, entering the road shoulder. The front of subject vehicle impacted the rear of a parked vehicle on the shoulder (Figure 14).

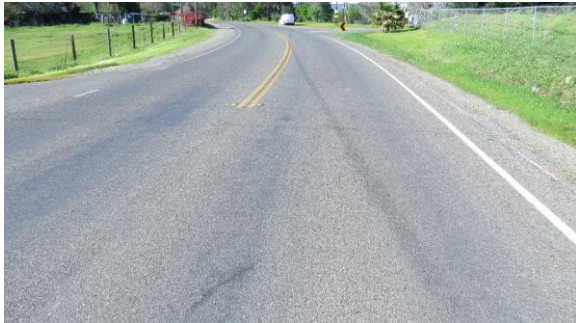
*Figure 15. CISS Case No. 1-33-2017-025-01 intersection example*

CISS Case No. 1-33-2017-025-01 is an example of a crash that occurred at an intersection. In this case, the subject vehicle drifted out of the travel lane into the adjacent lane. This occurred at an intersection where there were no lane markings. The vehicle proceeded to travel until it impacted a vehicle traveling in the opposite direction. Figure 15 shows the approach for the subject vehicle and the lack of lane markings at the intersection on the left side.

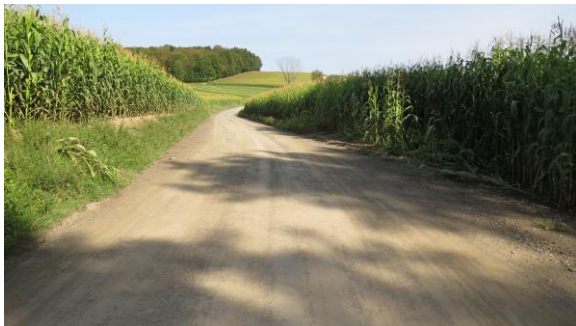
*Figure 16. CISS Case No. 1-28-2017-046-01 road edge example*

CISS Case No. 1-28-2017-046-01 is an example where there were no lane markings on a gravel road but a discernable road edge. In this case, the subject vehicle was negotiating a right curve. The vehicle departed the roadway to the left side and impacted a tree on the left side of the vehicle (Figure 16).

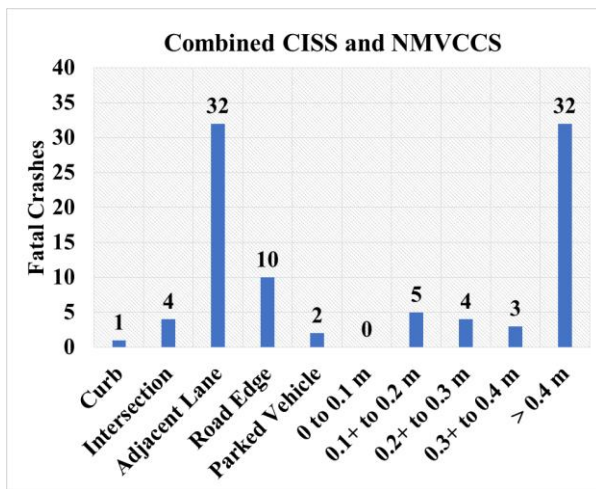
Figure 18. Combined CISS and NMVCCS roadway shoulder distance or characterization.

With respect to the roadway shoulder width, NMVCCS and CISS results (which encompassed 93 fatal crashes that were collected approximately 10 years apart) were consistent and showed similar distributions. For that reason, the combined results are presented in Figure 18.

Thirty-two of the ninety-three crashes shown in Figure 18 involved the subject vehicle drifting out of the initial travel lane into an adjacent lane. Crashes that involve the subject vehicle drifting out of its lane result in head-on crashes with an oncoming vehicle or a road departure from the adjacent lane.

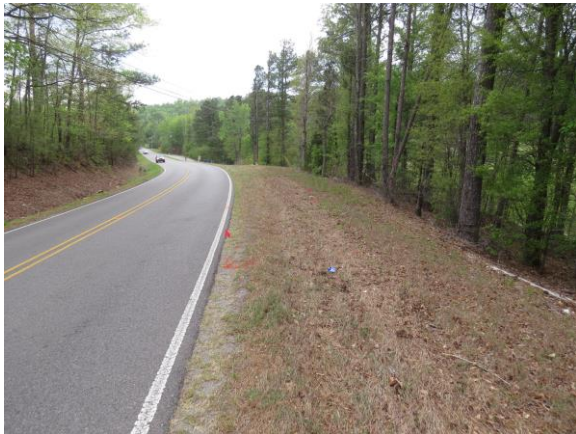
*Figure 19. CISS Case No. 1-19-2017-041-01 vehicle approach*

CISS Case No. 1-19-2017-041-01, is an example of a roadway with a narrow shoulder that only an LKS that allows very limited lateral deviation from the travel lane would be expected to prevent at least part of the subject vehicle from departing the roadway. The subject vehicle in this example was traveling west and departed the roadway to the right. The vehicle, traveled down an embankment, across an adjacent roadway prior to impacting a tree.

From Figure 19, the shoulder width was measured in CISS to be approximately 0.15 m. The test track data previously presented in Table 2 indicated that only the Volvo XC90 LKS interventions consistently (i.e., over a wide range of lateral velocities) prevented right-side lateral deviations below that distance. Except for the lower lateral velocity conditions, the other test vehicles generally exceeded a lateral deviation of 0.15 m.

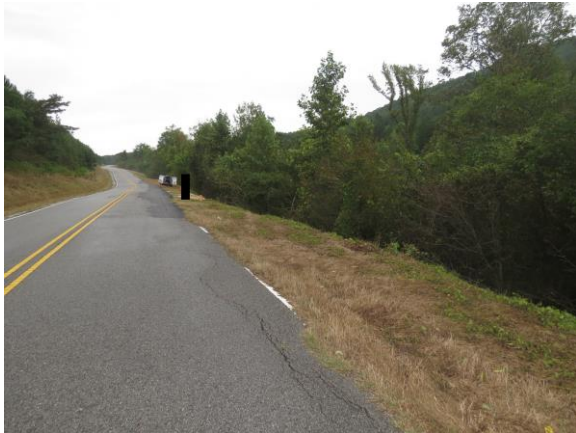
*Figure 21. CISS Case No. 1-19-2017-097-01 vehicle approach*

CISS Case No. 1-19-2017-097-01 is an example of a road edge case. In this fatal crash, the subject vehicle departed the roadway to the right where there was a disparate lane line and a discernable road edge (Figure 21). After departing the roadway, the vehicle traveled down a steep embankment, striking one or multiple trees and rolling over before coming to final rest. To prevent this type of crash, it is expected the most effective LKS intervention would occur prior to the vehicle leaving the road since pavement provides greater lateral force (turning) capacity than an unpaved deformable surface. With regards to intervention proximity to a lane line, the Volvo XC90 test track performance was indicative of this kind of operation; preventing the

vehicle from traveling past the line in each of the right-side approaches. However, and as previously stated, it is unknown whether the Volvo XC90 LKS system has been configured to respond to an imminent road edge departure which, in this case, is essentially a lane departure without a clear marking delineating the right side of the lane. This case provides evidence of why it may be important for an LKS system to address lane and road departures, to maximize the overall potential safety benefits provided by these systems during real-world driving where clear markings are not always present.

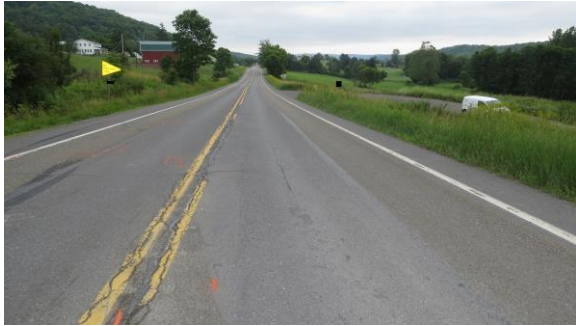
**Figure 22. CISS Case No. 1-28-2017-032-01 vehicle approach**

CISS Case No. 1-28-2017-032-01 is example where the subject vehicle encroaches into the adjacent lane and is involved in a fatal head-on collision. The subject vehicle was traveling west on a two lane non-divided roadway. A large truck was traveling east on the same roadway. The subject vehicle entered the truck's lane, and a head-on impact resulted (Figures 22 and 23).

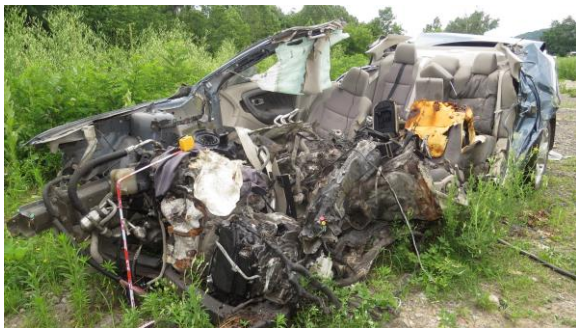
**Figure 24. CISS Case No. 1-28-2017-032-01 front end crush of subject vehicle**

Figure 24 presents the damage incurred by the subject vehicle. Based upon the crush pattern and interaction with the truck, the subject vehicle likely crossed over the centerline and into the adjacent lane by well over the 0.4 m allowance specified in the Euro NCAP LKA performance criteria.
