DETECTION OF CYCLIST AND PEDESTRIANS AROUND HEAVY COMMERCIAL VEHICLES

Transport Canada

19-0340

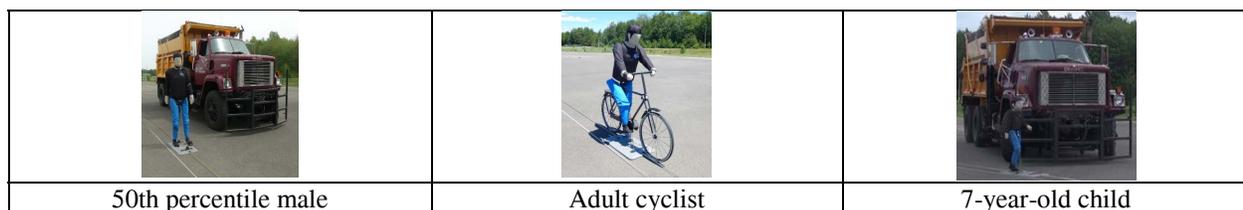
Figure 1. Surrogate dummies

Transport Canada owned a 1988 GMC Brigadier at its test facility. This test specimen represented a heavy-duty commercial vehicle, equipped with a dump box. The test vehicle was instrumented with RT4002 Inertial GPS Navigation Systems and RT-Range from Oxford Technical Solutions (Ox-TS) to measure the vehicle's position, heading, vehicle speed, angular velocities (yaw, roll, and pitch rate), linear acceleration (longitudinal, lateral and vertical) and distance to target. Three 4-Active articulated pedestrian dummies (50th percentile adult male, 7-year old child, 50th percentile adult cyclist as shown in figure 1) paired with the Soft Pedestrian Target (SPT-20) system from Anthony Best Dynamics were used to safely and accurately challenge the detection systems. The dummies were pulled by a track system and synchronized to produce dynamic conflicts between the heavy-duty commercial vehicle and the VRU. Used to evaluate passenger vehicles' ADAS systems (Advanced Driver Assistance Systems), the standardized dummies provided reliable and repeatable test conditions. These pedestrian/cyclist dummies are designed to be impacted by a vehicle. They have a radar signal cross section similar to a human and are articulated to mimic human motions which enable the evaluation of the detection system's safety and accuracy.

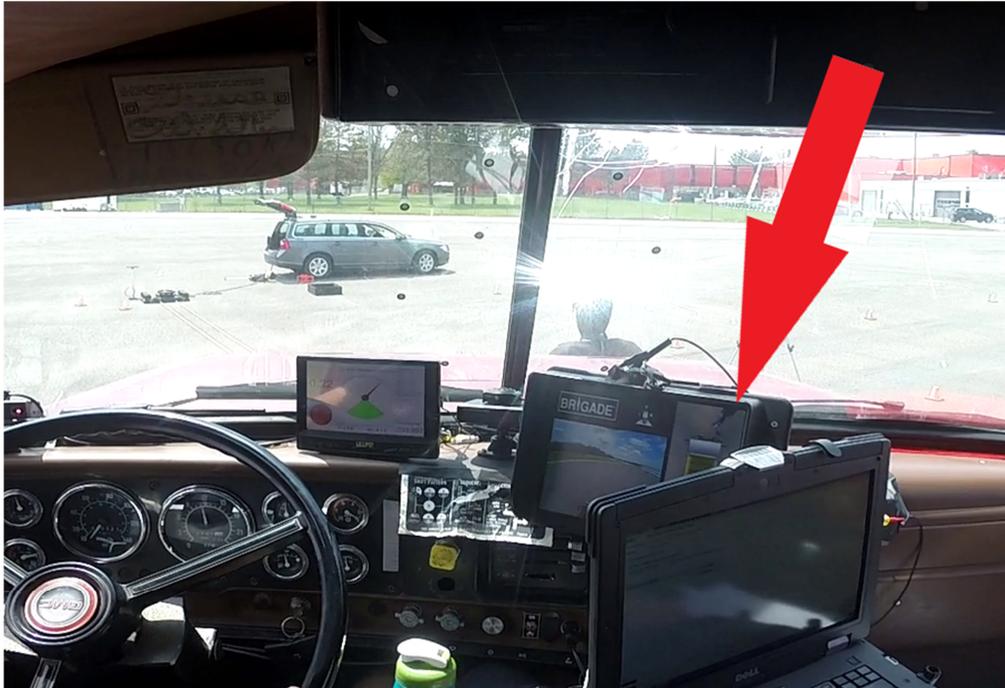
Figure 2. Dummy identifiable 0.43 seconds after emergency braking initiated during Scenario #1

Figure 2 below shows the dummy on the 360 view camera 0.43 seconds after the braking procedure was initiated. The monitor on the dashboard, right of the steering wheel was used by the technician to maintain a repeatable route and to activate the emergency braking procedure at the right time.

During dynamic scenarios, it was not possible to see the pedestrian on the screen on time for the operator to start the emergency manoeuvre. Two tests had 0.03 seconds lead time to the emergency procedure. This was not sufficient for the operator to realize that an action was required. As well, the operator needed to monitor the screen and this might distract from other safety tasks.

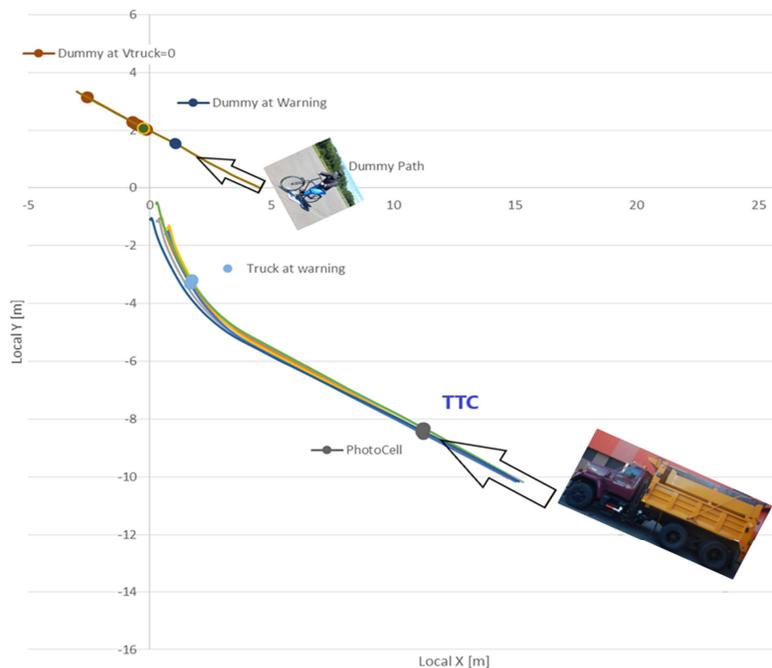
Figure 3. Sample top view Scenario 1 with a cyclist dummy

Figure 3 shows the path used during the scenario #1. The bullet “truck at warning” was repeatable indicating that the relation between the truck and VRU was constant. On that diagram, it is important to notice that the end of the heavy commercial vehicle’s path was not extrapolated to the front bumper, but simply the position of the RT range in the vehicle.
