A FRAMEWORK FOR IMPROVING OF HEAVY TRUCK CAB CRASHWORTHINESS UNDER ROLLOVER CONDITIONS

Friedman Research Corporation

Paper Number 19-0336

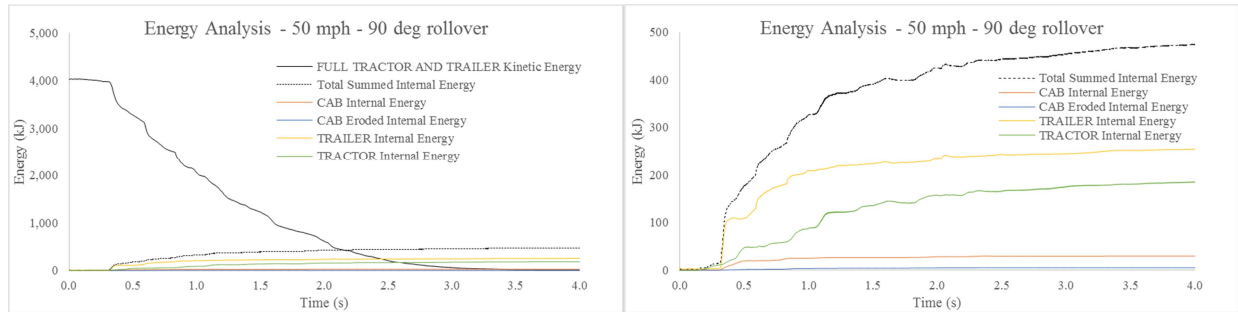
Figure 2 Energy summary for typical 90 deg heavy truck rollover

The vast majority of crash energy in typical heavy truck rollover crashes is dissipated through friction as the truck slides across the ground surface and only a relatively small percentage is associated with the damage related to the most harmful event (e.g. cab roof damage) [6]. This is demonstrated in Figure 2 which illustrates the total amount of energy that was dissipated through deformation (i.e. internal and eroded energy) vs the total amount of kinetic energy dissipated throughout the entire event. The total amount of energy associated with damage to the tractor, cab, and trailer was roughly 12 % of the total available energy.

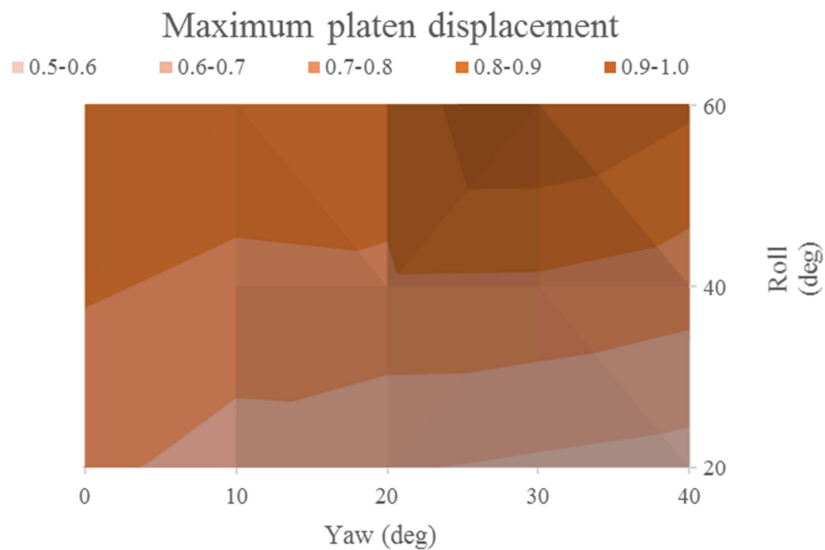
Figure 3 Contour plot of cab deformation vs orientation (data normalized to maximum value)

Platen motion was used to measure maximum cab deformation in the simulated sled tests. Cab deformation was highly dependent on the orientation of the platen relative to the cab as shown in Figure 3. Greater roll angles produced greater deformation. The maximum amount of deformation was achieved at a roll angle of 60 deg combined with a yaw angle of 30 deg. The lowest levels of deformation were 56% of the maximum value.

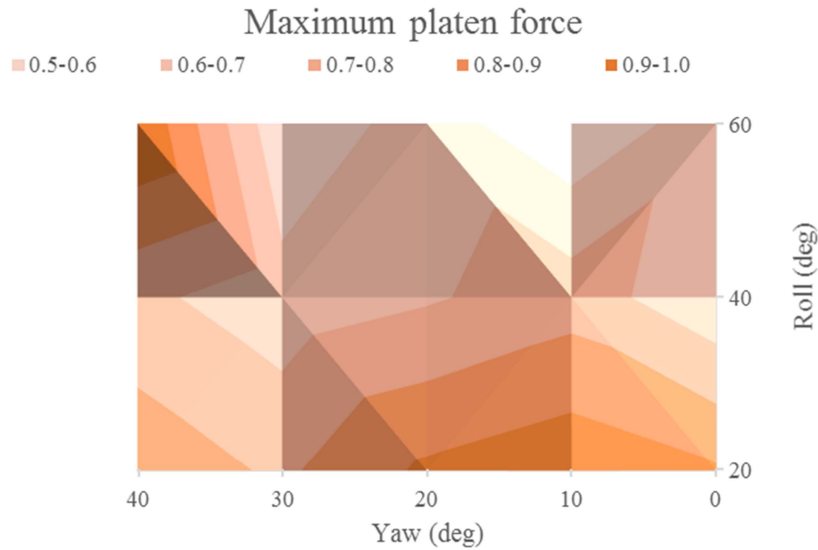
Figure 4 Contour plot of platen force vs orientation (data normalized to maximum value)

Platen force was inversely related to the cab deformation as described in Figure 4. The greatest platen force was measured in a 60 deg roll, 40 deg yaw orientation. Though, high force levels were also measured at 20 deg roll angles. It is expected that greater force values would be associated with lower deformations.

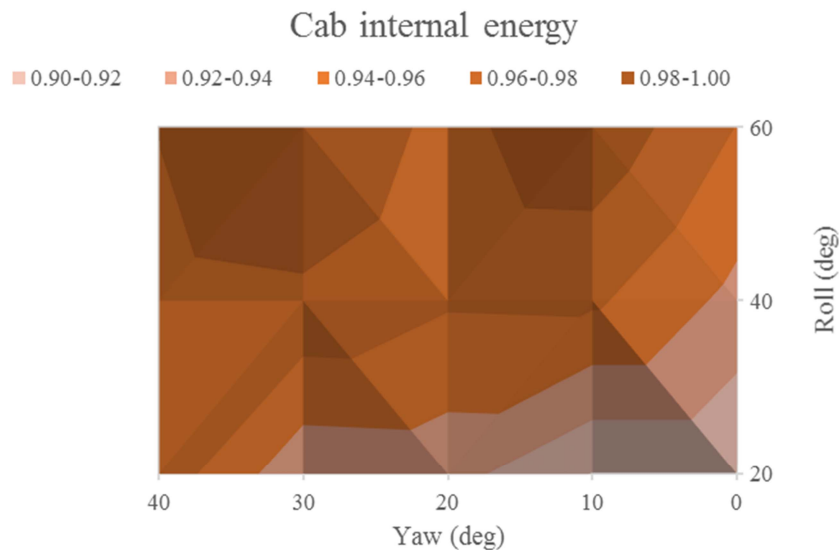
Figure 5 Contour plot of cab internal energy vs orientation (data normalized to maximum value)

The internal energy absorbed by the cab was distributed in a similar pattern as the maximum cab deformation values. Figure 5 shows that the maximum energy was absorbed in the 60 deg roll, 30 deg yaw orientation but that the range in absorbed energy was relatively small. For all orientations the difference in the minimum and maximum internal energy was 10.9 %

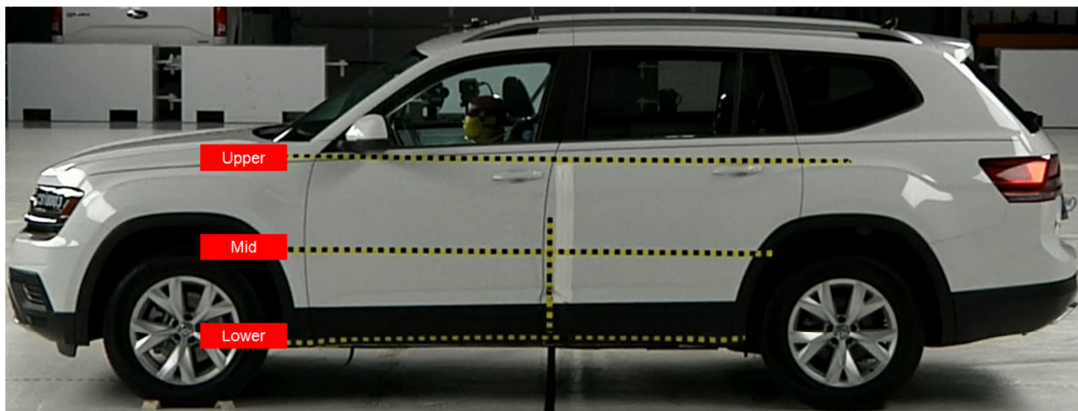
Figure 4. Measurement locations for external crush

For the struck vehicle, setup followed the IIHS side impact test protocol and UMTRI ATD Positioning Procedure [14] with the addition of pre- and postcrash measurements taken along the side of the vehicle to compare deformation patterns (Figure 4).

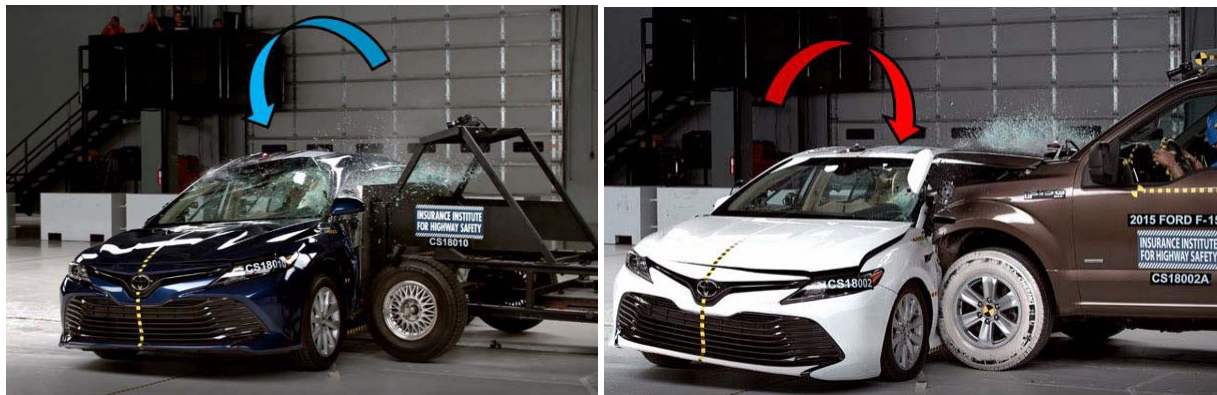
Figure 6. Vehicle dynamics comparison between Toyota Camry struck by the MDB (left) and Ford F-150 (right) at 60 km/h during maximum roll

High-speed video footage indicated different vehicle dynamics between vehicle partners and the MDB. The struck vehicles rolled away from the MDB (positive roll, as defined by SAE [15]), while struck vehicles rolled toward (negative roll) all three of the striking vehicle partners. This pattern was observed in all four struck-vehicle models in this study. An example of these kinematic differences is shown in Figure 6 with the Toyota Camry.

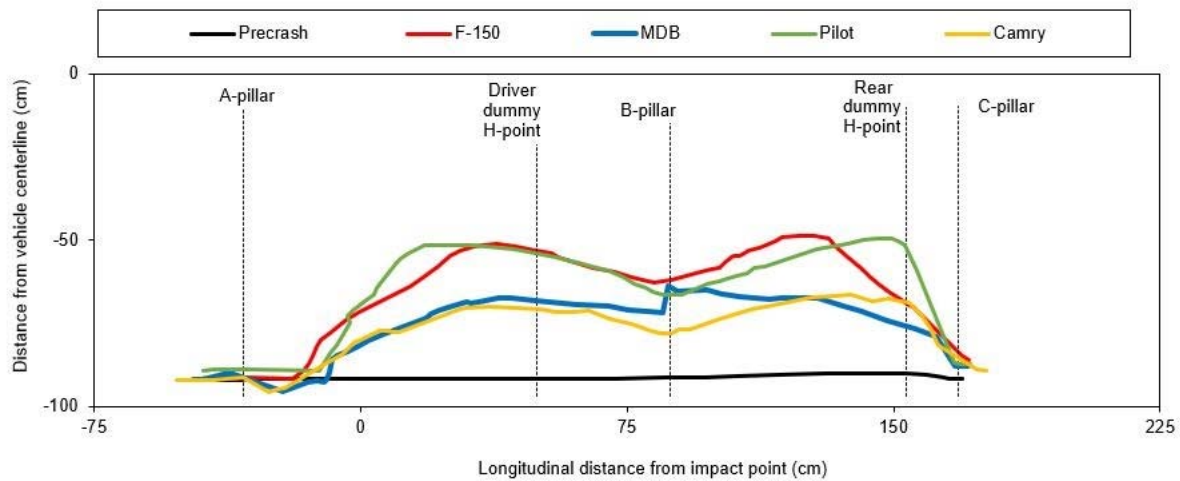
Figure 7. Comparison of external crush along the struck vehicle doors for the Toyota Camry struck by different vehicle partners at 60 km/h

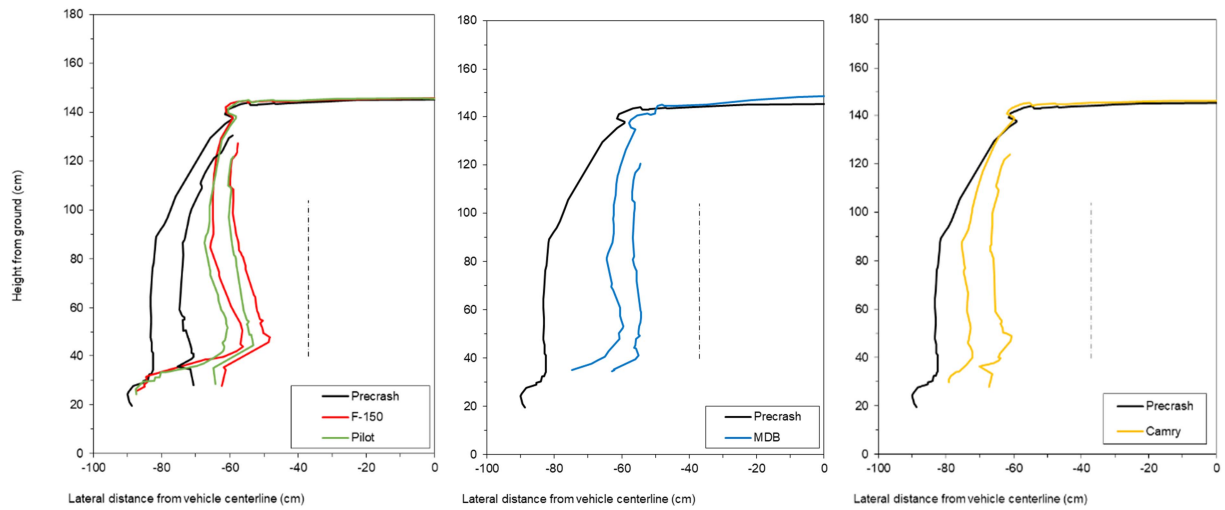
Figure 8. Comparison of B-pillar vertical deformation in Toyota Camry tests

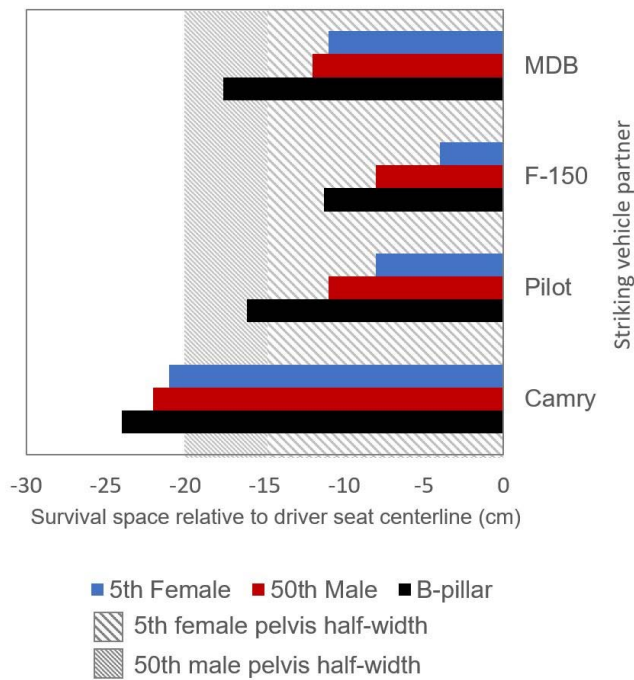
Figure 9. Comparison of occupant survival space measurements for 60 km/h striking vehicles against the Toyota Camry

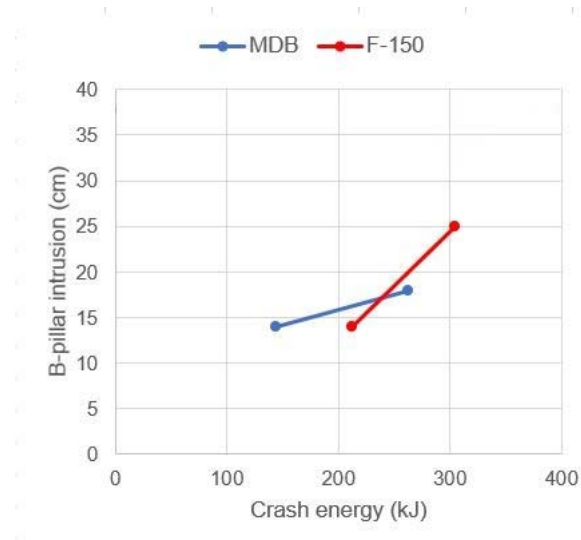
Figure 10. Crash energy and vehicle structural performance for Toyota Camrys struck at 50 km/h and 60 km/h

The effects of crash energy on performance for the Toyota Camry when struck by the F-150 and MDB are shown in Figure 10. The 10 km/h increase in speed for the F-150 test pair represents a 44% increase in energy and resulted in a 50% increase in intrusion on the Camry. In comparison, increasing the MDB mass and speed represented an 82% increase in energy yet resulted in only a 20% increase in intrusion. These specific comparisons highlight the observations that the MDB distributes loading over a broader area of the side structure than the striking LTV.

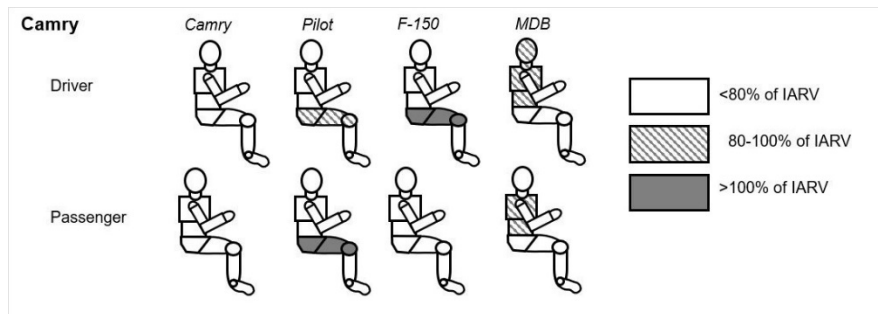
Figure 11. Injury patterns in Toyota Camry tests conducted at 60 km/h

Peak injury measures from the driver and rear passenger SID-II's dummies are summarized in Appendix B. General injury patterns in the Toyota Camry tests are illustrated in Figure 11. Striking vehicle partners caused vertically lower structural intrusions and dummies recorded elevated pelvic and femur injury measures, while dummies in the MDB partner tests had elevated head and chest measures.

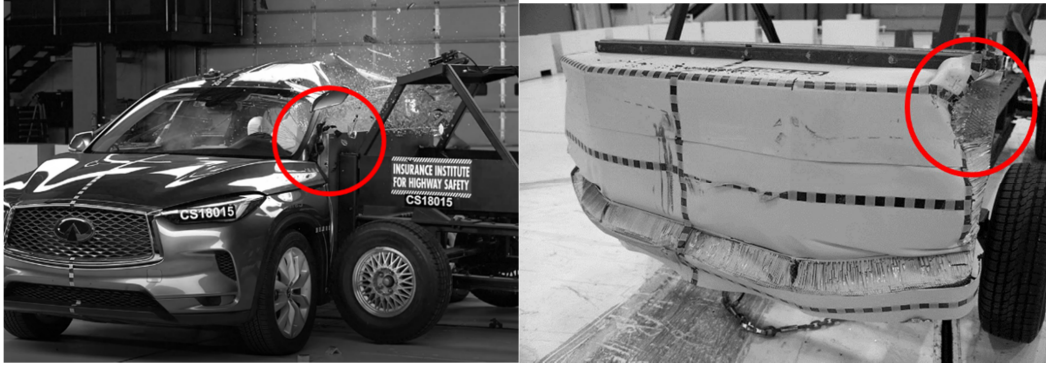
Figure 13. Barrier crush in the 60 km/h Infinity QX50 test highlights significant loading at the barrier’s edges that do not occur in laboratory LTV tests

The efforts in the current study suggest that the simplistic barrier design conceived in the late 1990s is no longer replicating the deformation and injury patterns of current striking LTVs. Design requirements in regulatory and consumer information tests in the 1990s did not necessitate structural improvements of vehicle sides to perform well, but current testing requirements require consideration for stronger vehicle structures. Consequently, the lack of fidelity of the IIHS MDB to real LTV front structures was not as apparent as the present tests show. Current side designs now tend to fend off the MDB by carrying large loads through the B-pillar, door sill, and roof rail. However, the fronts of modern vehicles are stiffer at the frame rail locations while sections outside and in the middle are softer, contrasting with the MDB's uniform stiffness. Thus, the strongest parts of vehicles' sides do not align with the stiffer portions of the striking vehicles' fronts, so less load can be carried by the B-pillar, door sill, and roof rail than is apparently the case when struck by the IIHS MDB. Additionally, the MDB is loading A-pillars and lower rear door frames of the struck vehicles, which is not seen with LTV striking vehicle comparisons (Figure 13).

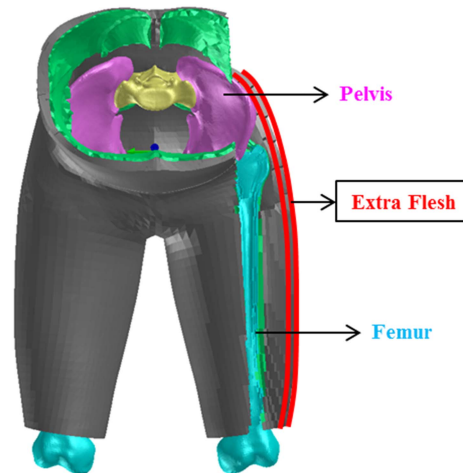
Figure 21 Extra layer of flesh added to hip region of HBM to simulate increased BMI occupant.

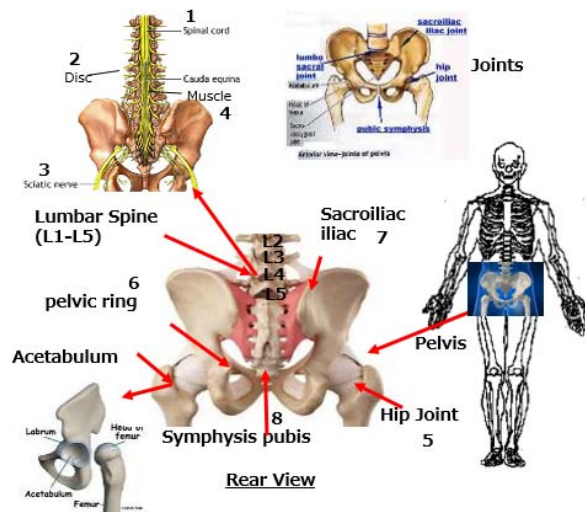
Figure A1. Schematic view of the pelvis region

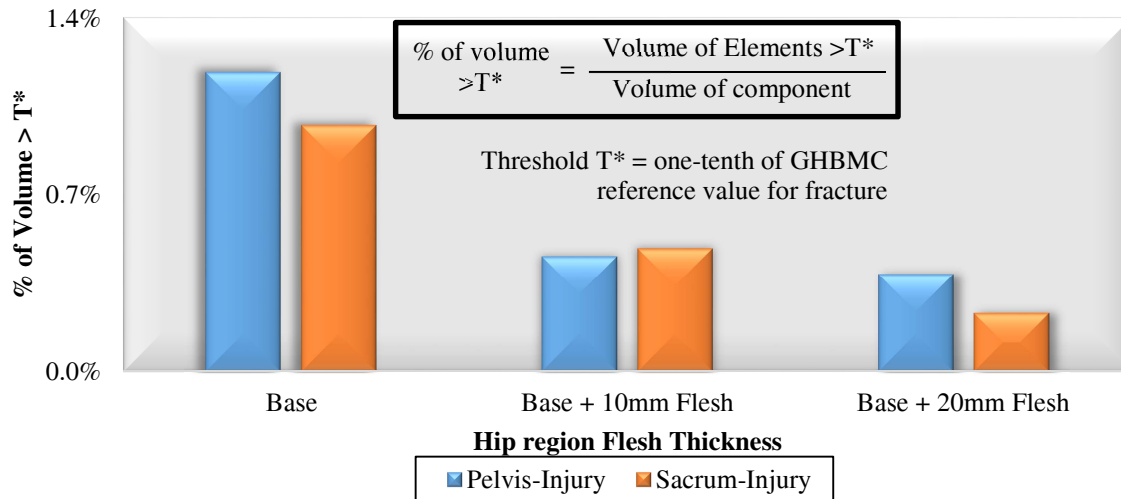
Figure A7. Influence of hip region flesh thickness on pelvis injury

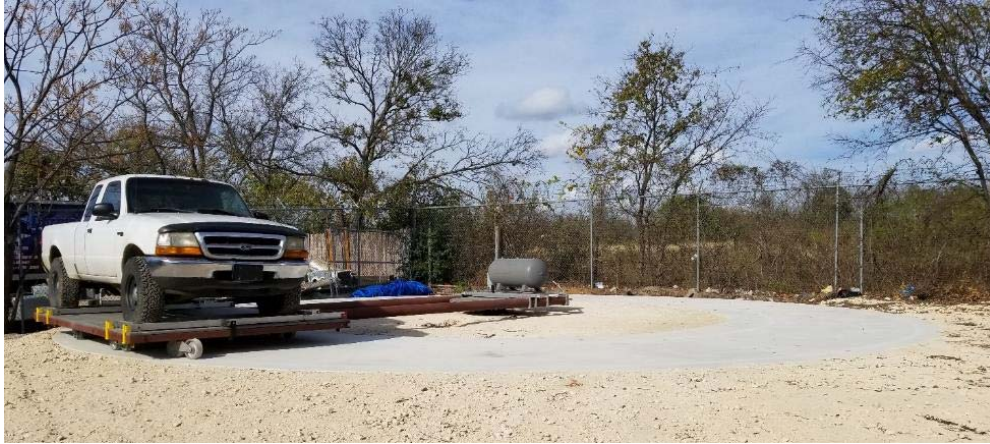
Figure 1 Test fixture with test article at start position

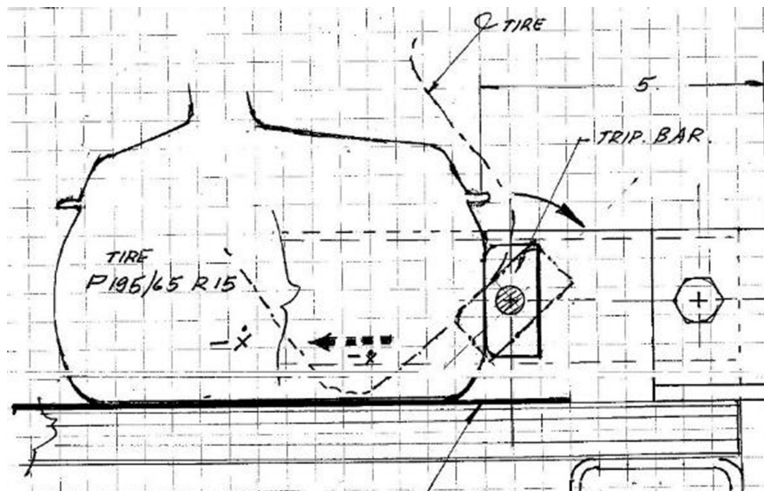
Figure 2 Cross-section view of tire and trip bar

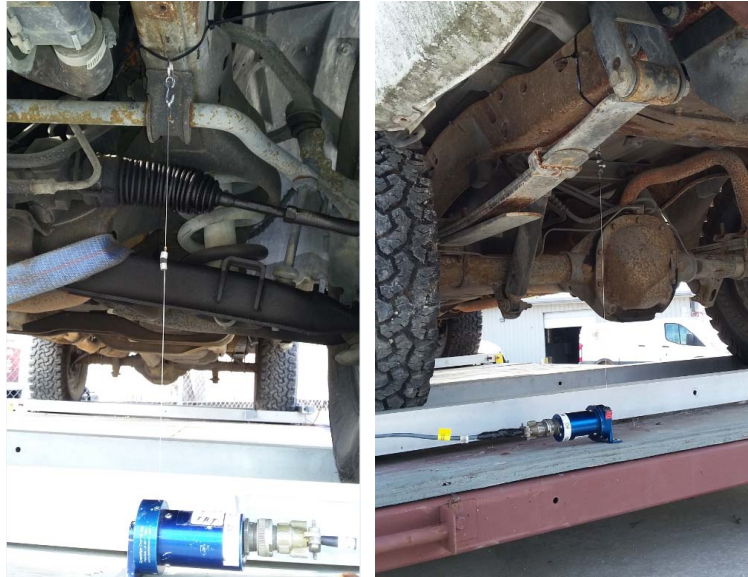
Figure 3 Front (left) and rear (right) string potentiometer placement

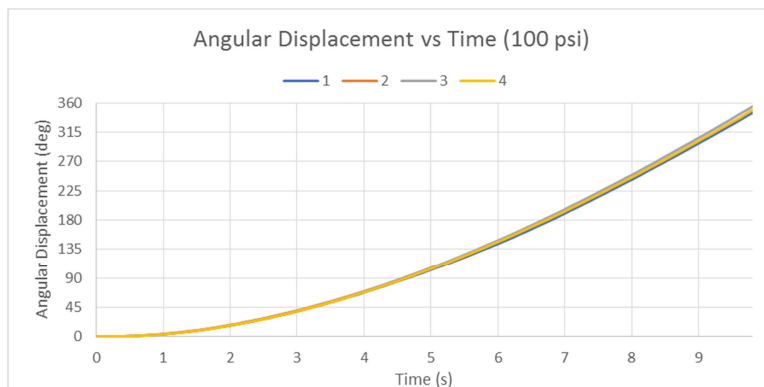
Figure 4 Platform angular displacement time-history (Test Series 1)

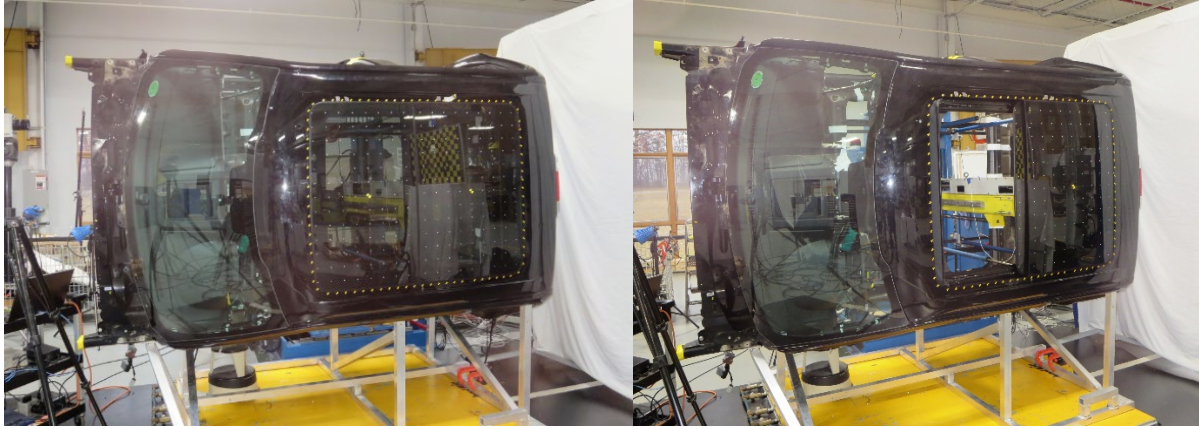
Figure 1. View of F-150 sunroof panel in both closed (left) and open (right) positions from outside. The F-150 had one of the largest sunroofs available at the time.

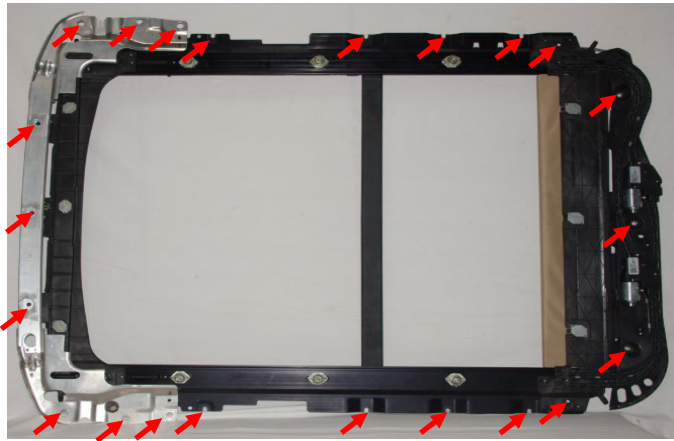
Figure 2. Red arrows indicate where sunroof module was bolted to the roof of the vehicle.

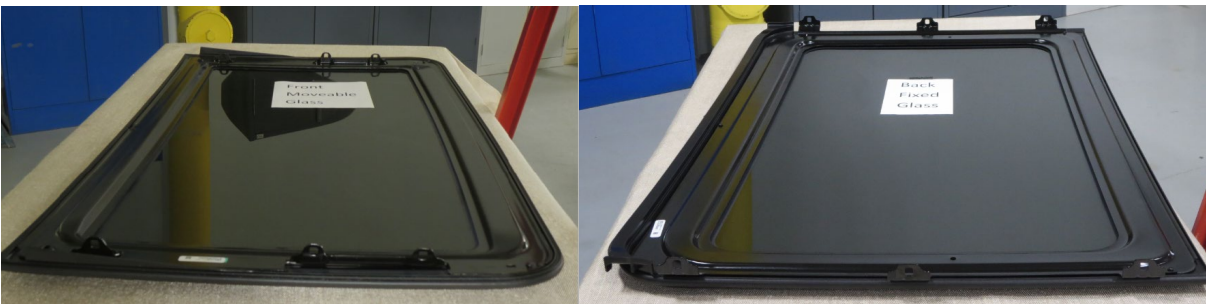
Figure 3. F-150 sunroof panels – left: front moveable panel, right: rear fixed panel.

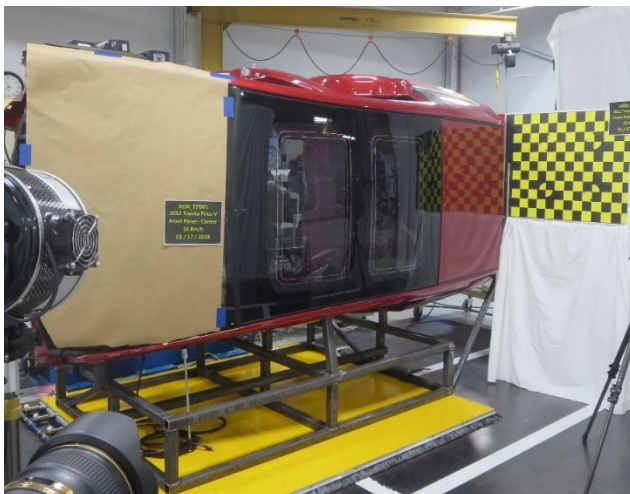
Figure 6. Sunroof panel glued to roof of vehicle with polyurethane.

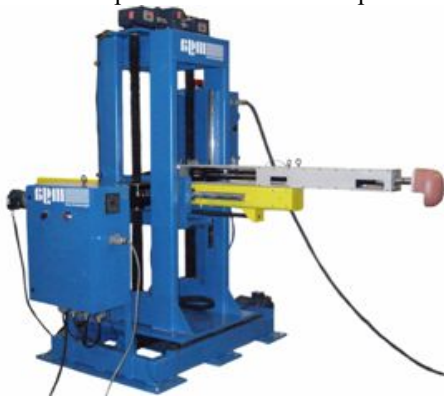
Figure 10. Ejection guided impactor with 18 kg featureless headform.

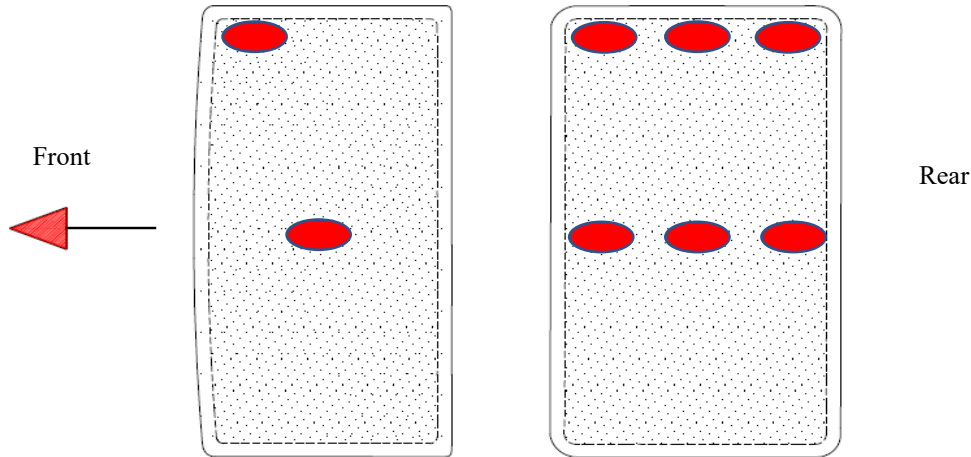
Figure 11. Initial test locations and headform orientation (F-150).

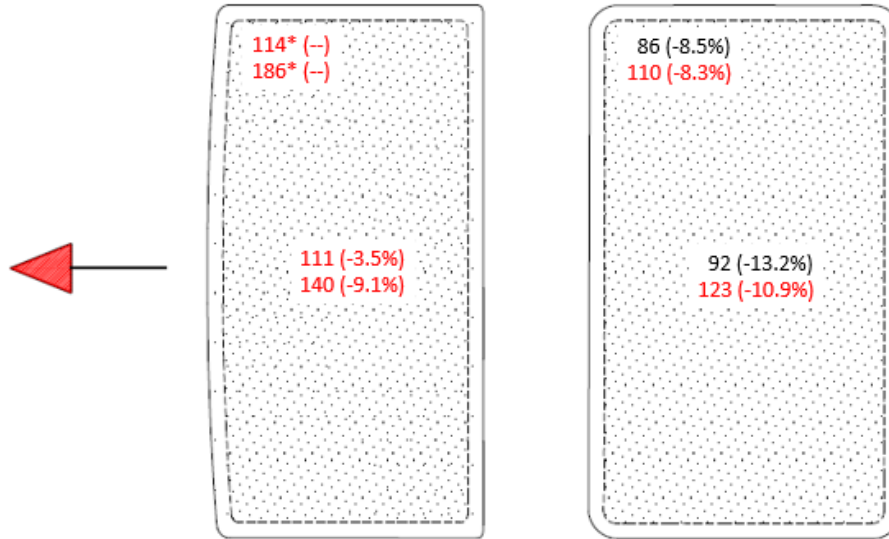
Figure 13. Thicker PVB Results.

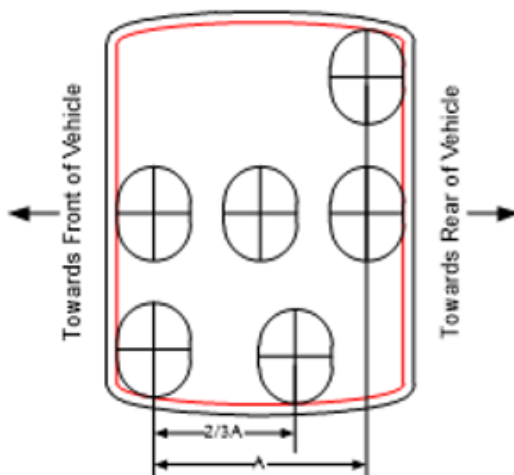
Figure 15. New Test Setup.

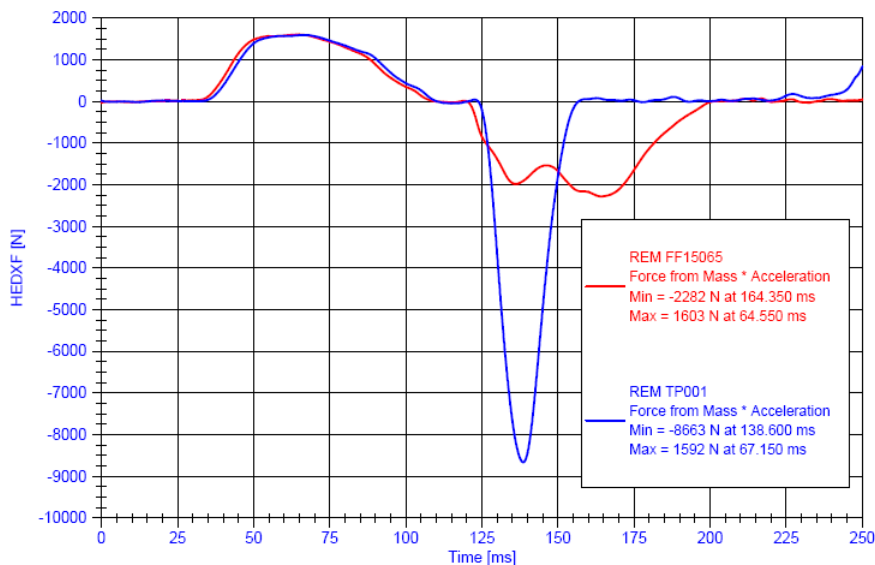
Figure 18. Comparison of forces on headform of F-150 (red) and Prius (blue).

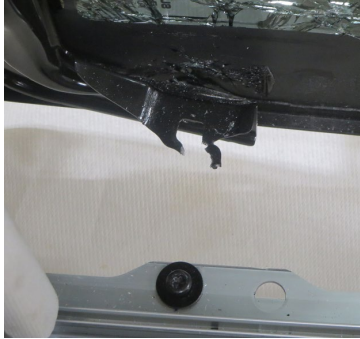
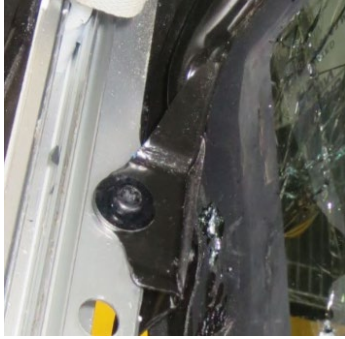
Rear panel - attachment bracket	Rear panel bracket – glue attachment	Rear panel – PVB tear at attachment
