POST COLLISION VEHICLE FIRE ANALYSIS

Markus Egelhaaf

DEKRA Automobil GmbH, Accident Research Stuttgart
Germany

DEKRA Automobil GmbH, Heilbronn Office
Germany
Paper Number 11-0315

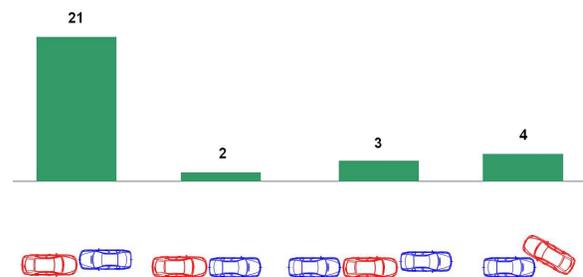
Figure 1. Distribution of main impacts in 30 crashes resulting in a fire, DEKRA 2008 [15]

The main results of the DEKRA study was a disproportionately high percentage of frontal damage among those vehicles which caught fire [13]. The results corresponded very well to those of an NHTSA study [14]. 30 fire accidents involving at least two vehicles [15] were analyzed as part of a 2008 DEKRA study [16]. In this case, too, frontal impacts were the most frequent, Figure 1.

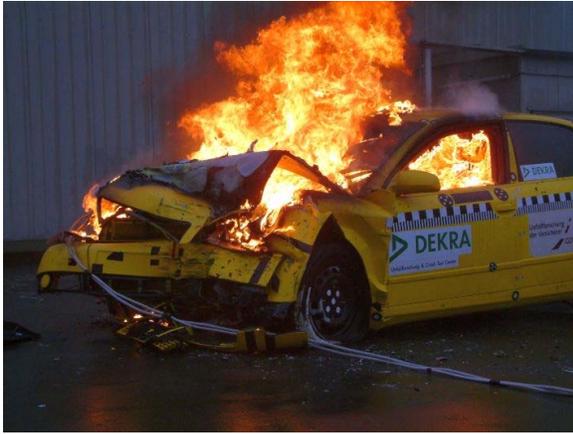
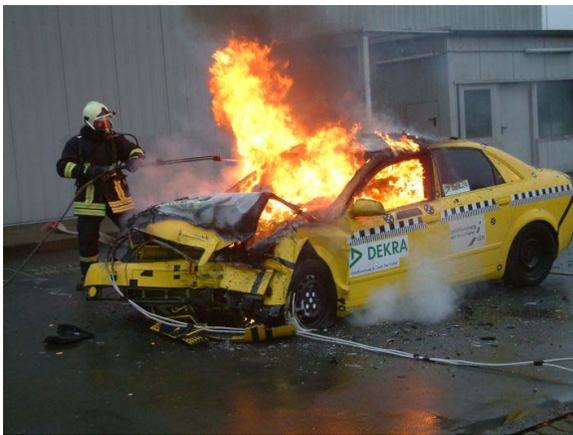
Figure 9. Sequence of fire test 1

The car was electrically ignited on the right side of the engine compartment. A 12V starter battery was used for that. In accordance with a real-life accident, the area around a battery-connected wire near the air intake was chosen for the short circuit. The course of fire is displayed in Table 1 and Figure 9.

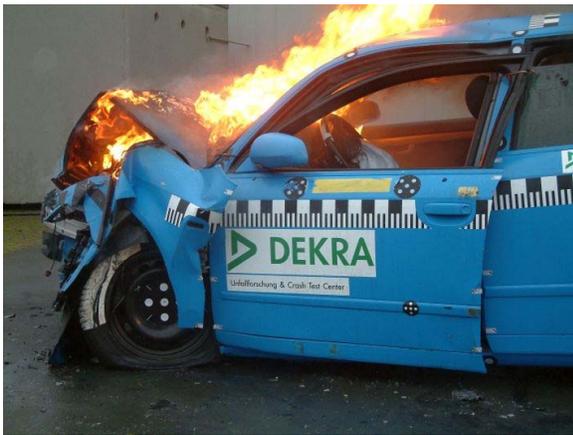
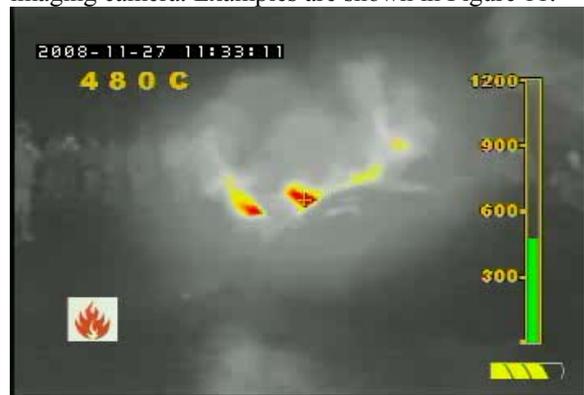
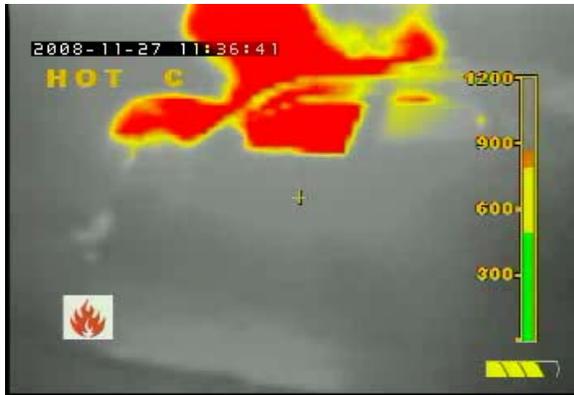
Figure 11. Thermal images of the engine fire and the moment before the flashover in the passenger compartment

The test was additionally monitored with a thermal imaging camera. Examples are shown in Figure 11.

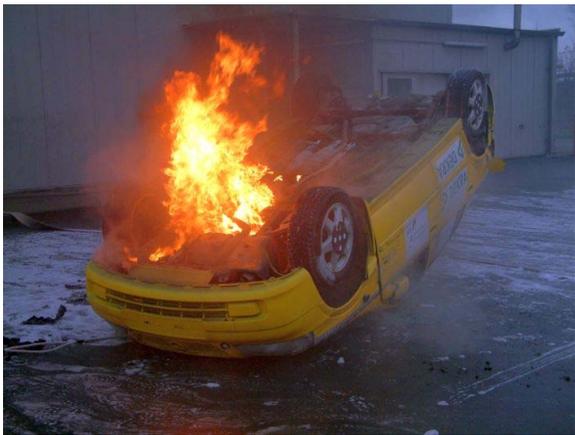
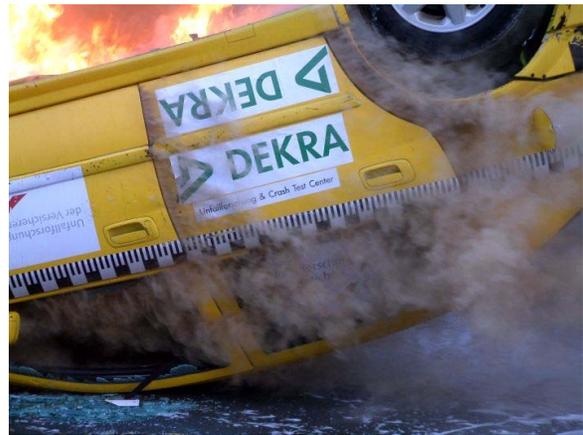
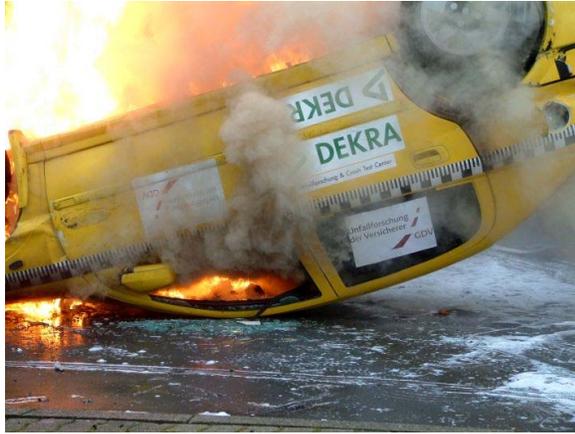
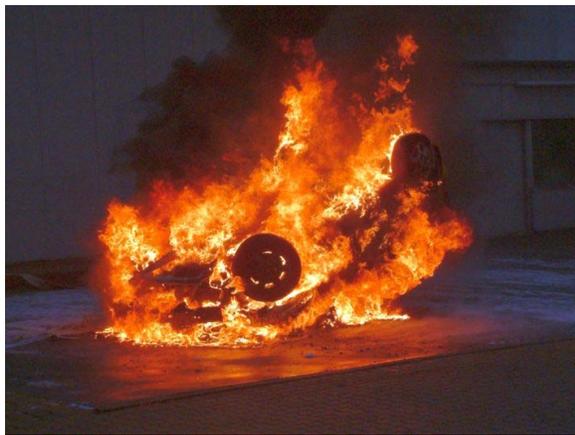
Figure 12. Sequence of fire test 3

The car was electrically ignited at the front of the engine compartment by simulating a stuck radiator fan motor, which had been found to be the cause of fire in a rollover accident. The course of fire is displayed in Table 3 and Figure 12.
