STATUS OF NHTSA'S EJECTION MITIGATION RESEARCH

National Highway Traffic Safety Administration
United States of America

Paper Number 19-0036

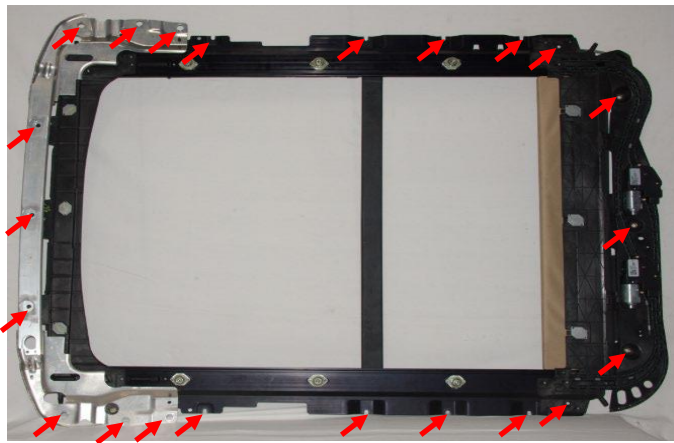
Figure 2. Red arrows indicate where sunroof module was bolted to the roof of the vehicle.

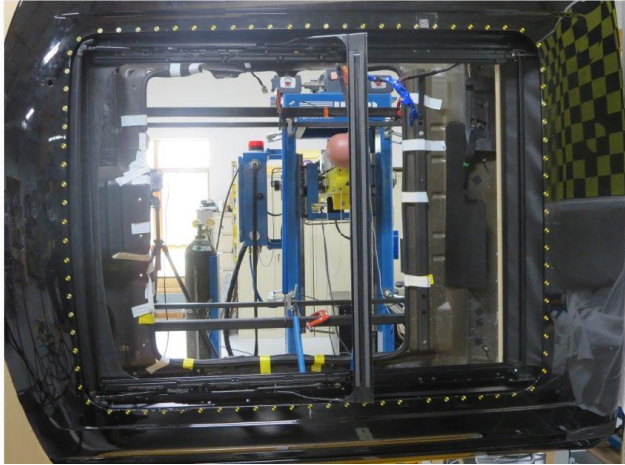
Figure 4. Front and rear panels assembled to module using screws along longitudinal edges.

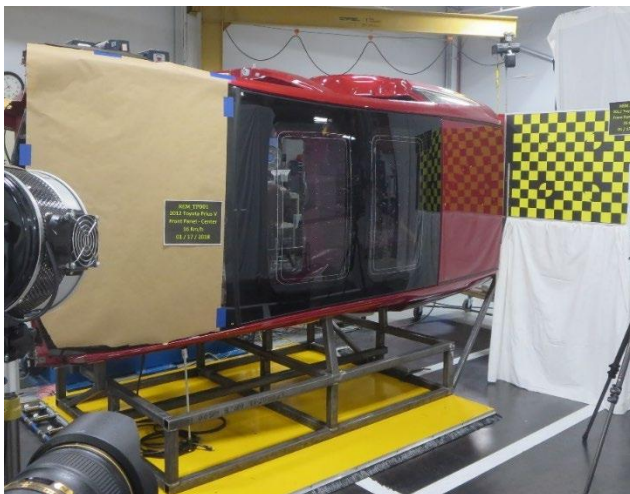
Figure 6. Sunroof panel glued to roof of vehicle with polyurethane.

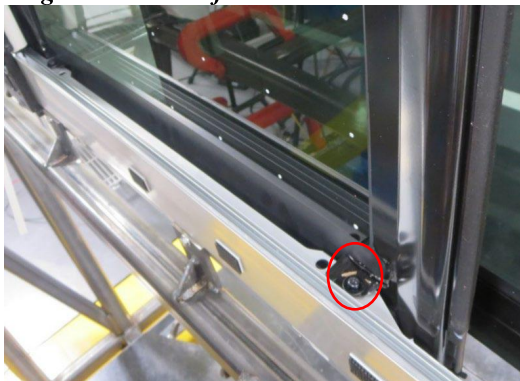
Figure 9. Panels attached to module using plastic brackets and glue along longitudinal edges.

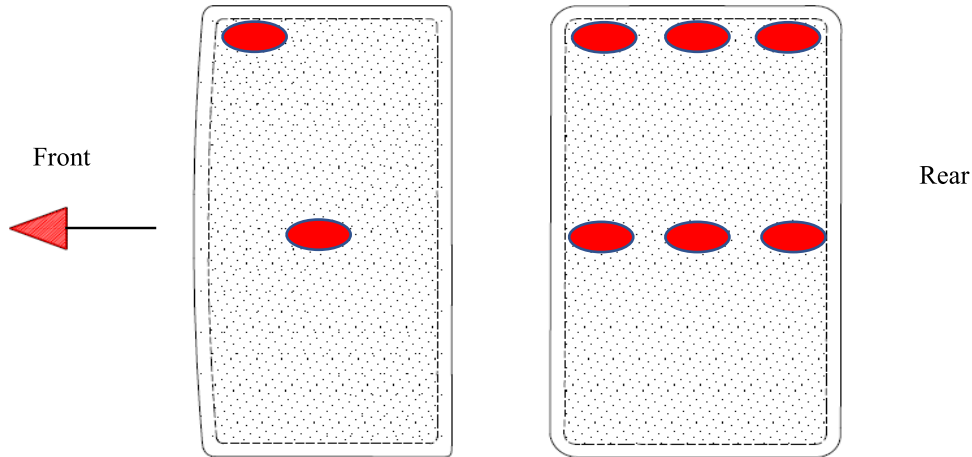
Figure 11. Initial test locations and headform orientation (F-150).

Countermeasures tested were the thicker PVB interlayer and the Protec® II glazing. Countermeasures were only tested at the center and front corner locations. Production glass was tested at the additional locations shown above. The test was setup following the procedure outlined in the section above for each of the tests. The only exception was test 74 where the Protec® II glazing was punched on both sides.

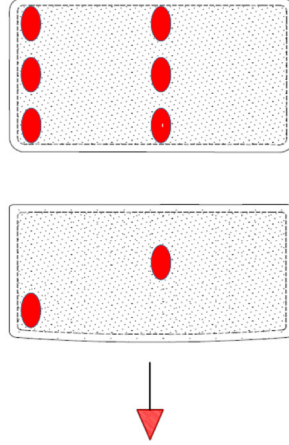
Table A2: 2016 Ford F-150 – New Test Setup

As seen in previous testing, the movable panels presented more challenges in containing the headform than fixed panels. Failure at the inserts into the rails occurred on the moving panel. The fixed panel had higher excursions at the unsupported edges (front and rear edges of rear panel).

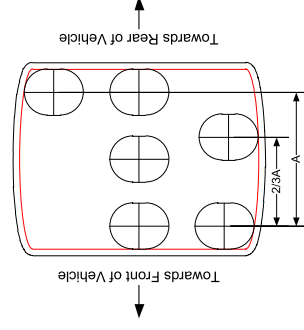
Table A3: 2012 Toyota Prius V

All Prius impacts had less than 100 millimeters excursions, generally around 50 millimeters. No separation at the glue interface was seen. Additionally, no failure of the polycarbonate or glue interface was seen even for multiple impacts at 20 kilometers per hour at the same location. Overall there were low ram displacements, however, due to less flexion of the sunroof panel there were high head deceleration values and therefore high forces on the headform. For example, when comparing an impact in the center of the Ford F-150 fixed panel at 16 kilometers per hour to an impact in the center of the Toyota Prius panel at 16 kilometers per hour, the forces on the headform were 2282 and 8663 Newtons, respectively. This is shown in Figure 18 below, with the F-150 in red and the Prius in blue.

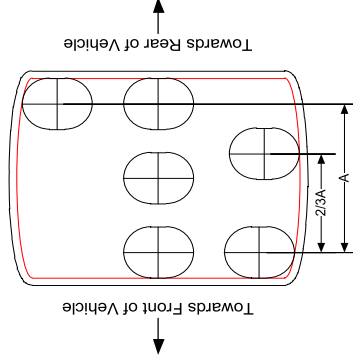
Table A4: Aisin Sunroof

The headform did not push through the PVB layer for any of the tests. In some tests, where the frame inserts didn't fail, the PVB layers had tears in it. On the front movable, panel brittle fracture of the plastic cam, which is used to raise the front edge when sliding the panel to open, occurred in some tests. In tests where the panel was moved to a partially open configuration there were also rail insert failures. The rail inserts had weakness at all locations impacted on the front panel. The rear fixed panel had weakness at the attachment brackets. Failures occurred at the bracket to glass glue adhesion as well as at the bracket attachment bolt. Bending of the encapsulation frame was also observed for many tests.
