# A STUDY OF FUEL SYSTEM INTEGRITY AND ELECTRIC SAFETY OF HFCV

Korea Automobile Testing and Research Institute

Paper Number 11-0412

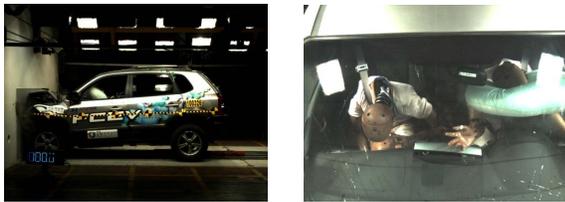
Pictures in Fig. 10 show the vehicle of frontal impact test scene. After the test, the occupant safety requirements met KMVSS article 91, 102.

**Figure 10. The test vehicle of frontal impact test.**

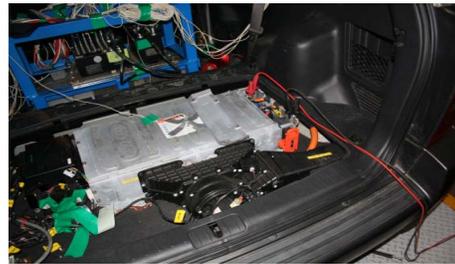
Picture in Figure 13 show the insulation resistance measurement scene. After the Frontal Impact Test, 3.1 kΩ/V values for the battery and body insulation resistance measurement were to meet the criteria. (100Ω/V)<sup>1),3),5),6),8)</sup>

**Figure 13. Insulation resistance measurement.**

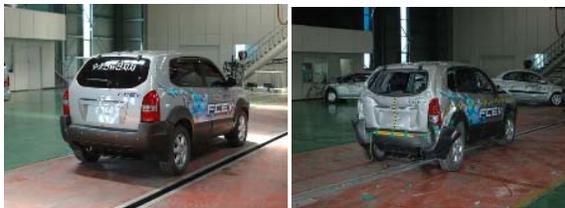
Pictures in Figure 15 show the vehicle before and after the test. Other than some weights to adjust the total weight of the vehicle, no additional system was installed in the engine compartment and the luggage compartment of the vehicle. After the test, the rearmost fuel tank was displaced toward the front by 172 mm, but not damaged.

**Figure 15. Rear-right view of the test vehicle before and after test.**

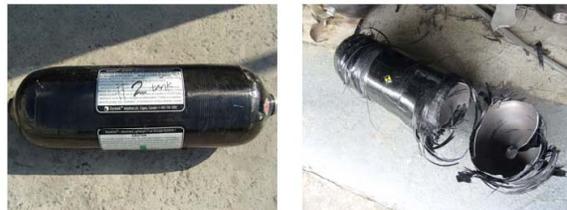
It was possible that the shock from the impact caused some deterioration to the tank's function to be filled at high pressure repeatedly. The tank was ruptured at the pressure of 103.8 MPa. This was high enough to satisfy the criteria, 82.2 MPa, which was 2.35 times the nominal working pressure, the EIHP standard. The tank withstood the pressure cycling test of over 11,250. Therefore there was no functional deterioration in the tested fuel tanks.

**Figure 19. Rupture test of hydrogen fuel tank after rear test.**

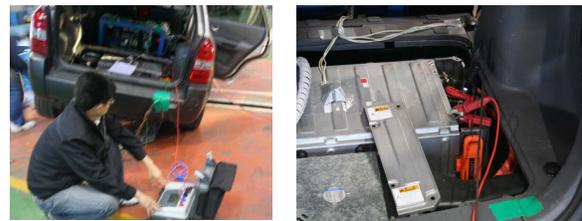
Picture in Figure 23 show the insulation resistance measurement scene. After the Frontal Impact Test, 4.8 kΩ/V values for the battery and body insulation resistance measurement were to meet the criteria. (100Ω/V)<sup>1),3),5),6),8)</sup>

Figure 23. Insulation resistance measurement.

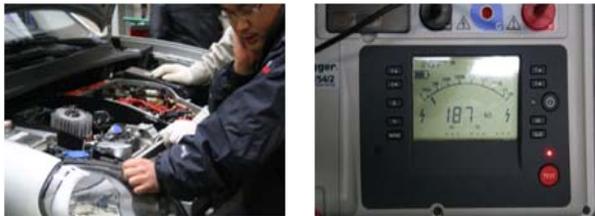
The minimum of electrical insulation resistance should be more than 100  $\Omega/V$  (DC), 500  $\Omega/V$ (AC).<sup>5),6)</sup> Insulation resistance of AC and DC input and output with both the vehicle chassis was evaluated above 1.28 k $\Omega/V$

**Figure 26. Insulation resistance evaluation.**

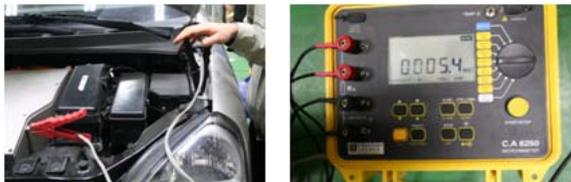
The test criteria of Protection against indirect contact should be less than 100 m $\Omega$ .<sup>5),6)</sup> The high voltage box enclosure and the Chassis was evaluated 5.4 m $\Omega$ . The supercapacitor enclosure and the chassis was evaluated 45.4 m $\Omega$ .

**Figure 27. The high voltage box enclosure and the chassis evaluation.**

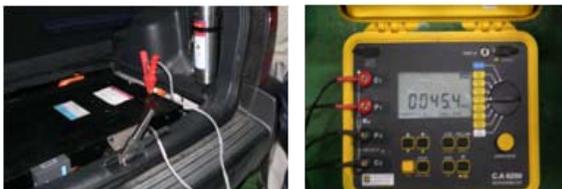
**Figure 28. The supercapacitor enclosure and the chassis evaluation.**
