ENERGY DISSIPATION AND STRUCTURAL INTEGRITY IN FRONTAL IMPACT

Izabella Ferenczi
Dr. Stefan Kerscher
Dr. Frank Möller
BMW Group
Munich, Germany
Paper Number 13-0321

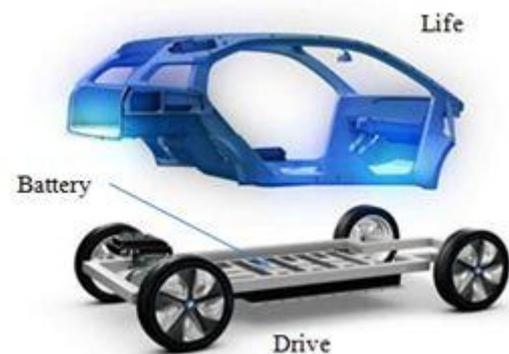
Figure 1: Life/Drive concept BMW i3

The battery is enclosed by the aluminum Drive structure with the advantages of a low center of mass, balanced weight distribution and ideal protection against external impact. This space-efficient storage in the under floor section has also the advantage of significantly more interior space than other vehicles with the same wheelbase due to omission of a centre tunnel. The front and rear structures are part of the 'Drive' module and as such made of aluminum. The 'Life' cell (passenger compartment) is a CFRP-shell construction which is mounted and affixed on top of the 'Drive' module. In case of frontal or rear impact the main part of the energy absorption is completed

The classification of the crash zones will be illustrated using the example of the i3, BMW's electric mega-city vehicle. The general vehicle concept is based on a horizontal-split variant of a Life/Drive-architecture:

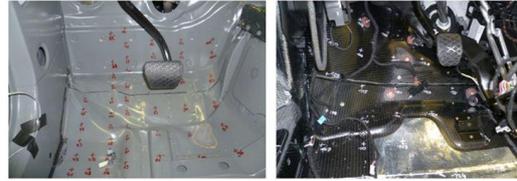
In spite of the occurrence of damage for example in the bulkhead (in case of frontal impact) or the side frame (in case of side impact) the intrusion level of a passenger compartment made of CFRP is comparable to that of similar conventional vehicles (i.e. size and mass) made of steel. As figures 6 and 7 show, the intrusion after frontal impact as well as after side impact (oblique pole) are in similar ranges.

Figure 6: foot well after frontal impact steel vs. CFRP

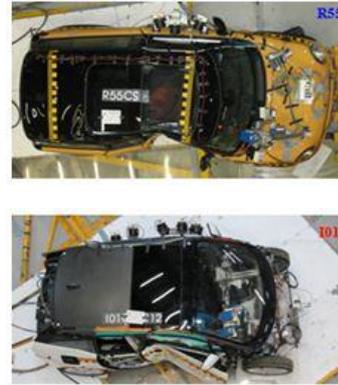
Figure 7: passenger compartment after side impact steel vs. CFRP

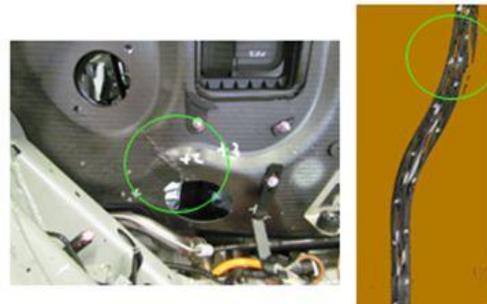
The main difficulty when judging damage and splintering in CFRP structures is the determination of the degree of damage (i.e. are all fiber layers affected or are there still intact fiber layers). Usually one cannot determine this by a simple sight check. One possibility for checking such undetermined damage is CT-scanning. This was done for example for typical damage and splintering in the bulkhead (see figure 8) after frontal impact.

Figure 8: CT-scan of splintering in bulkhead after frontal impact

The results of the CT-scanning show that permitted splintering in this area is not significant, i.e. many fiber layers are still intact. The resulting documentation for characteristic damage modes in different laminate layups can be used as an assessment catalogue for further visual inspections.

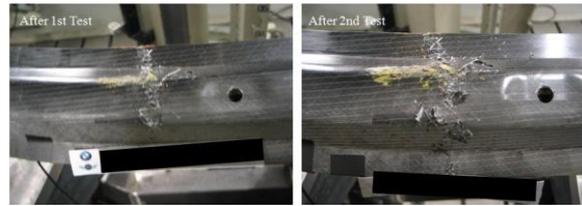
The test was repeated with the same, now partially damaged, structure. The set up, thus the load impact (mass and velocity of impactor) was equal to the first test. Although the characteristic of the damage in the CFRP structures corresponded to the damage after a FMVSS214 oblique pole test, the structures were able to absorb the same energy a second time (as shown in figures 11 and 12). Even the load level was nearly the same. In case of metal structures one would expect a considerable drop off of the force level if a significant rupture occurs.

Figure 11: roof panel after 1st (left) and 2nd (right) impact

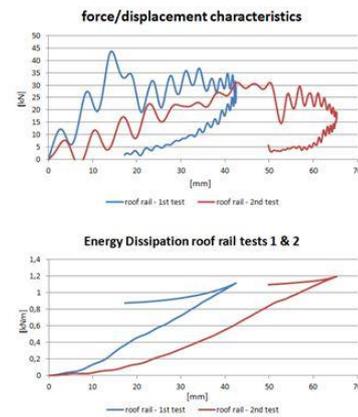
Figure 12: Force/Displacement characteristics of both roof rail tests
