CYCLIST-CAR ACCIDENTS – THEIR CONSEQUENCES FOR CYCLISTS AND TYPICAL ACCIDENT SCENARIOS

German Insurers Accident Research

Paper Number 15-0243

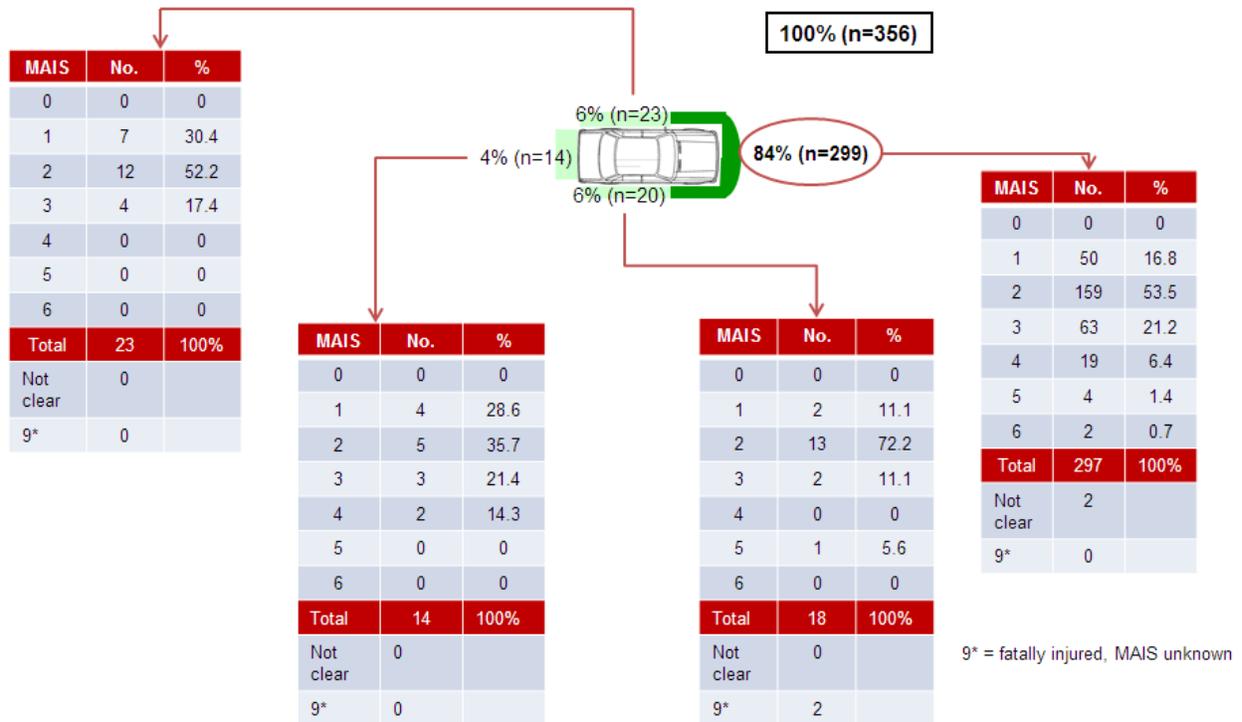
Figure 1 indicates how seriously the cyclists were injured in collisions involving each of these areas of impact. Figure 1 clearly shows that measures to improve the safety of cyclists need to be focused primarily on the front of the car. This is true in relation to both the frequency of the impacts and cyclists' maximum level of injury severity [3].

Figure 1. Maximum levels of injury severity (MAIS) in the cyclists by area of impact on the car

Figure 1 illustrates that most collisions between bicycles and cars involve impact with the front part of the car (n = 299 cases). In 23 of these cases the car was parked. Consequently, only 276 cases are included in our consideration of typical accident constellations. Thus, both parties involved were in motion at the time of the accident in these remaining cases.

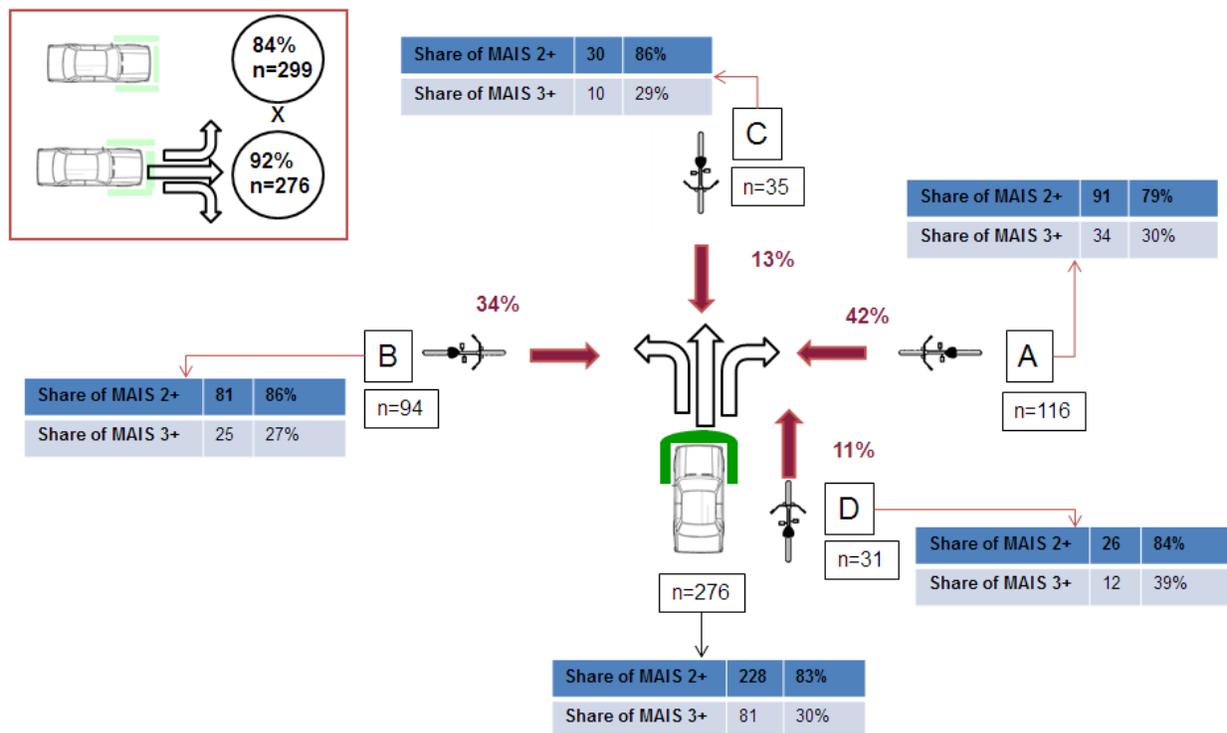
Figure 2 shows four different impact constellations, to which all the observations that follow apply:

- **A:** The car is traveling straight ahead or turning left or right, and the bicycle is coming from the right.
- **B:** The car is traveling straight ahead or turning left or right, and the bicycle is coming from the left.
- **C:** The car is traveling straight ahead or turning left or right, and the bicycle is approaching head-on.
- **D:** The car is traveling straight ahead or turning left or right, and the bicycle is moving in the same direction.

Constellation A is the most common one (with 116 cases), followed by constellation B (94 cases) and then constellations C (35 cases) and D (31 cases).

The box in the upper-left corner of Figure 2 shows the subset of the cyclist-car accident material to which the information in the main part of Figure 2 applies. The same principle applies to the boxes in Figures 3 to 5.

Figure 2. Frequency of different impact constellations at the front part of the car with the corresponding distributions of MAIS 2+ and MAIS 3+ in the cyclists

thus significantly higher (at 39%) than in constellation A (30%), constellation B (27%) or constellation C (29%). As shown in Figure 2, however, constellation D is the least common of the accident constellations investigated here (at 11%).

It can be seen from Figures 2 and 3 that accident constellations A (116 cases) and B (94 cases) are clearly more common than the other constellations in this accident material. These two accident constellations will be described in depth below.

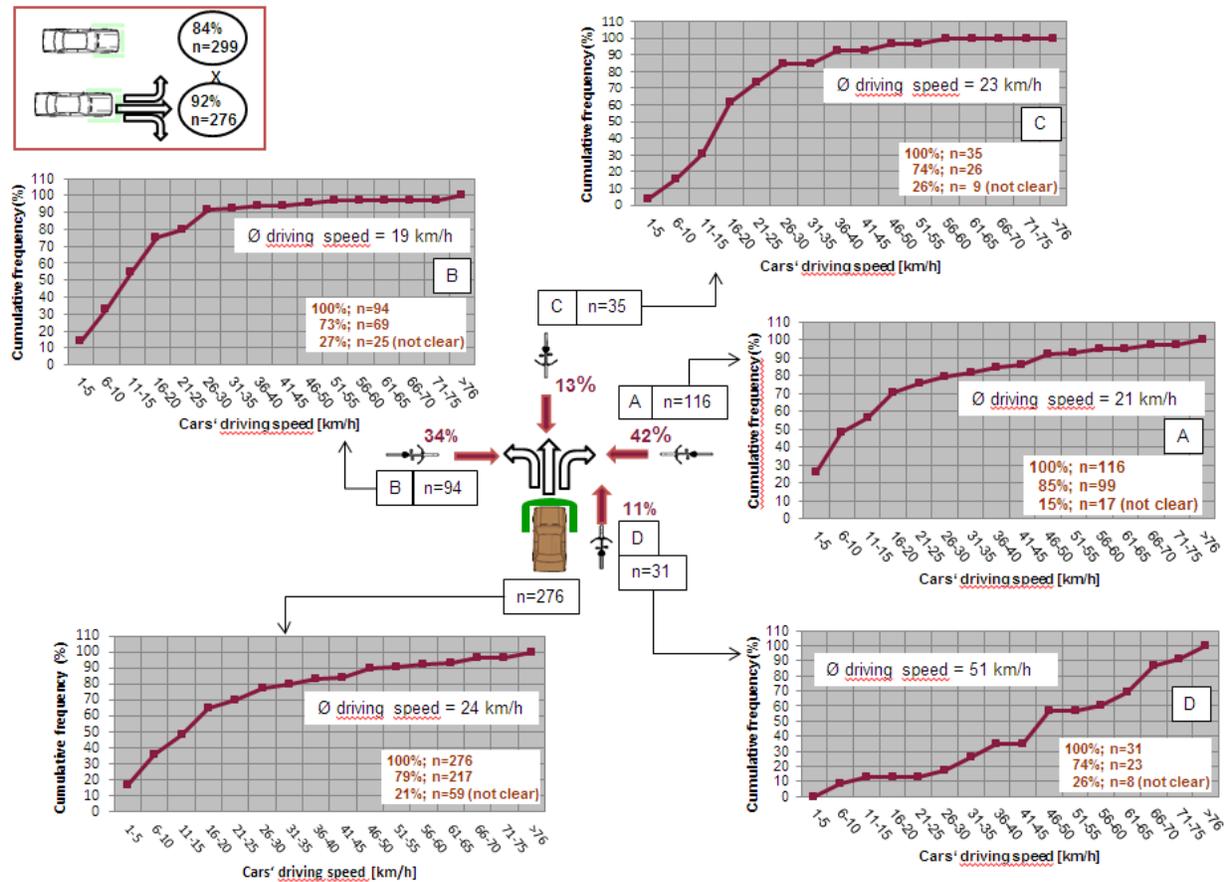
Figure 3 shows the average speeds of the cars for these four constellations. The average speeds of the cars in constellations A, B and C were very similar (19 km/h to 23 km/h), while for constellation D the average speed was significantly higher (51 km/h).

Figure 3. Average speeds of the cars by impact constellation

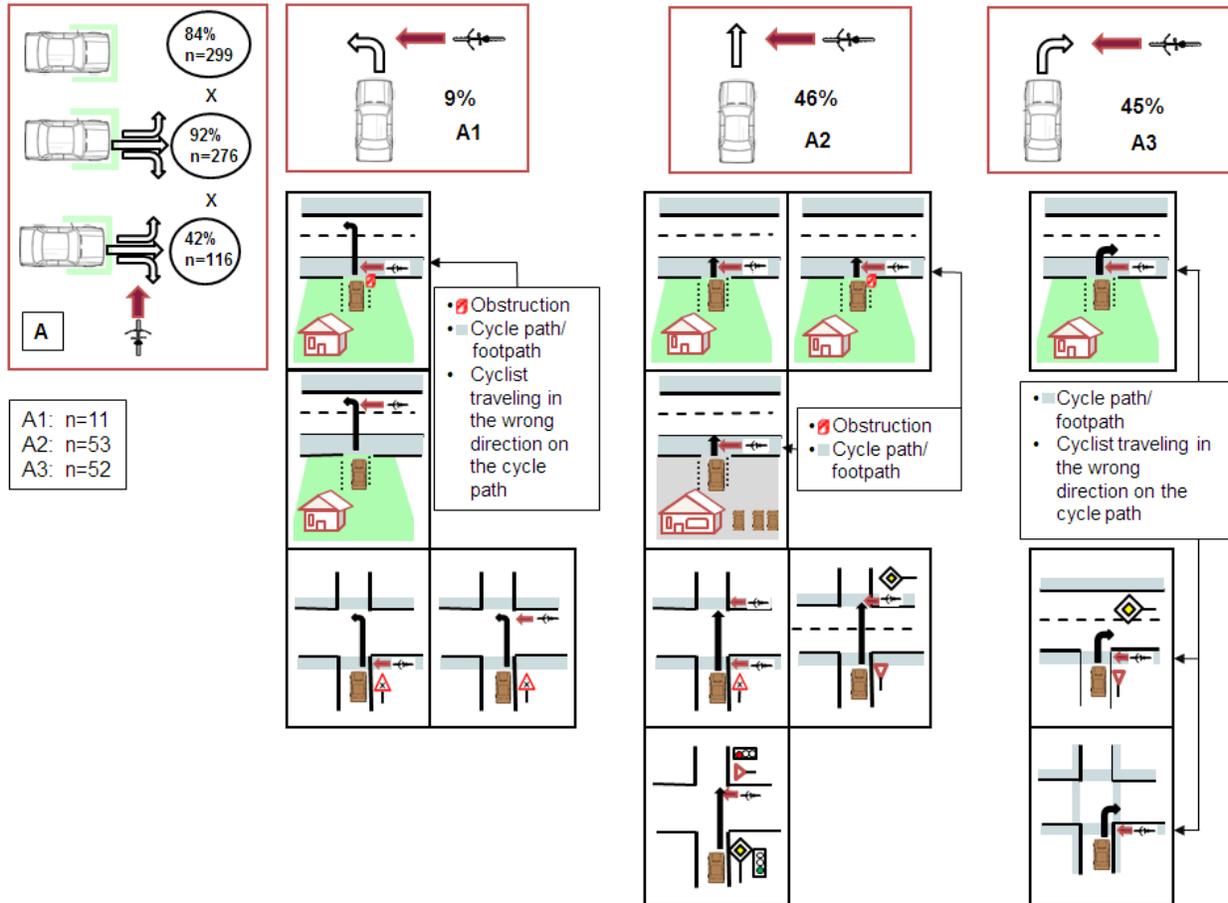
Accident constellation A, bicycle coming from the right: Accident constellation A can be subdivided into three separate scenarios (see Figure 4):

- A1: The car is turning left, and the bicycle is coming from the right.
- A2: The car is traveling straight ahead, and the bicycle is coming from the right.
- A3: The car is turning right, and the bicycle is coming from the right.

Accident scenarios A2 and A3 occur with almost exactly the same frequency, accounting for 46% and 45% of the cases. Scenario A1, on the other hand, occurs much more rarely (9%). The lower part of Figure 4 sets out concrete situations for each of the three accident scenarios (A1, A2 and A3) that show the circumstances of the cyclist-car collision in more detail.

Figure 4. Distribution of accident scenarios A1, A2 and A3 and illustration of typical cases

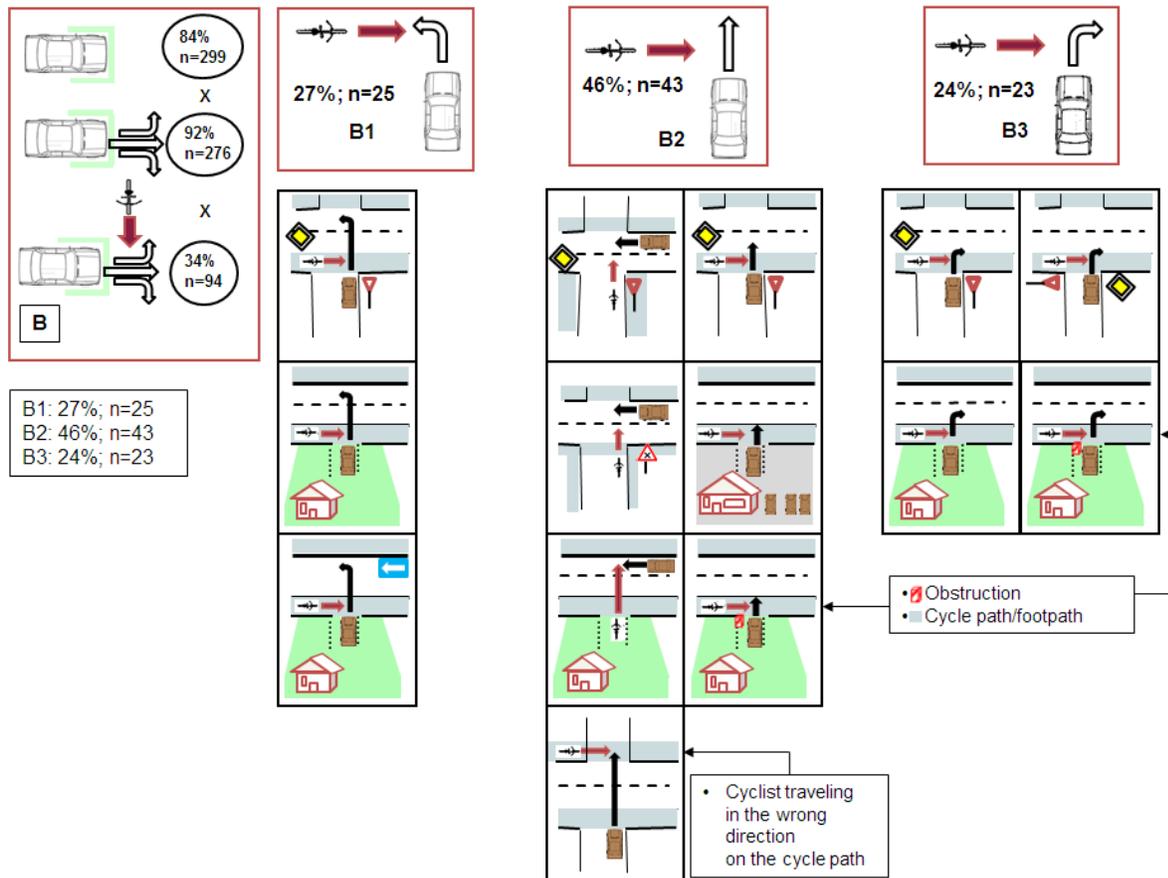
Accident constellation B, bicycle coming from the left: Like accident constellation A, accident constellation B can also be subdivided into three separate scenarios (see **Figure 5**):

- B1: The car is turning left, and the bicycle is coming from the left.
- B2: The car is traveling straight ahead, and the bicycle is coming from the left.
- B3: The car is turning right, and the bicycle is coming from the left.

Figure 5. Distribution of accident scenarios B1, B2 and B3 and illustration of typical cases

B2 is the most common accident scenario (accounting for 46% of the cases), while scenarios B1 and B3 occur with a similar frequency (27% and 24%). The lower part of Figure 5 sets out concrete situations that show the circumstances of the cyclist-car collision in more detail.

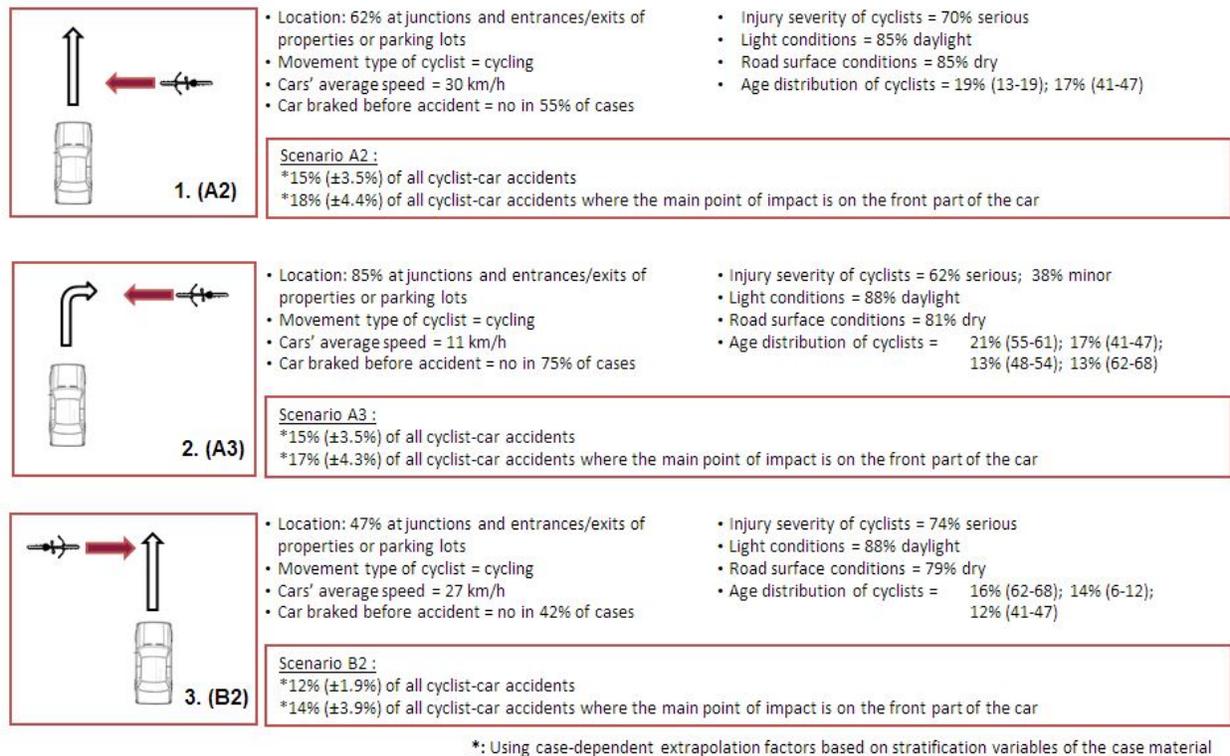
Two out of three A2 accidents take place at entrances or exits, the average speed of the car is 30 km/h, and the driver does not brake in 55% of all cases. In scenario A3, 85% of the collisions between cyclists and cars take place at entrances or exits, and the driver does not brake in three of every four cases. This suggests that the driver either does not see the cyclist or does not have enough time to brake. The average speed of the car in scenario A3 is 11 km/h. The percentage of entrances and exits involved in scenario B2 is also very high (47%). The average speed of the cars in scenario B2 is 27 km/h, and the driver does not brake in 42% of the collisions. Further characteristics of scenarios A2, A3 and B2, such as light conditions, the condition of the road and the injury severity and age distribution of the cyclists, are also shown in Figure 6.

Figure 6. The three most common accident scenarios, their significance in relation to all cyclist accidents and characteristic features of these accident scenarios

Summary assessment of the three most common accident scenarios In addition to the findings described in this paper, a range of further analyses were also carried out and assigned to the various accident scenarios. Moreover, extrapolation factors were used to extrapolate the cyclist-car accident material described here to all claims reported to the GDV. When all these findings are combined, the picture shown in **Figure 6** is obtained: Scenarios A2 and A3 are the most common, followed by B2. These three scenarios alone account for 42% (15% + 15% + 12%) of all cyclist-car accidents.
